WMSA Commissioner Brief: W-0057 – Improper RWP near Fort Totten & Takoma Stations – August 27, 2020

FINAL REPORT OF INVESTIGATION A&I E20318

Fort Totten Station – Improper Roadway Worker Protection

August 27, 2020

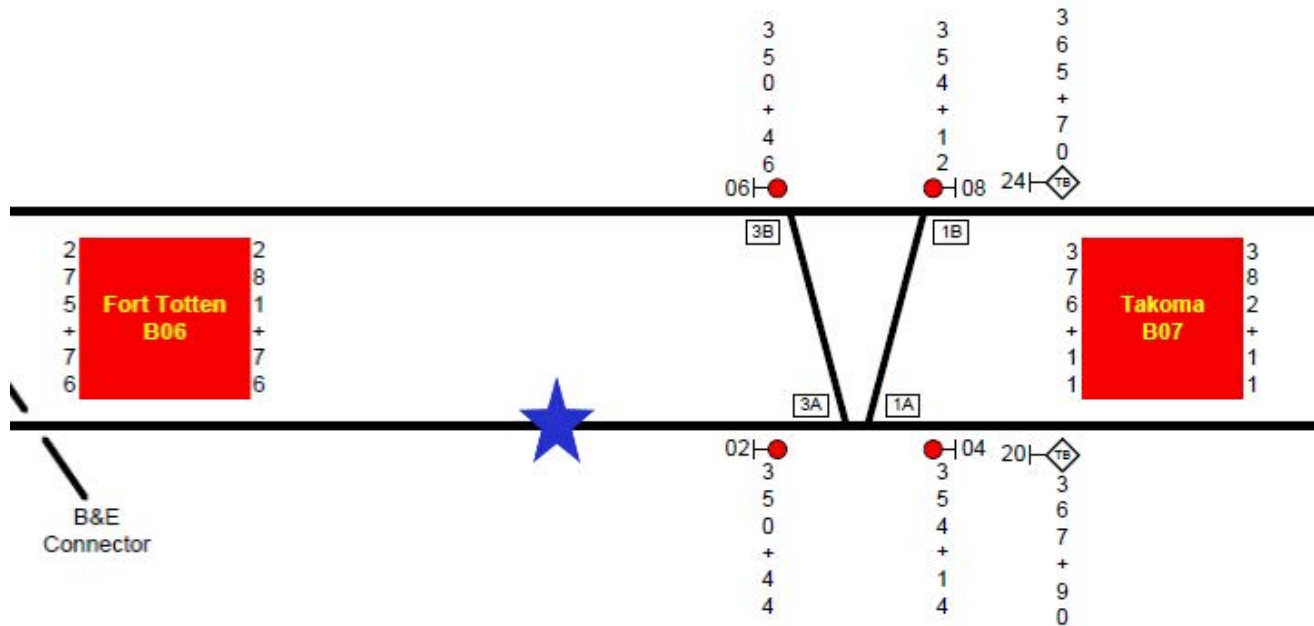
Figure 1: Track diagram of incident location.

Between Takoma Station and Fort Totten Station, Track #1

Hot Spot: Restricted Curve [Blind Spot; Curve]

FT AREA: CM B1-325+00 to B1-305+00

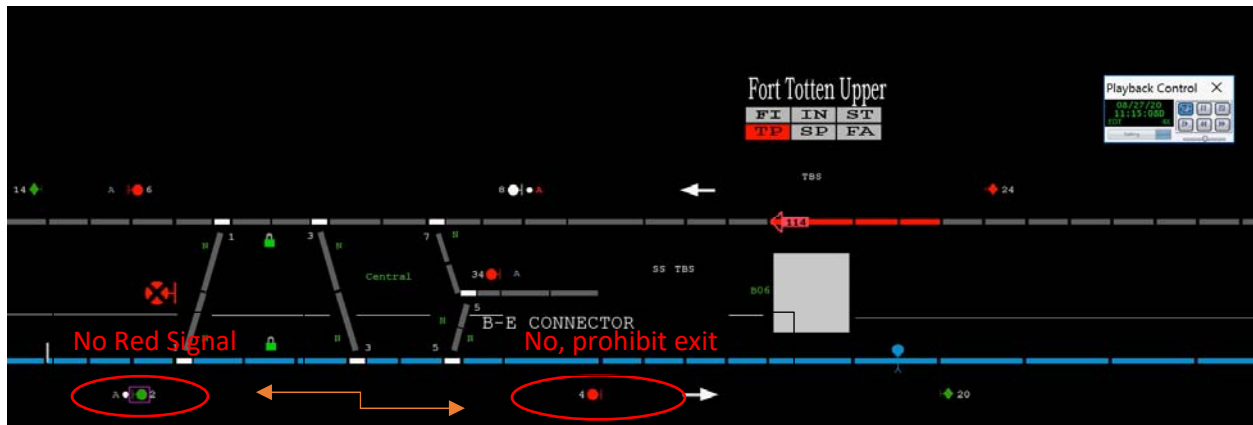
Figure 2: AIM display indicating no FT protection for TRST at 11:15 hrs. B06-02 signal remained fledged, and the B06-04 signal did not display a prohibit exit. TRST RWIC was instructed to standby and stand clear.

Note: Had TRST been permitted FT, the Button RTC would have canceled the B06-02 signal and placed a prohibit on the B06-04 signal.
