## **WMSC Commissioner Brief: W-0058 – Improper RWP near Silver Spring Station – August 29, 2020**

**FINAL REPORT OF INVESTIGATION A&I E20319**

**Silver Spring Station – Improper RWP  
August 29, 2020**

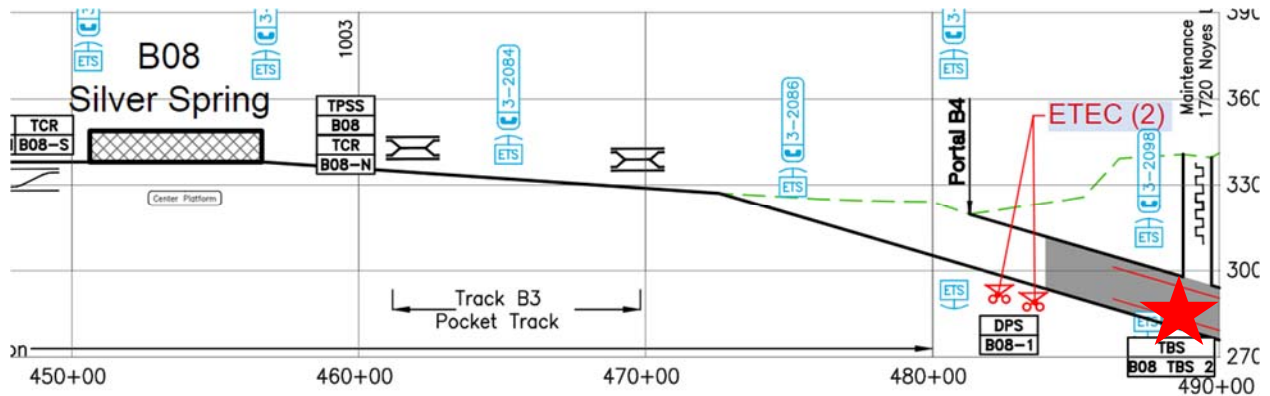
Figure 1: Incident site, near Silver Spring Station, Tracks 1 and 2, CM 488+00

Near Silver Spring Station, Tracks 1 and 2, CM 488+00
