WMSC Commissioner Brief: W-0059 – Improper RWP at Tysons Corner Station – September 3, 2020

FINAL REPORT OF INVESTIGATION A&I E20328

Date of Event:	9/3/2020
Type of Event:	Improper Roadway Worker Protection
Incident Time:	00:29 hrs.
Location:	Tysons Corner Station, Tracks 1 and 2
Time and How received by SAFE:	02:21 hrs. – SAFE – Self-Reported
WMSC Notification Time:	04:27 hrs.
Rail Vehicle:	N/A
Injuries:	No
Damage:	No
SMS I/A Incident Number:	20200903#88722

**Tyson's Corner Station – Improper Roadway Worker Protection
September 03, 2020**

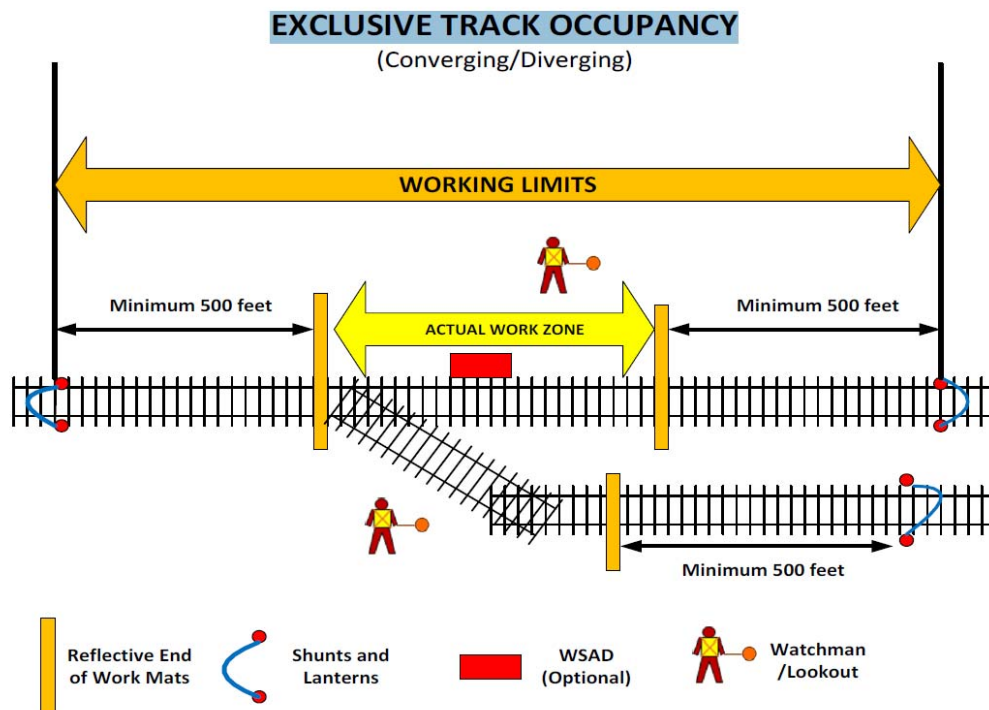
Due to the nature of work being performed in proximity of the third rail, the request to downgrade protection by the RWIC and approval by ROCC was not in accordance with Metrorail Safety Rules and Procedures Handbook (MSRPH) 5.17.4. The RWIC was supposed to contact the Rail Operation Control Center (ROCC) and request FT for setting-up Exclusive Track Occupancy (ETO) under Roadway Worker Protection (RWP) safety rules in the MSRPH 5.13.7. The correct ETO RWP set-up requires shunts located at 500 feet outside of each end of the working zone, red lanterns or e-flares, "END Work AREA" mats, and WASDS. Once all safety equipment was in place, the RWIC was supposed to contact the ROCC and relinquish FT and inform ROCC that the work limits were under ETO protection, which did not happen. The following steps are the ETO "RWIC Procedures to establish ETO Authority:

Diagram 1 – Correct ETO protection diagram.

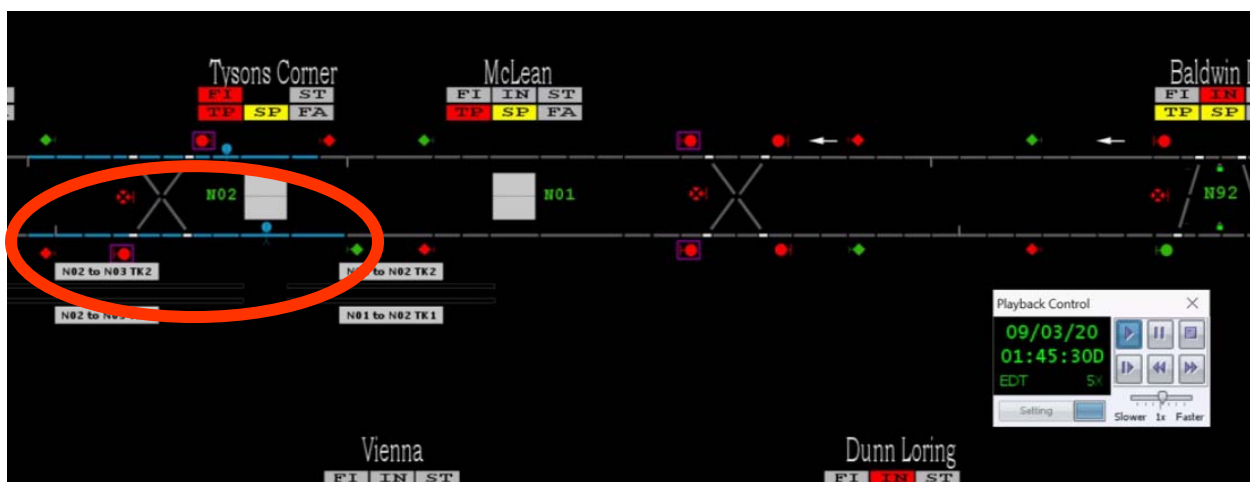
The Advanced Information Management System (AIMS) playback shows prohibit exits, block calls, cancellation of automatic signals, blue block, and human form status were implemented as required for FT while the work crew was on the roadway at Tysons Corner, Tracks 1 and 2.

Diagram 2 - Shows prohibit exits, block calls, cancellation of automatic signals, blue block, and human form status are in place while the work crew was on the roadway at Tysons Corner, Tracks 1, and 2.
