WMSC Commissioner Brief: W-0060 – Fire/Smoke at Capitol Heights Station – June 6, 2020

FINAL REPORT OF INVESTIGATION A&I E20214

Date of Event:	6/6/2020
Type of Event:	Fire/Smoke
Incident Time:	18:07 hrs.
Location:	Capitol Heights Station, Track 2
Time and How received by SAFE:	18:26 hrs. - Phone Call
WMSC Notification Time:	19:31 hrs.
Rail Vehicle:	N/A
Injuries:	No
Damage:	Damaged Insulators

Capitol Heights Station – Fire and Smoke Arcing Insulator

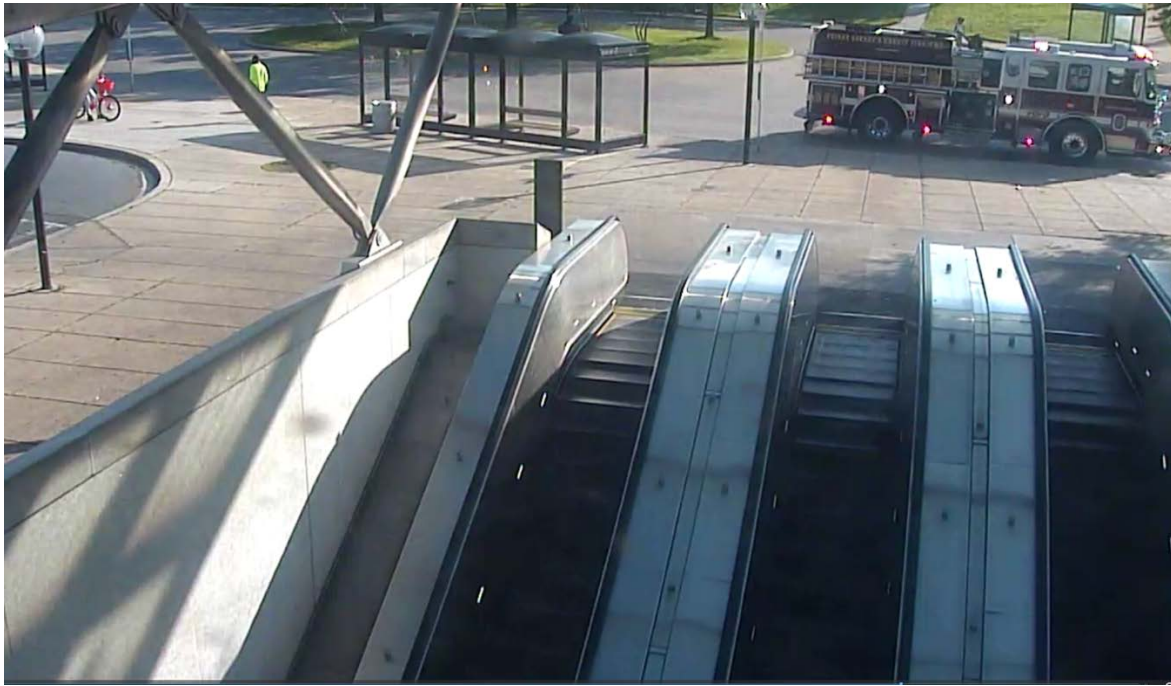
Photo 1 – 18:17 hrs. PGFD arrives at Capitol Heights Station.

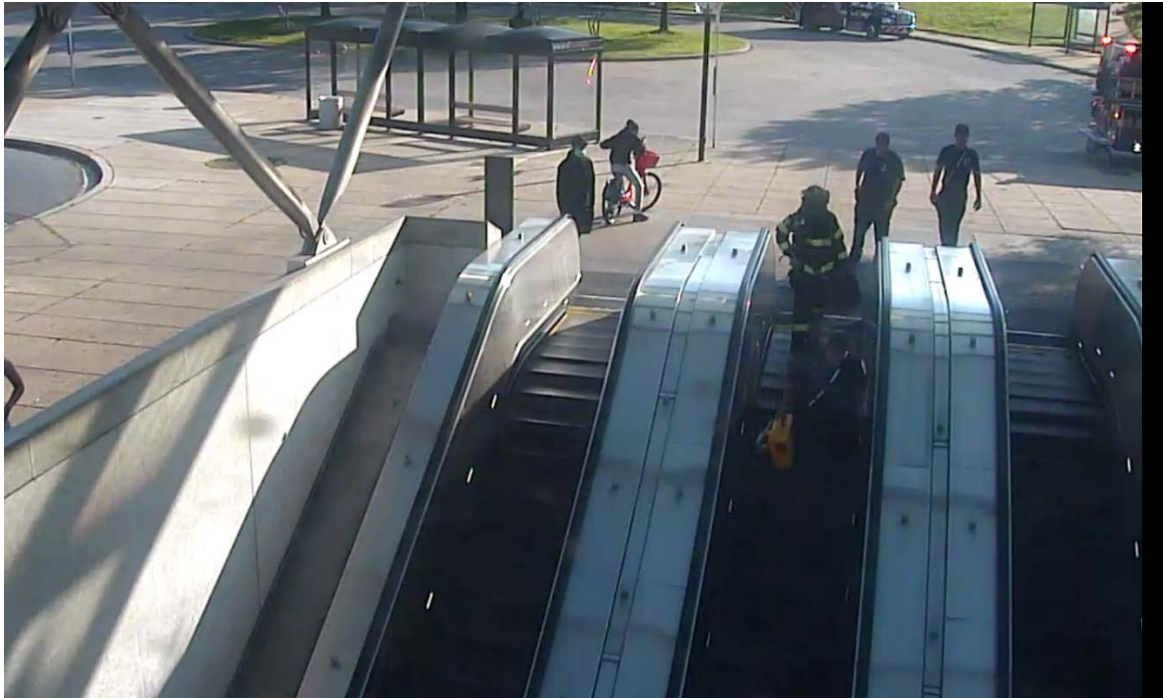
Photo 2 – 18:19 hrs. PGFD Enters Capitol Heights Station.

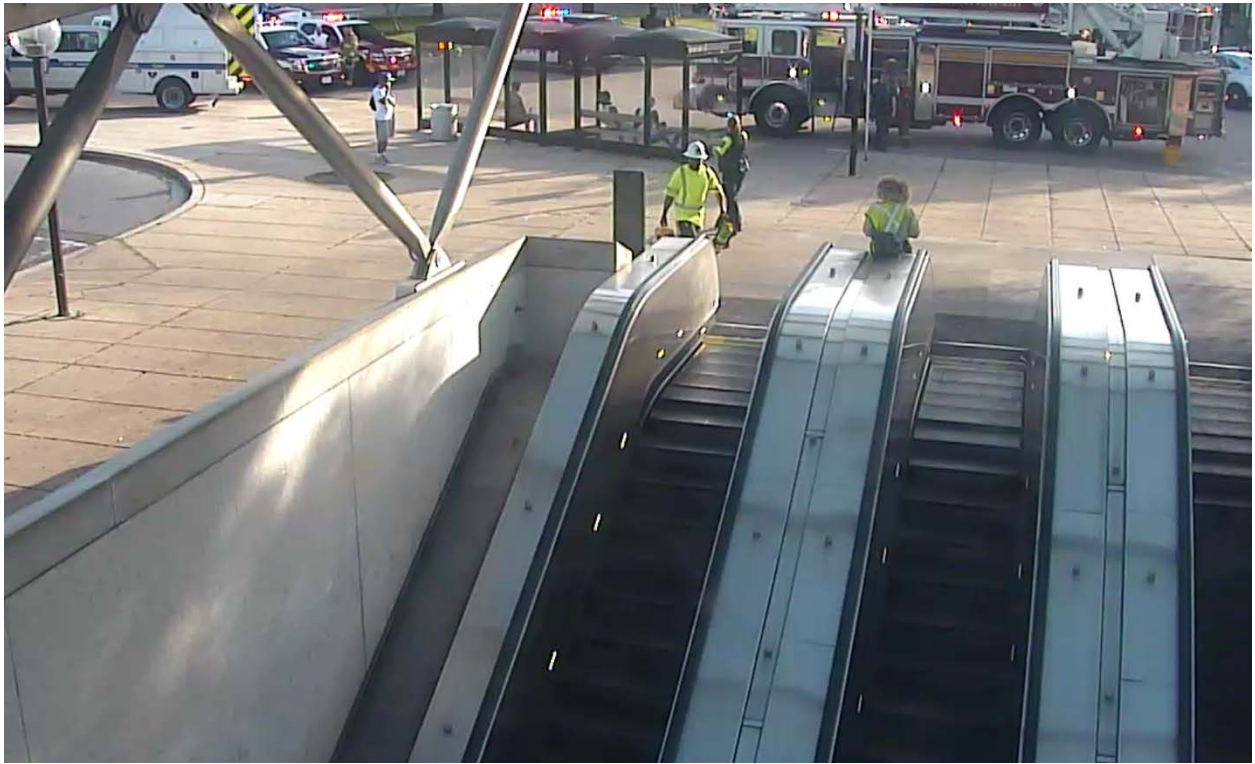
Photo 3 – 18:42 hrs. ERT enters Capitol Heights Station and bypasses MTPD.

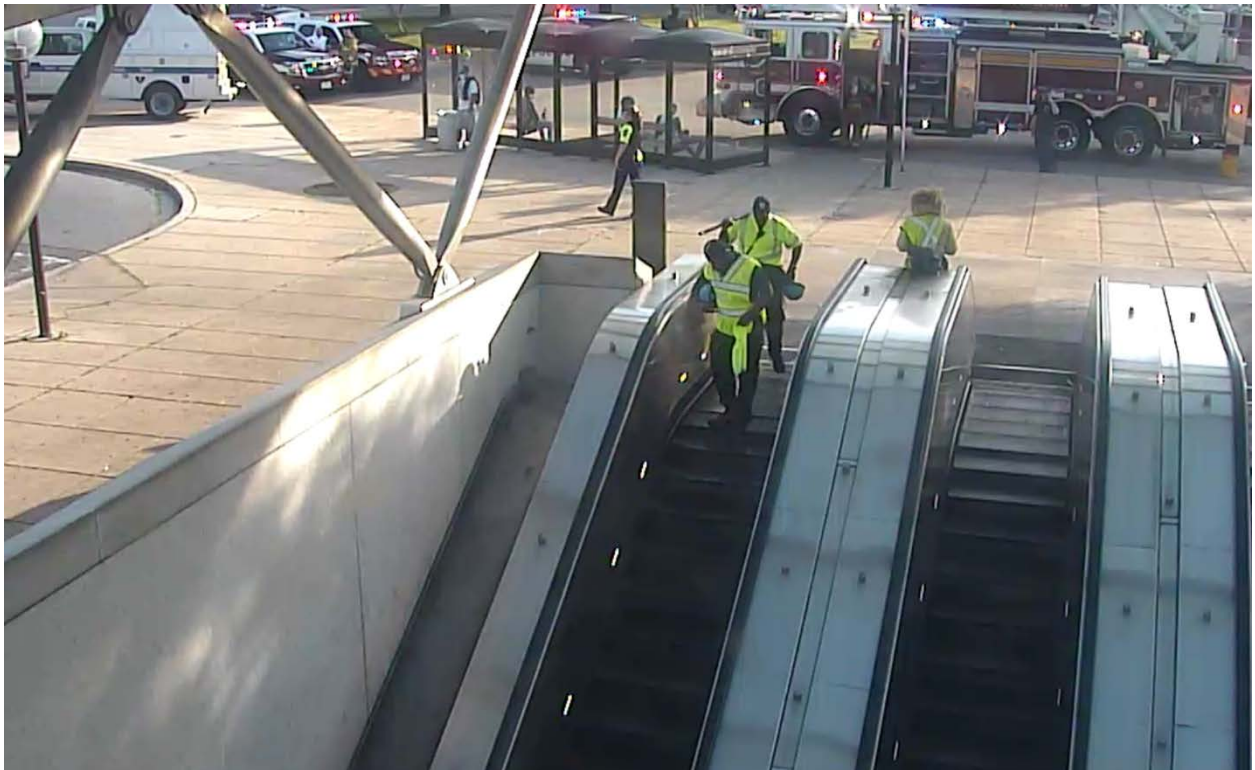
Photo 4 – 18:43 hrs. Additional ERT personnel bypass MTPD and Station Manager.

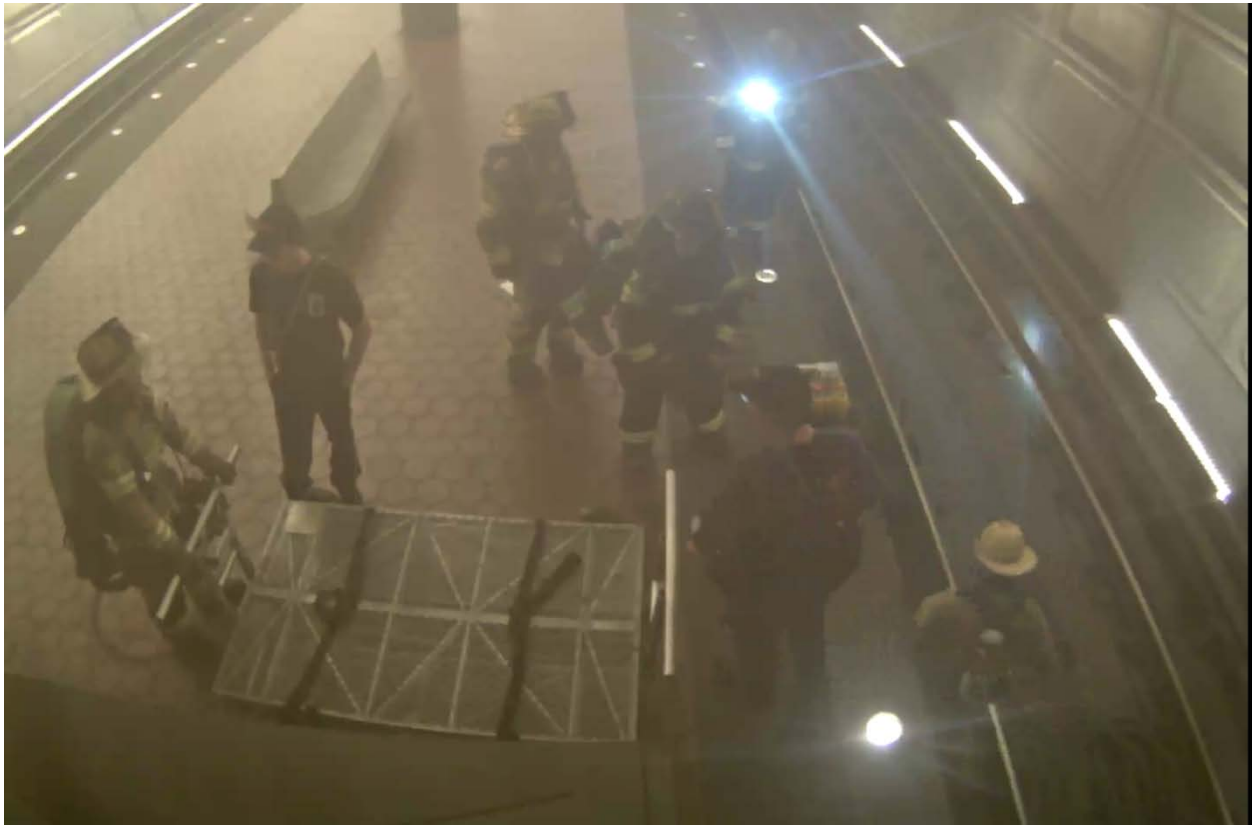
Photo 5 - 18:43 hrs. PGFD was observed on the roadway.

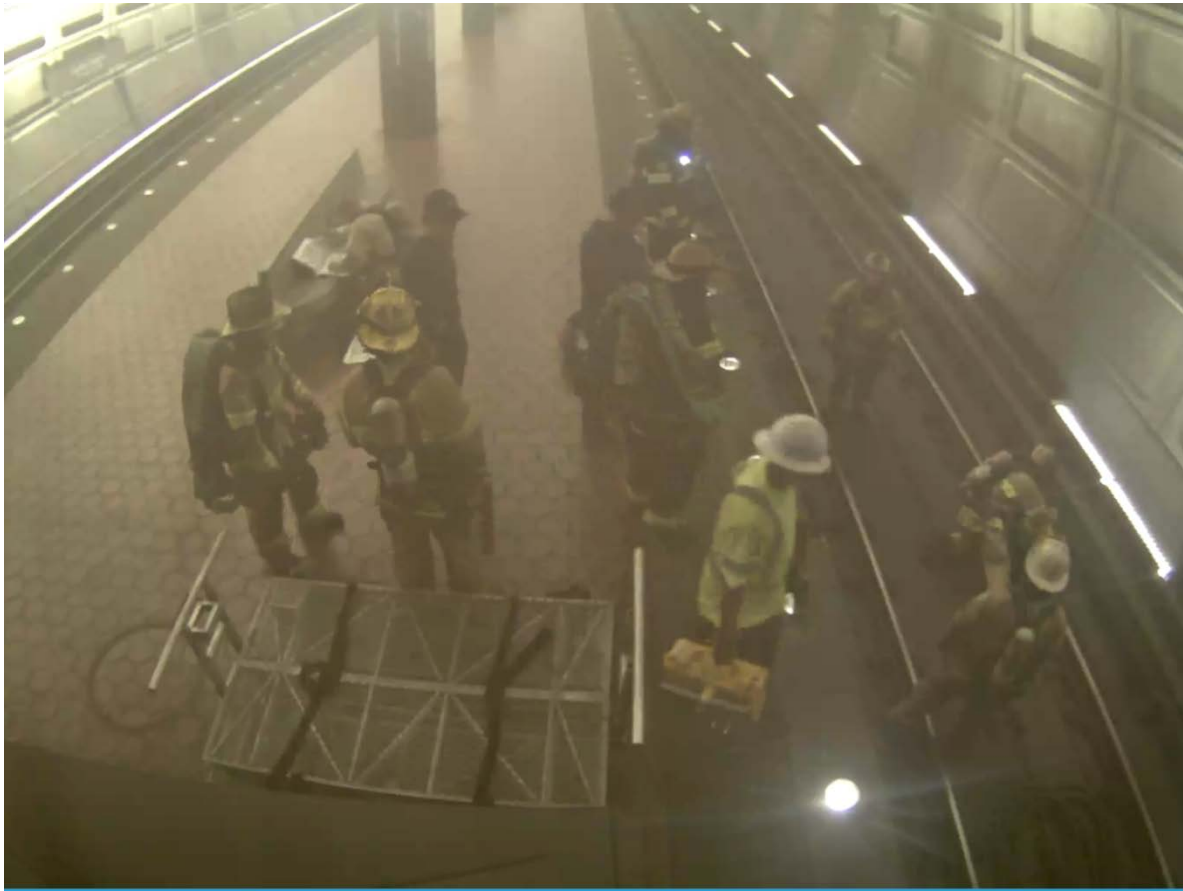
Photo 6 – 18:44 hrs. ERT arrived on location and engaged in conversation with PGFD.

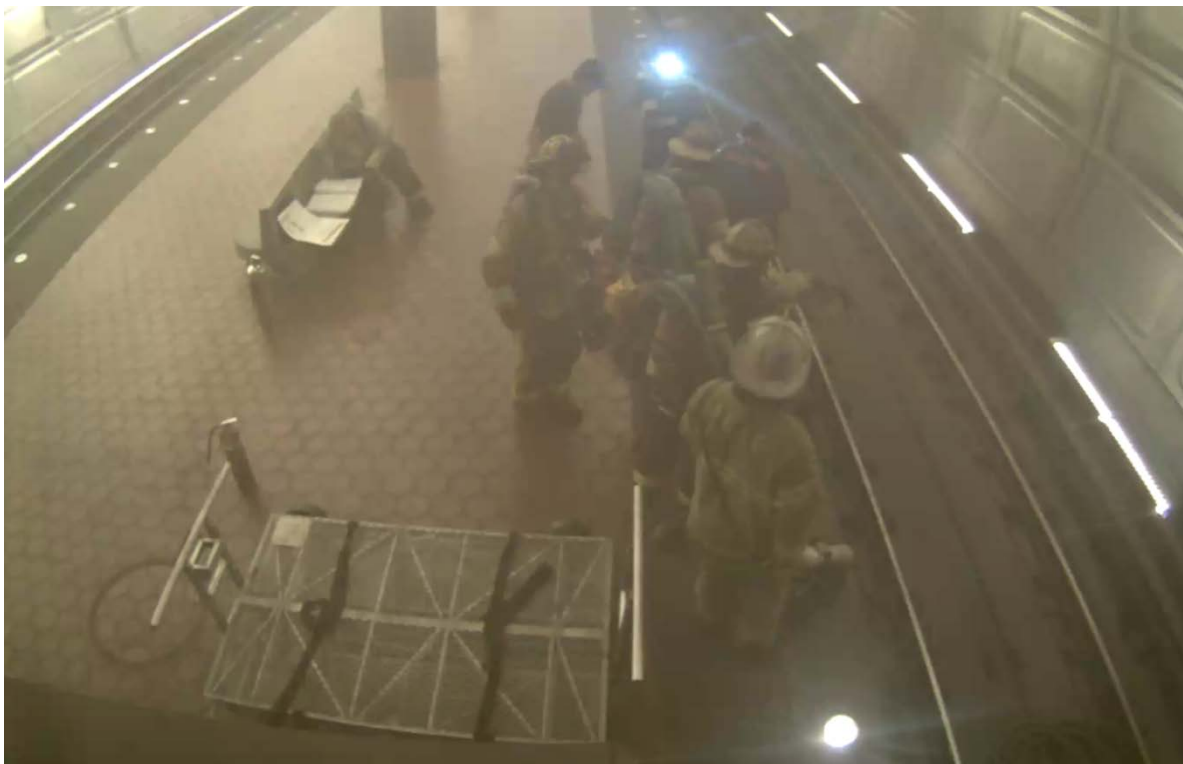
Photo 7 – 18:47 hrs. PGFD cleared the roadway.

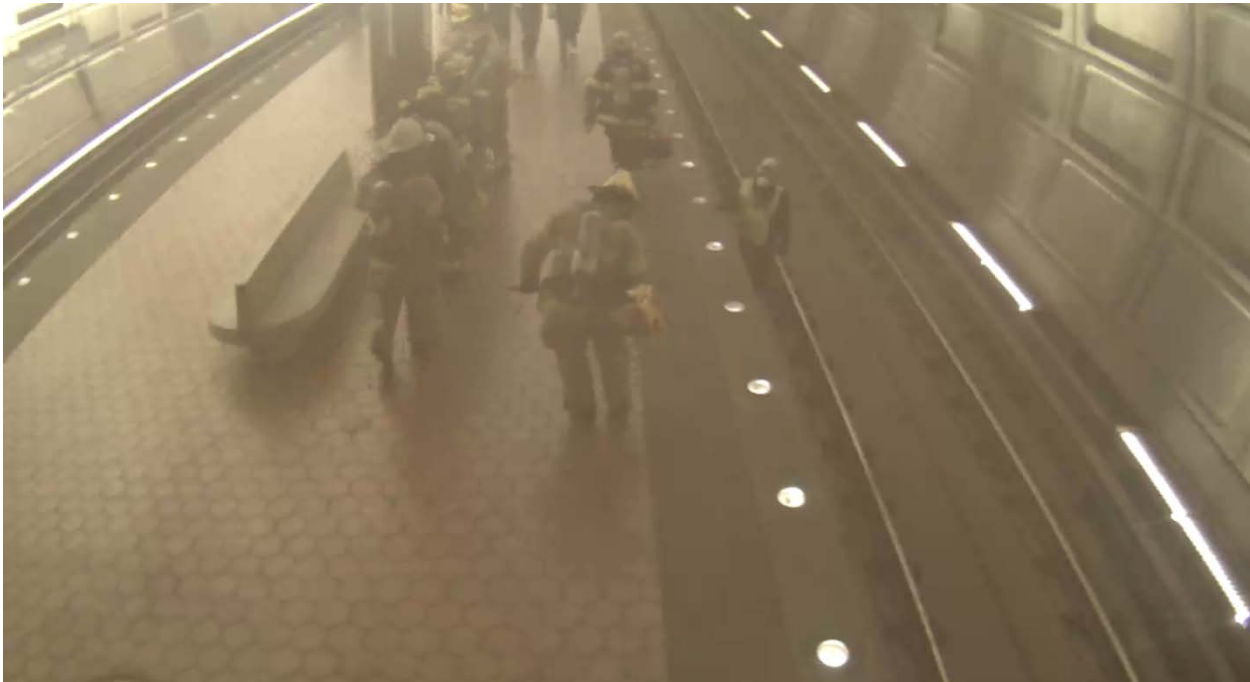
Photo 8 –19:22 hrs. PGFD observed leaving the station.

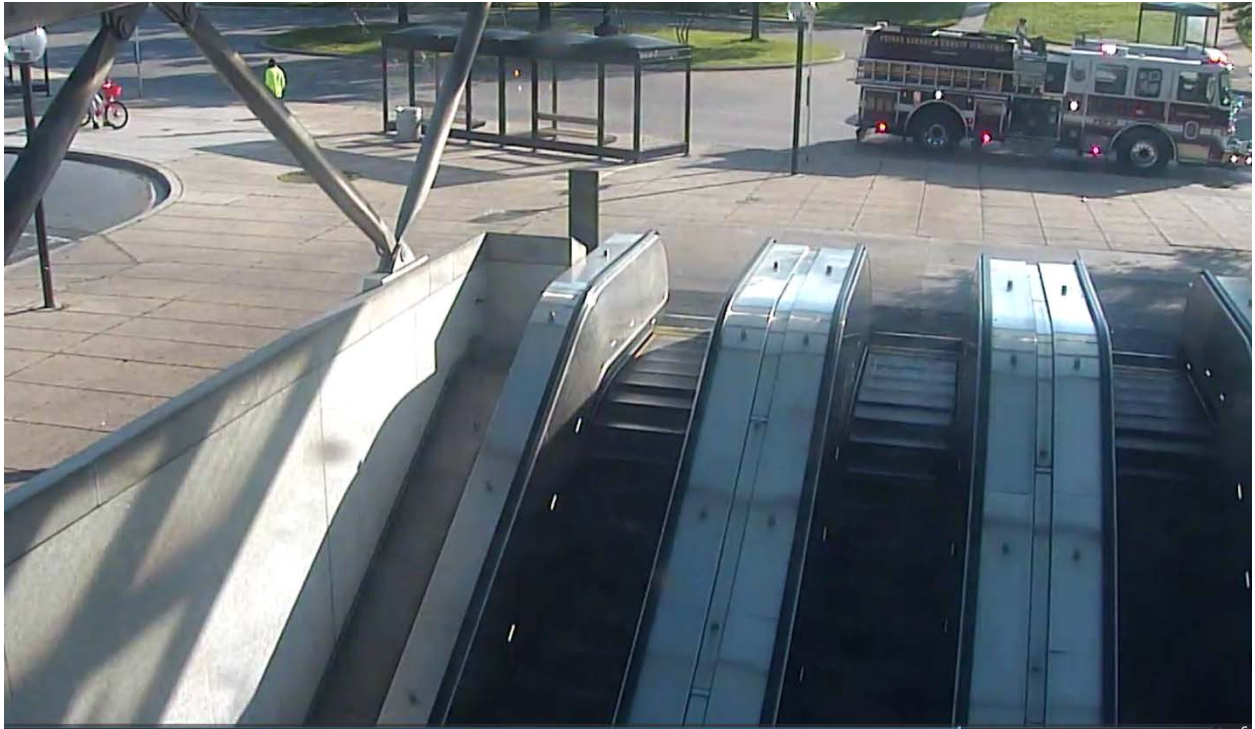
Photo 1 – 18:17 hrs. PGFD arrives at Capitol Heights Station.

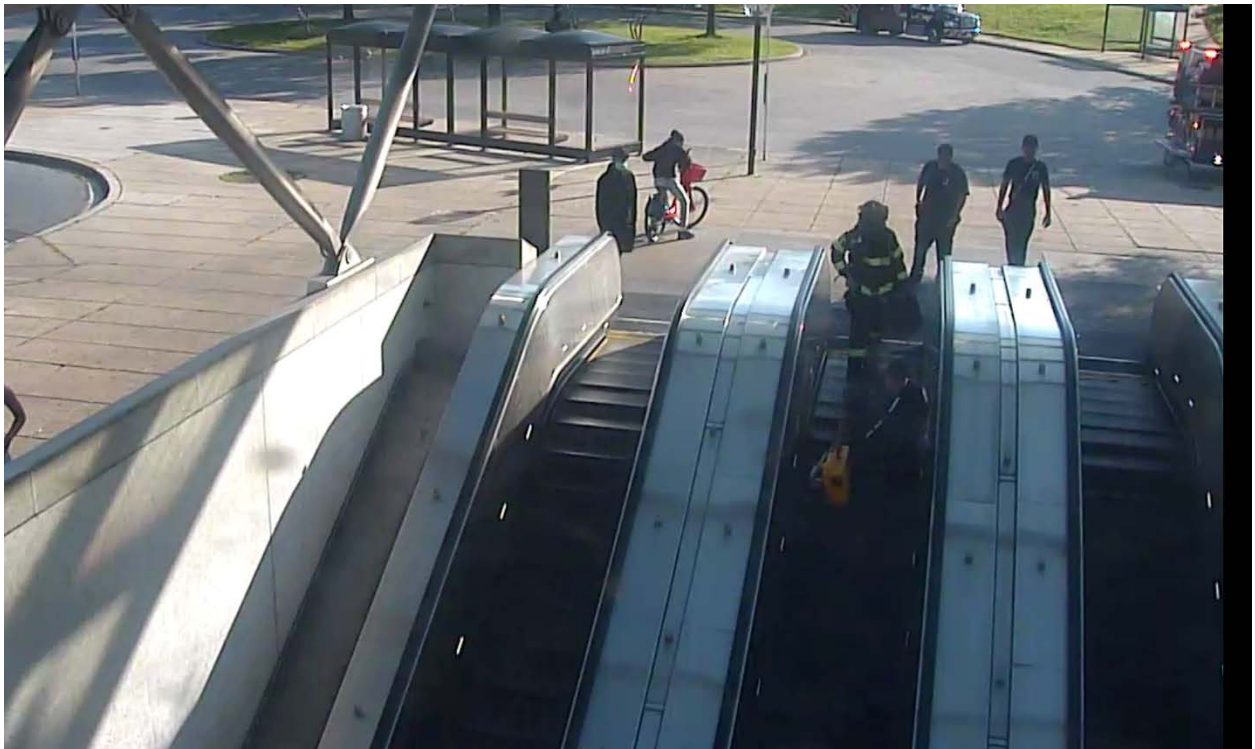
Photo 2 – 18:19 hrs. PGFD Enters Capitol Heights Station.
