WMSC Commissioner Brief: W-0061 – Improper movement – Branch Avenue Yard – September 3, 2020

FINAL REPORT OF INVESTIGATION A&I E20329

Branch Avenue Yard – Unintended Movement

September 3, 2020

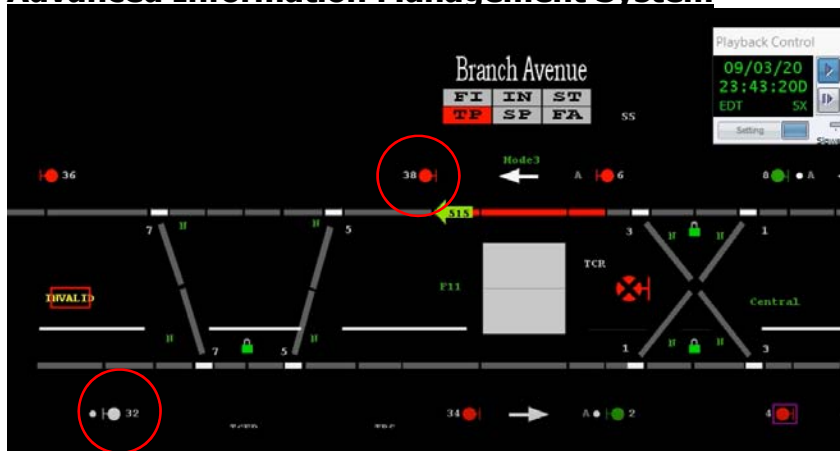
Photo 1: Train ID 515 standing by to enter the yard. F11- 32 lunar set for Sperry Unit 800 to enter the mainline tracks.

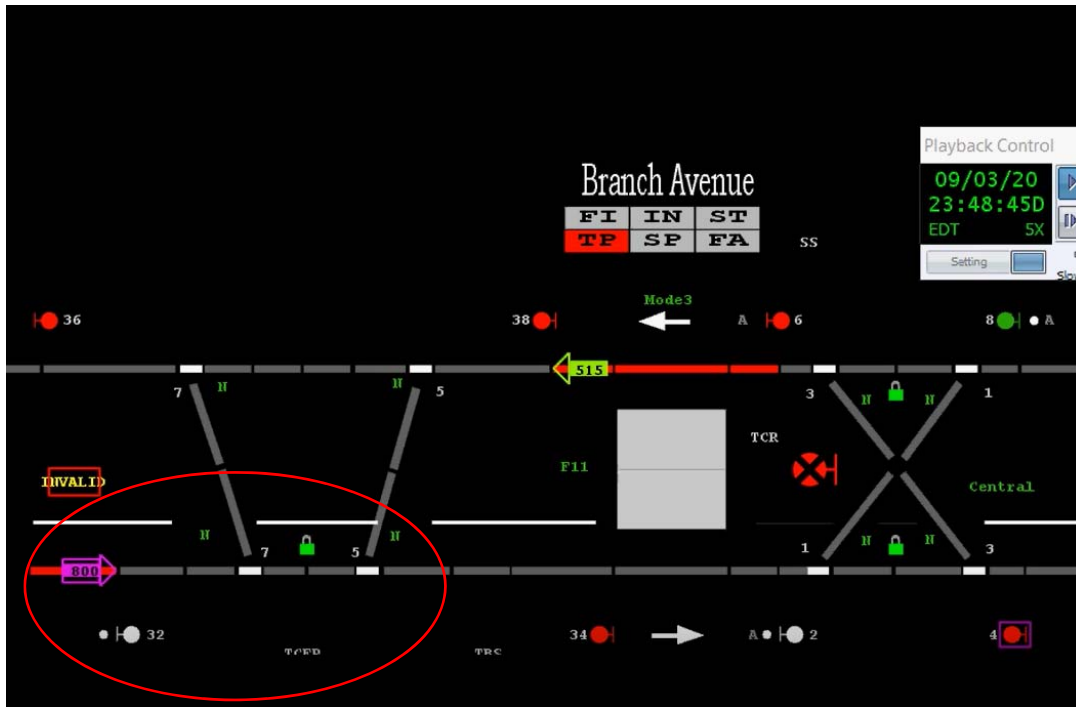
Photo 2: Sperry Unit 800 showing occupancy with a lunar and rail alignment for Branch Avenue, Track 1.

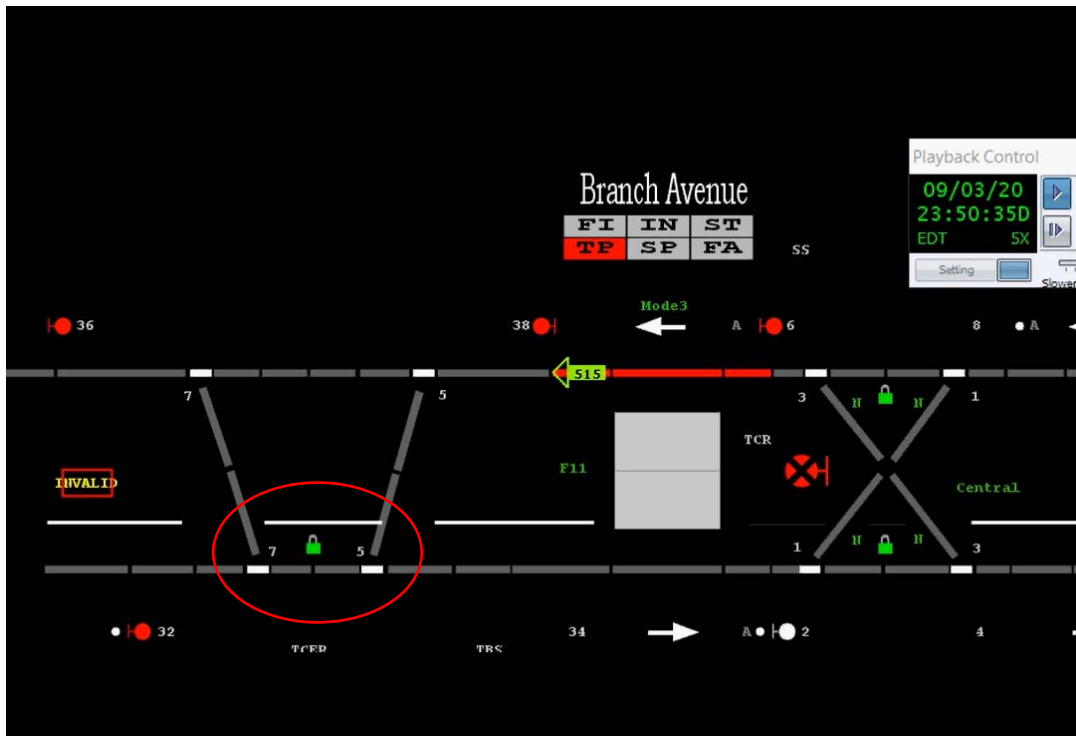
Photo 3: Sperry Unit 800 showing occupancy with a lunar and rail alignment for Branch Avenue, Track 1.

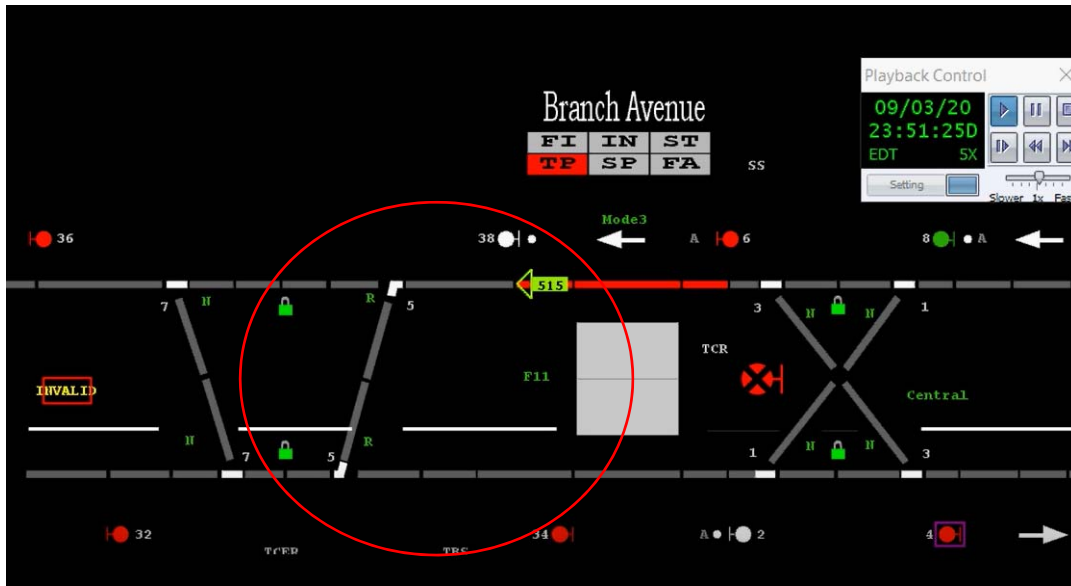
Like other hi-rail vehicles, the Sperry vehicle does not always shunt the rails (show occupancy in the automatic train control and signal system). Therefore, the vacancy showing in the area of the interlocking was not accurate. AIM playback shows that the Sperry vehicle showed occupancy prior to entering the interlocking but did not shunt within the interlocking.

Photo 4: Route set for Train 515 to enter the yard. No occupancy is shown at the F11-32 signal.

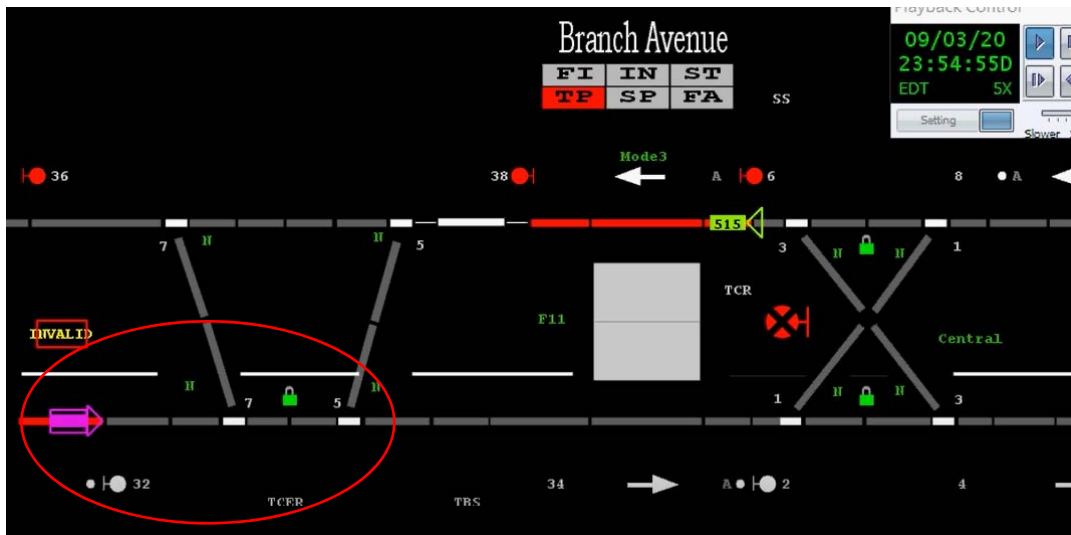
Photo 5: Alignment reset for Sperry Unit 800; Unit now showing occupancy.
