**WMSC Commissioner Brief: W-0062 – Improper Roadway Worker Protection
Anacostia Interlocking – September 9, 2020**

FINAL REPORT OF INVESTIGATION A&I 20341

Anacostia Station – Improper RWP

September 9, 2020

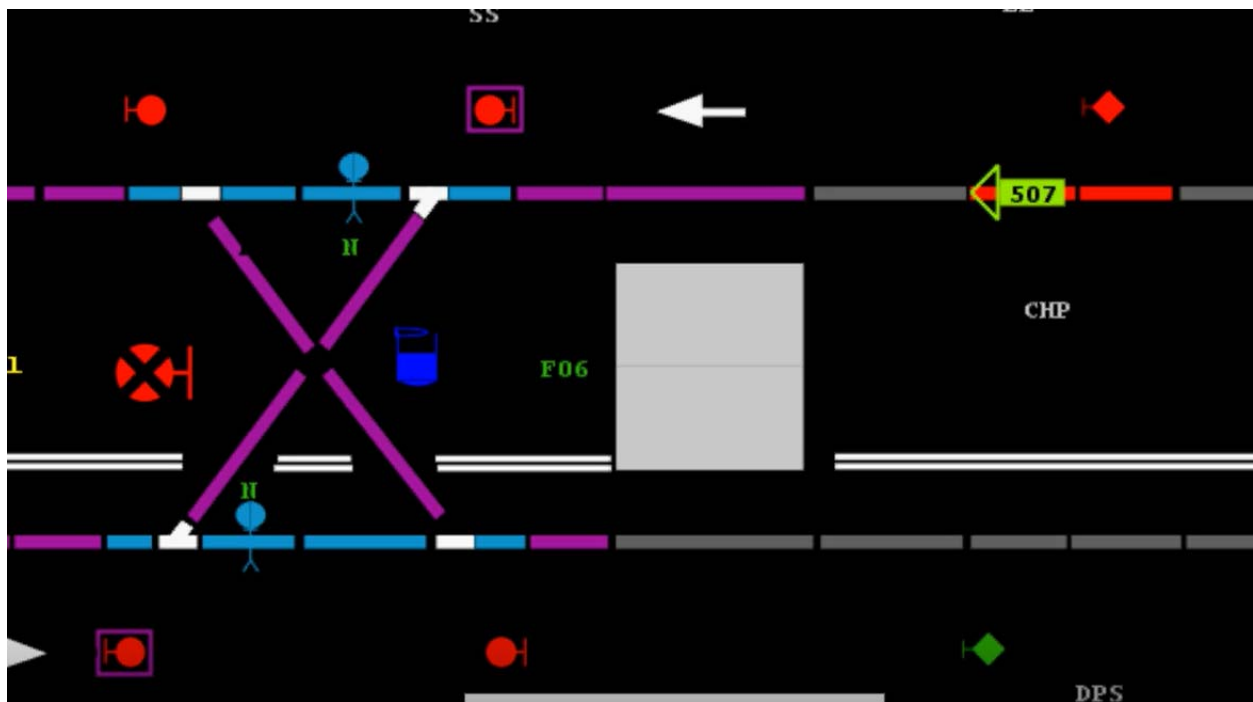
At 10:20 hrs., AIMS indicated that F06 1A/B switches were out of correspondence in the normal position with revenue train ID 507 holding at F06-08 signal red. At approximately 10:26 hrs., the Radio RTC attempted to contact the RWIC on Ops 3 with three transmissions to no avail. The Radio RTC appeared to have the ability to transmit over the Radio; however, personnel in the field were unable to receive any transmissions. At 10:27 hrs., the Button RTC contacted the Train Control Room (TCR) to ascertain if the Local Control Panel Operator can transmit directly to the RWIC at the interlocking due to the revenue train holding at a red signal outside the interlocking. At 10:30 hrs., the Radio RTC continued to experience issues of the Radio failing to communicate with personnel in the field.

| 10:20:32 hrs. | AIMS displayed F06 1A/B switches out of correspondence in the normal position with a revenue train holding outside of F06-08 signal red. [AIM] |

Photo 1: AIMS indication shows F06 1A/B switches of correspondence with F06-08 signal red.
