**WMSA Commissioner Brief: W-0063 – Red Signal Overrun – Brentwood Yard entrance –September 11, 2020**

*Prepared for Washington Metrorail Safety Commission meeting on March 2, 2021*

**FINAL REPORT OF INVESTIGATION A&I E20343**

<b>Date of Event:</b>	9/11/2020
<b>Type of Event:</b>	Red Signal Overrun
<b>Incident Time:</b>	04:07 hrs.
<b>Location:</b>	Brentwood Yard, B99-06 Signal, Track 1
<b>Time and How received by SAFE:</b>	04:18 hrs. – SAFE On-Call Phone
<b>WMSC Notification Time:</b>	06:16 hrs.
<b>Rail Vehicle:</b>	Flatcar (F) 510-Prime Mover (PM) 38

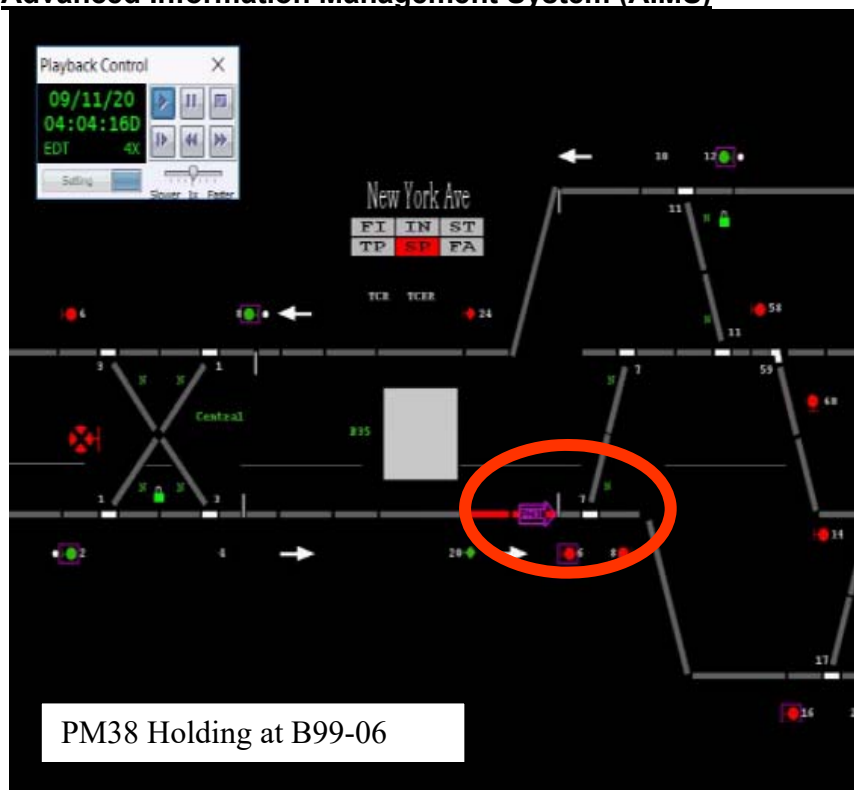
Illustration 1 – PM38 holding on Track 1 at B99-06 signal displaying a red aspect.

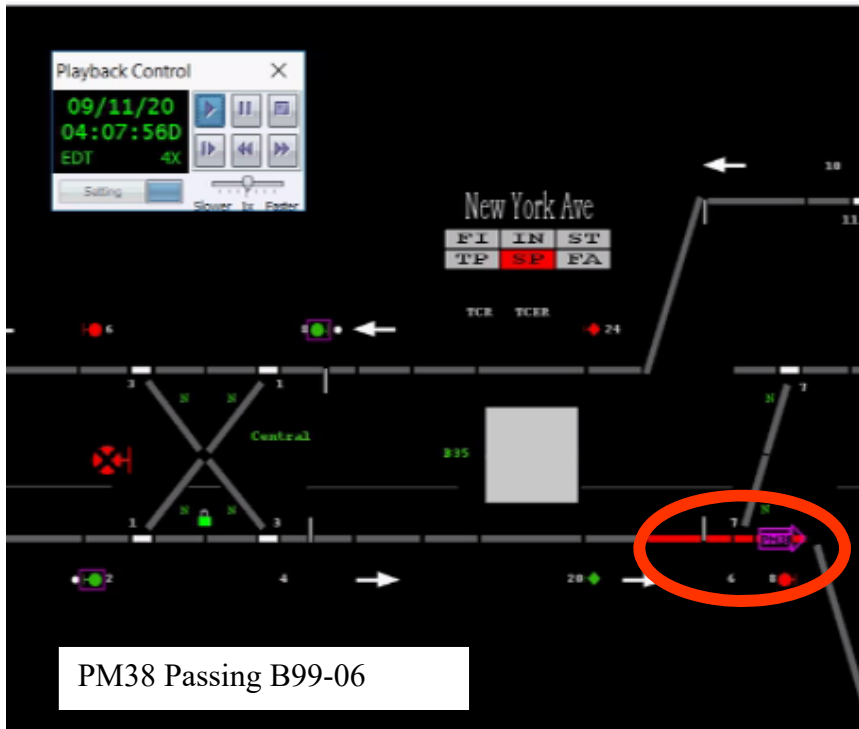
Illustration 2 – PM38 proceeded past the B99-06 signal displaying a red signal aspect.

- The E/O and the F/M claimed to see a lunar displayed on the B99-06 signal before proceeding. However, AIMS playback indicates that PM38 E/O proceeded past the B99-06 signal displaying a red aspect. This is not in compliance with OR 3.67 – Rail vehicles shall not be operated past or closer than a point of ten (10) feet in the approach of any interlocking signal or lamp displaying a red aspect. A red flag, or a dark interlocking signal, unless authorized by ROCC or the Interlocking Operator, and the move is consistent with customer safety as specified in Rule 3.1.

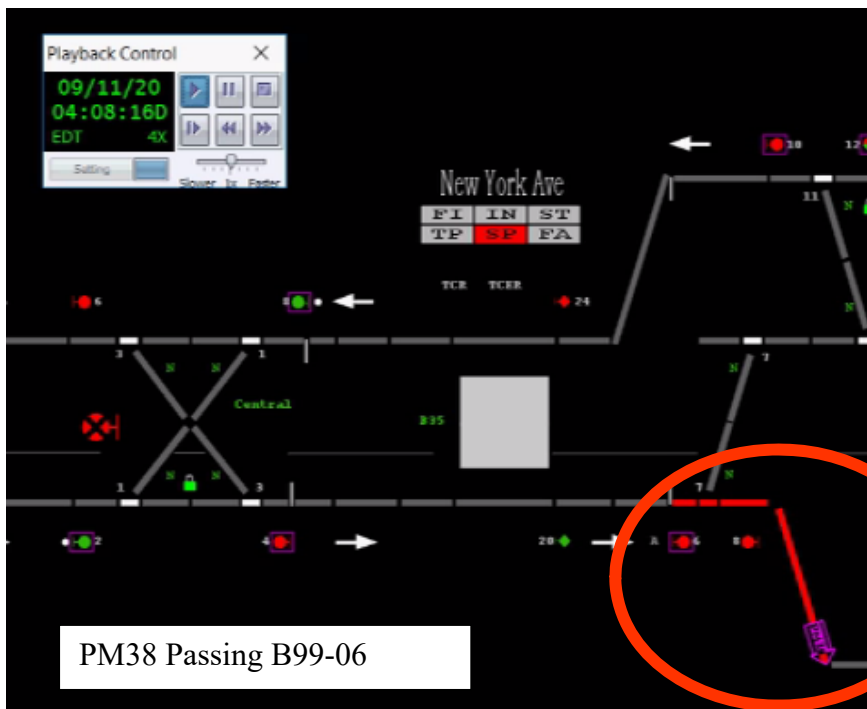
Illustration 3 – PM38 proceeded past the B99-06 signal displaying red signal aspects.

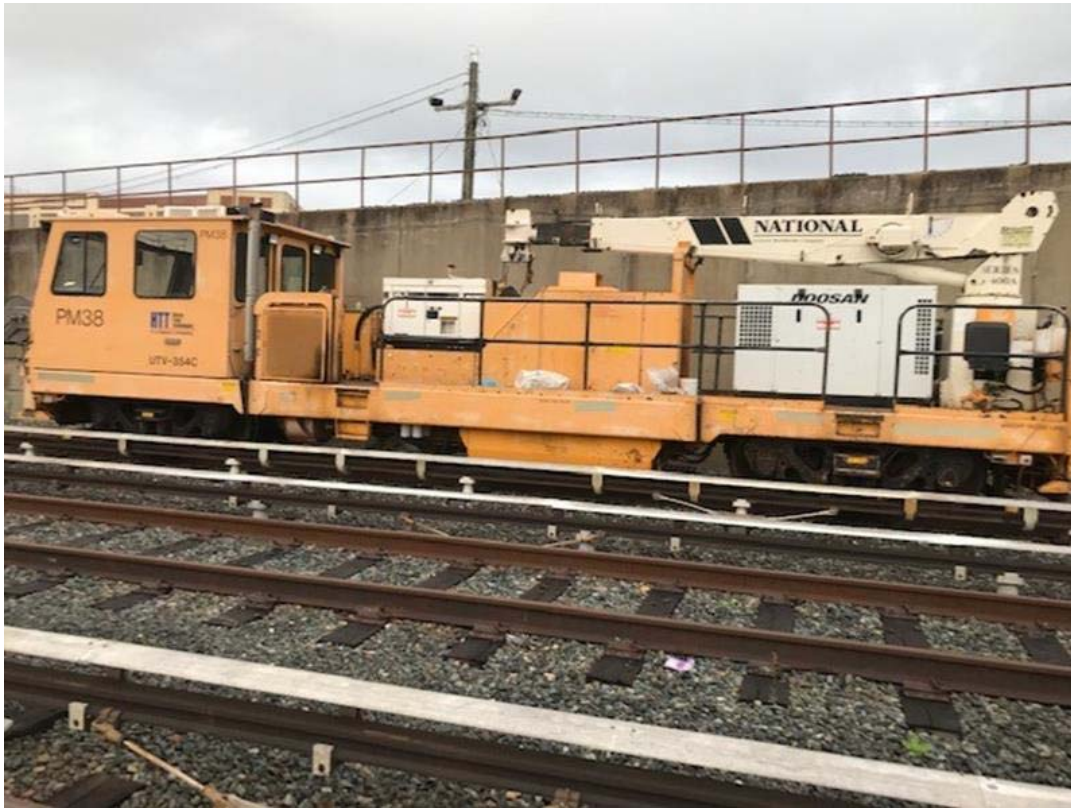
Photo 1 – PM38

- Car Track Equipment Maintenance (CTEM) personnel performed a post-incident inspection of the affected F510-PM38 and found no anomalies.

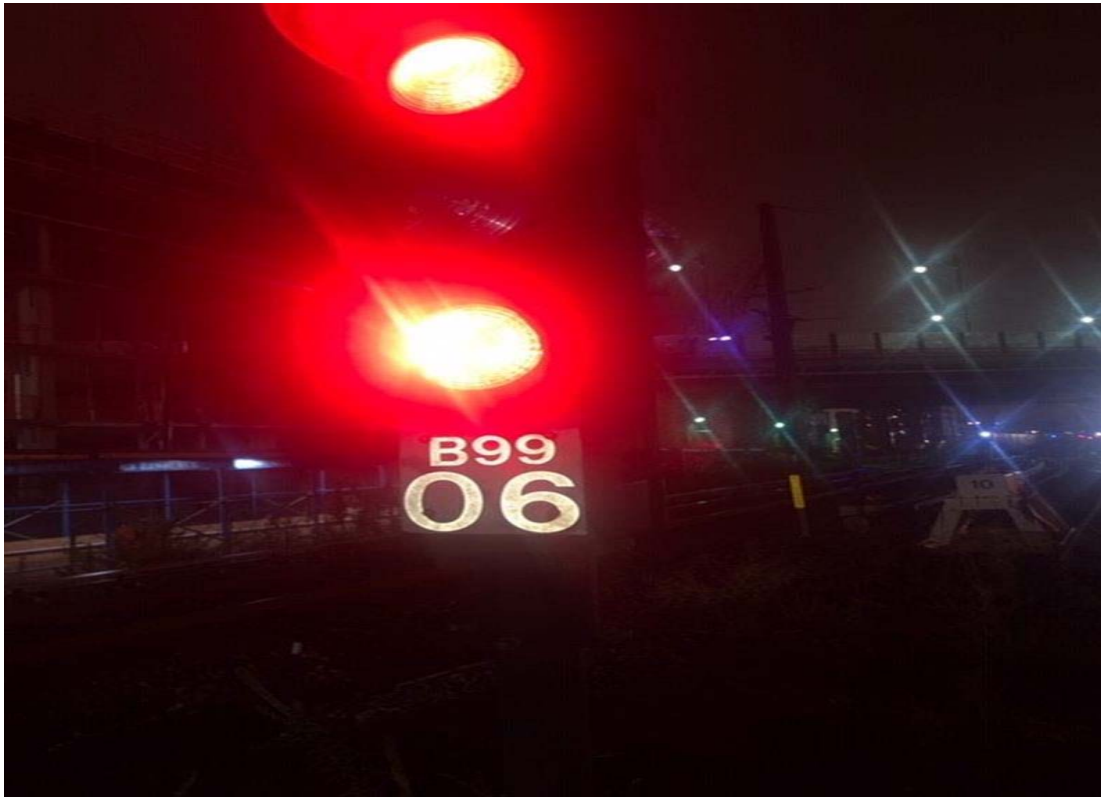
*Photo 3 - B99-06 signal displaying a "red" aspect*

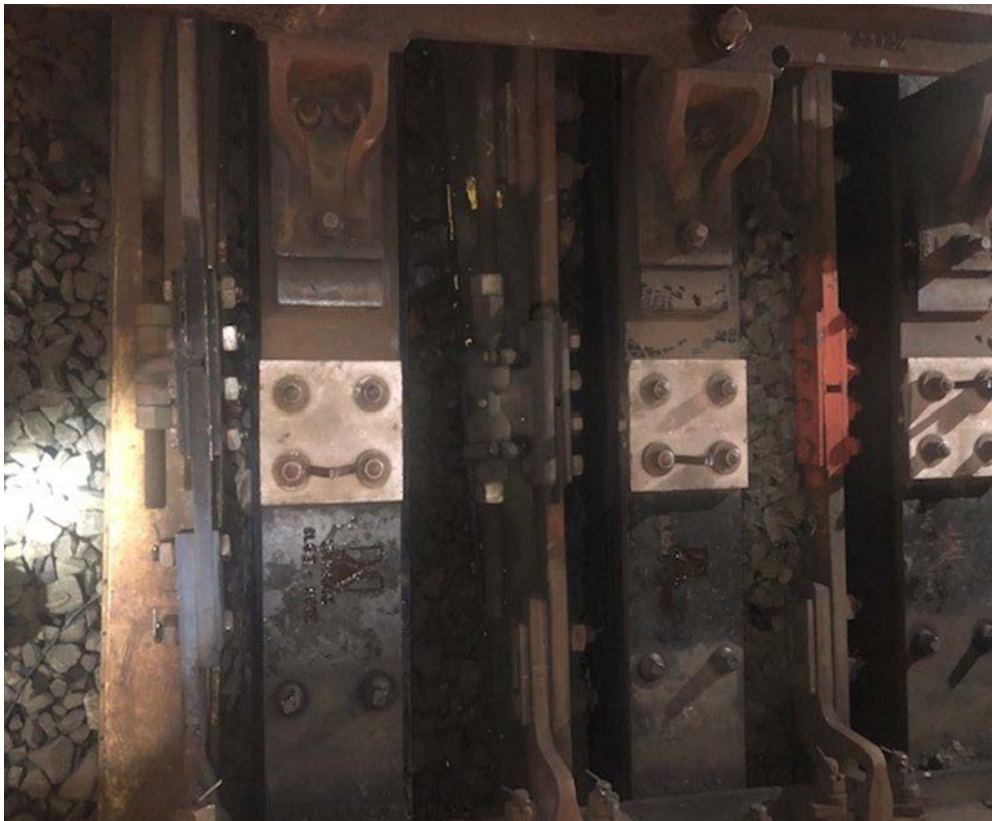
*Photo 4 – There were no anomalies found to switch 7A/B.*

ATCM performed an inspection and verified that there was no damage to any switches or ATCM components.
