WMSC Commissioner Brief: W-0064 – Red Signal Overrun – Greenbelt Yard – September 15, 2020

FINAL REPORT OF INVESTIGATION A&I E20350

Date of Event:	9/15/2020
Type of Event:	Red Signal Overrun
Incident Time:	21:53 hrs.
Location:	Greenbelt Yard, Track 15
Time and How received by SAFE:	22:06 hrs., On-Call Phone
WMSC Notification Time:	23:55 hrs.
Rail Vehicle:	L7272.7273-7065.7064-7216-7217.7141-7140T
Injuries:	None
Damage:	None

Greenbelt Yard – Red Signal Overrun

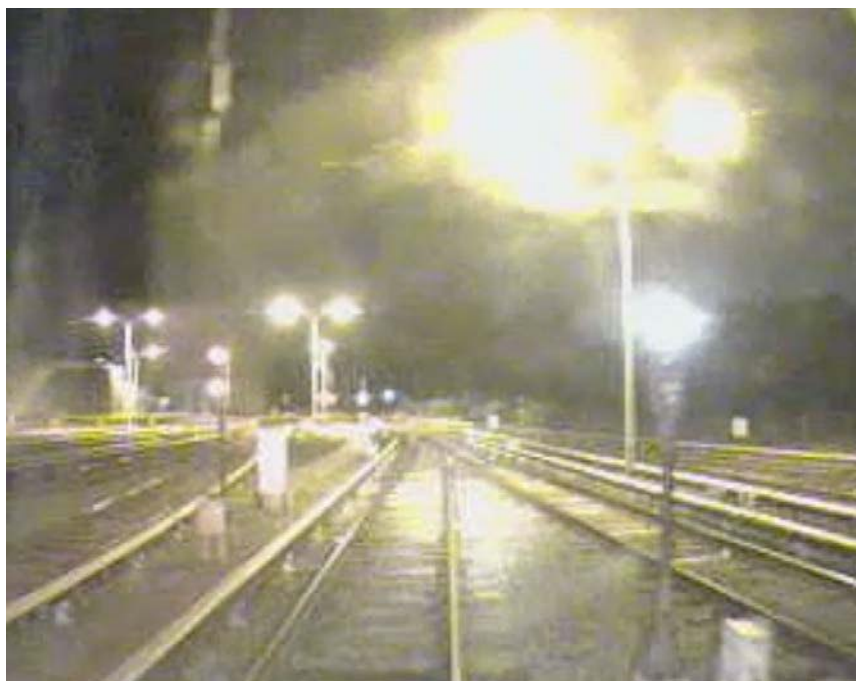
Based on NVR System's forward-facing playback, the Train Operator proceeded to pass the E99-30 lunar on Track 15.

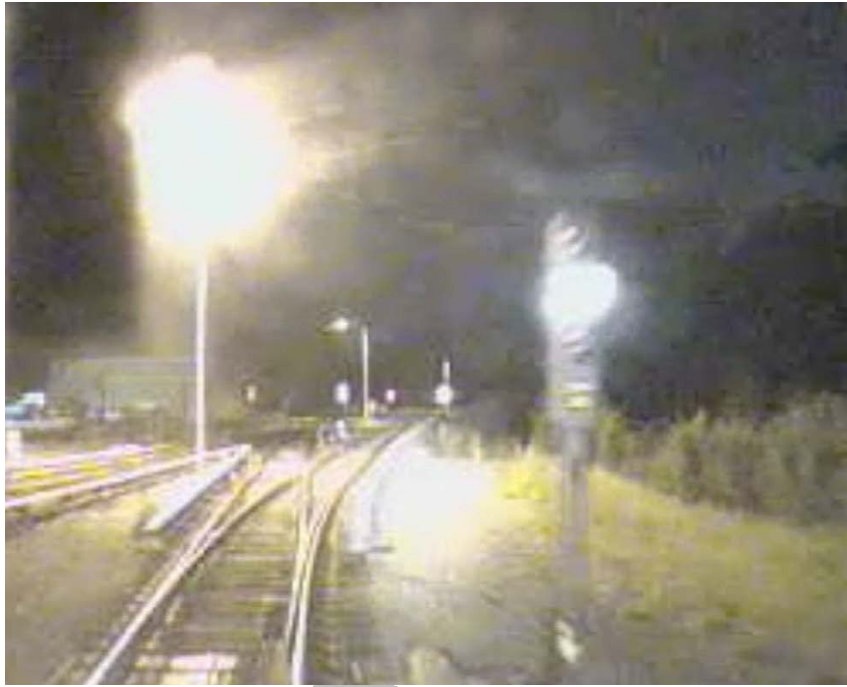
Train Operator crossed over from Track 15 towards the Ladder Track and passed E99-150 lunar signal.

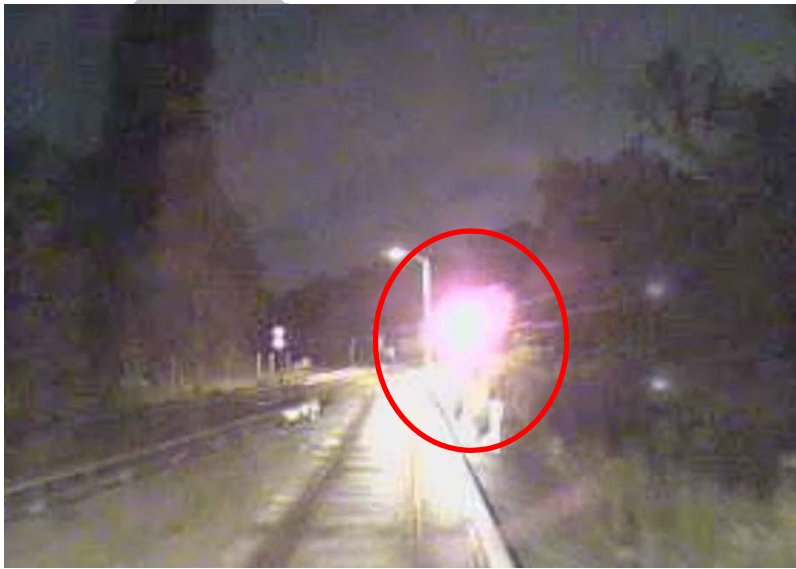
21:53:00 hrs.	Car 7272 passes RED SIGNAL. Distance traveled approximately 500 feet at 7 mph. (CENV).
21:53:36 hrs.	Interlocking Operator reports to Train Operator; they have passed Signal E99-160 (Red).
21:53:41 hrs.	Car 7272 stops and Master Controller is placed it in Auto Store. Distance traveled approximately 565 past the red signal. (CENV).
21:53:43 hrs.	Train Operator asked Interlocking Operator if they are clear.
21:54:12 hrs.	Interlocking Operator reports to Train Operator, the block was to Signal E99-160 Red, and they have passed the red signal.
21:54:25 hrs.	Train Operator acknowledges they have passed the red signal at E99-160.

As the Train Operator approached, E99-160 was displaying a red signal aspect; the Train Operator proceeded to pass the signal.

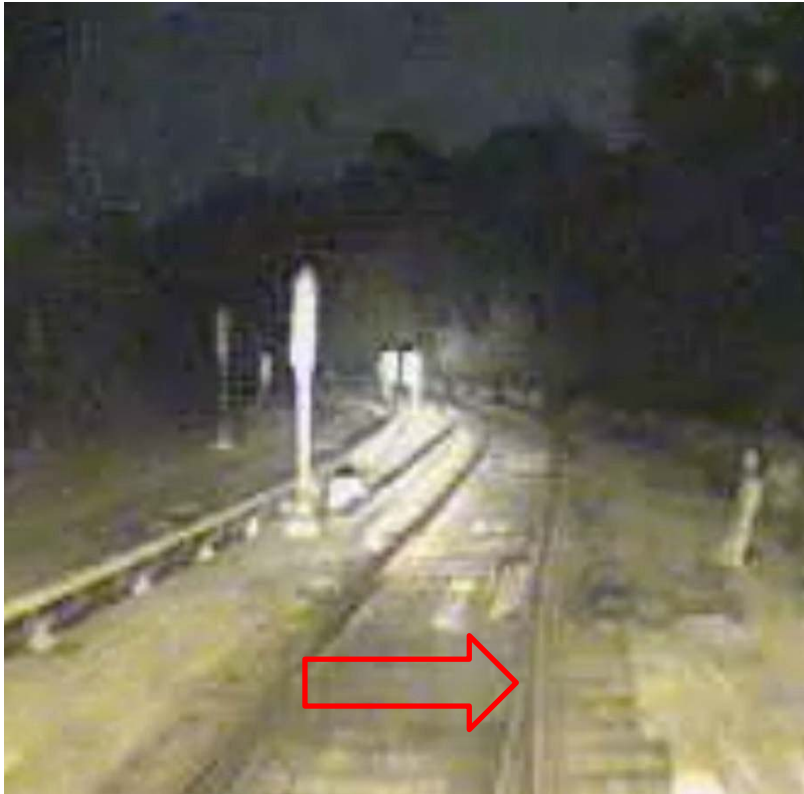
As a result of the event, SAFE, ATC, and TRST personnel responded to Greenbelt Yard for a reported trailed switch condition on Switch #155. ATC inspected the switch and found no physical damage. ATC also conducted Obstruction Tests, which successfully passed. ATC returned Switch #155 to service at approximately 02:35 hrs.

The Train Operator traversed switch 155, which was aligned in the normal position for a straight-through move for trains moving from the adjacent Track and subsequently splitting the switch.
