## **WMSC Commissioner Brief: W-0065 – Serious Injury – Vent Shaft FF2 – September 9, 2020**

**FINAL REPORT OF INVESTIGATION A&I E20338**

# Archives Station – Serious Injury

September 9, 2020

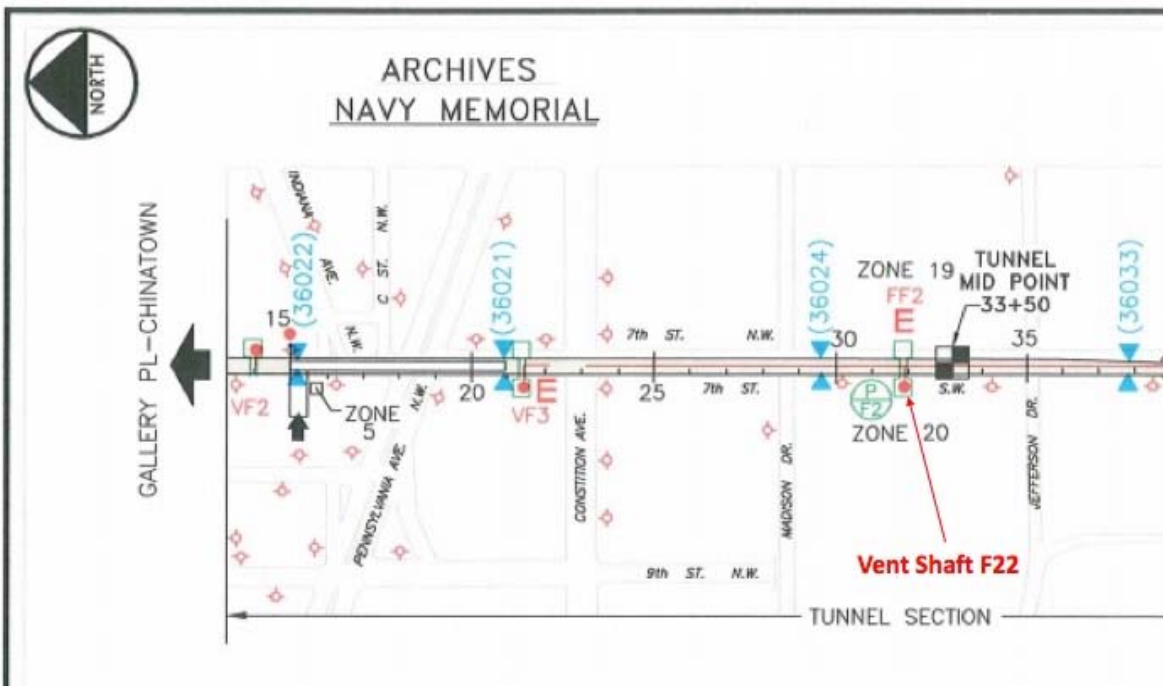
## **Field Sketch/Diagram**

Based on findings, the Contractor was working to replace grating in Vent Shaft FF2. While kneeling on the grating, the Contractor reached over to remove another grating piece; they lost their balance and fell into the pit. Fall protection and adequate Personal Protective Equipment (PPE) were not used in doing this work process and are required by OSHA 29 CFR 1926.501. The Contractor sustained a fractured tibia and a broken nose. The required PPE and fall protection should have been in place before work commenced.
