WMSC Commissioner Brief: W-0066 – Fatality – Gallery Place-Chinatown Station – September 14, 2020

FINAL REPORT OF INVESTIGATION A&I E20346

Gallery Place Station – Person Struck by Train

September 14, 2020

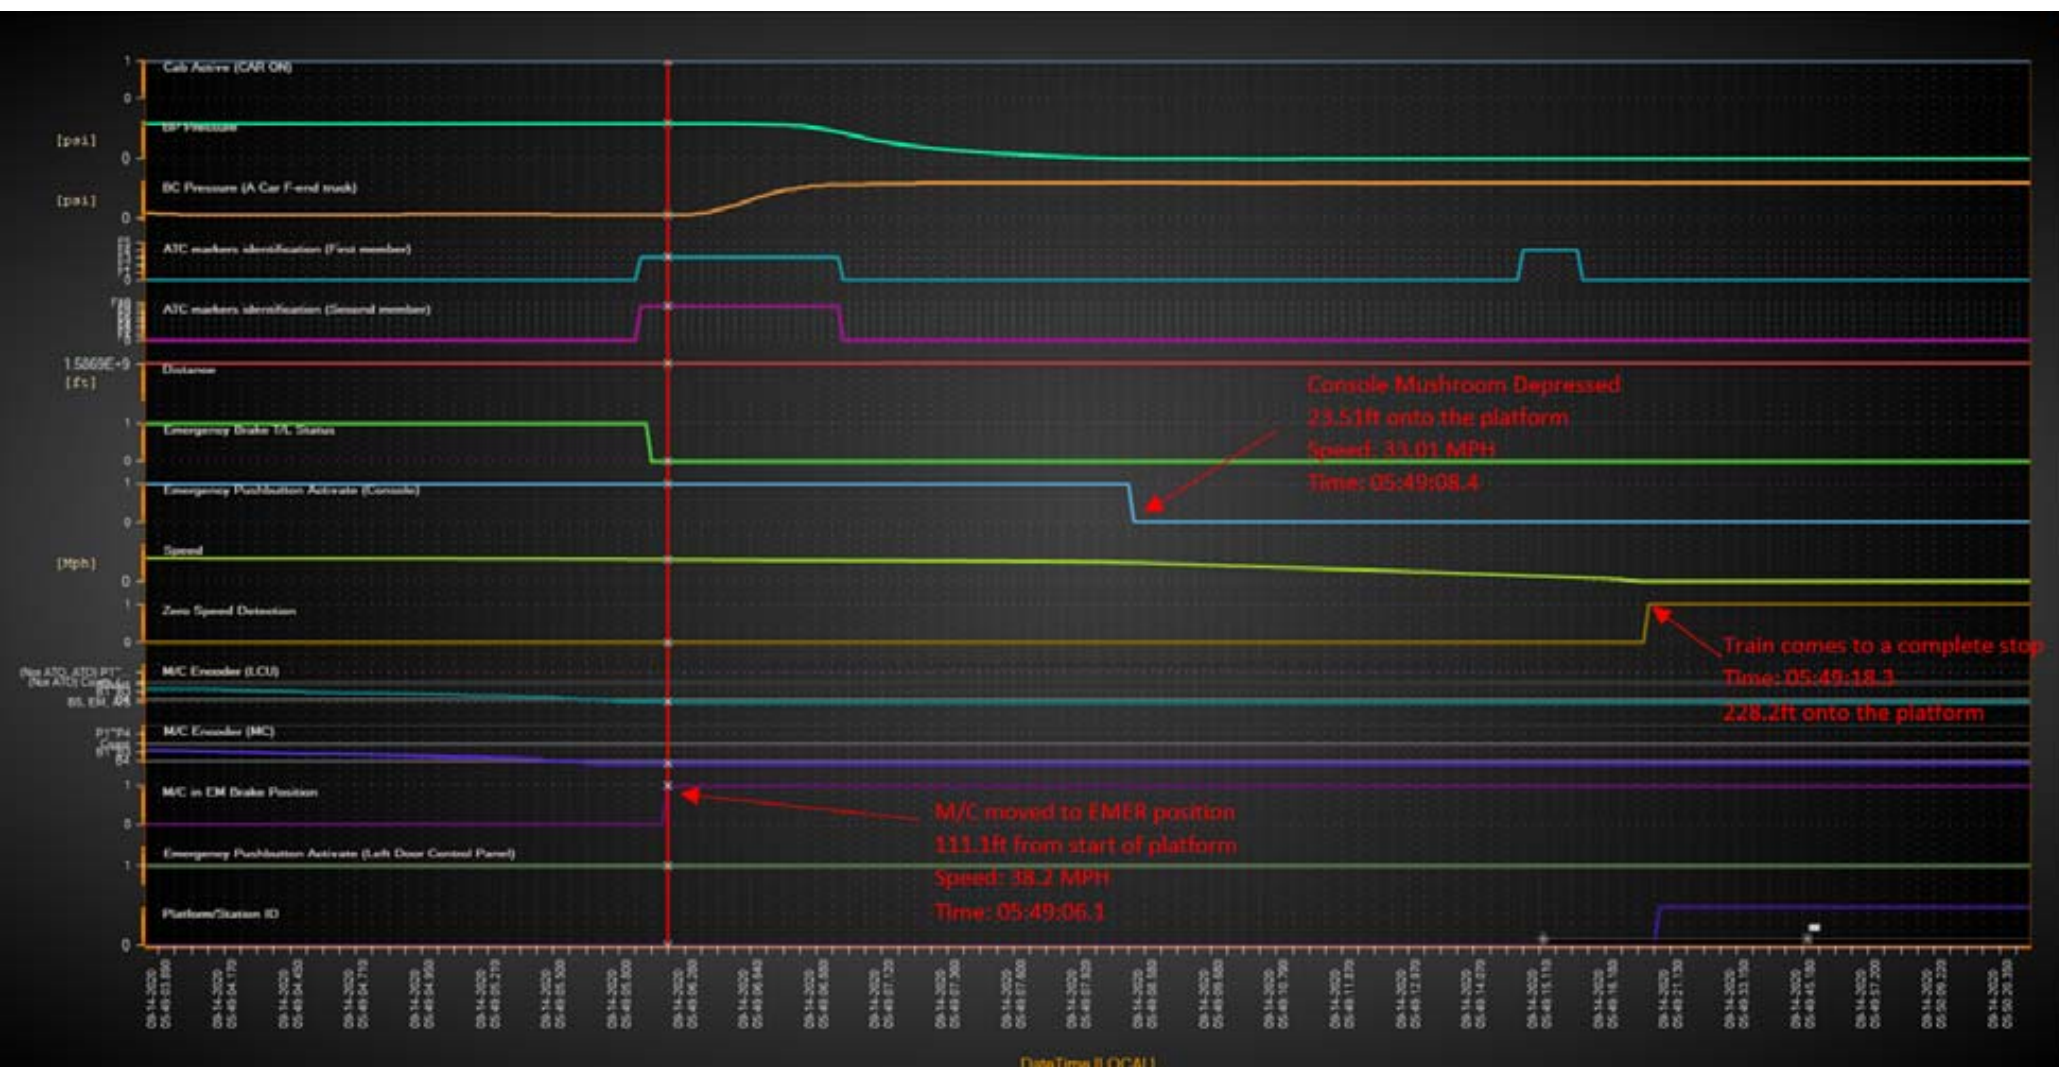
Diagram 1- ER Graphical Analysis

05:49:05 hrs.	Master Controller was placed in the B5 brake position, with a train speed of 38.69 MPH, 111.1 ft from the beginning of the Gallery Place Station platform.
05:49:06 hrs.	Prior to entering the platform, Master Controller was placed in the EMERGENCY position; Train ID 513 was traveling at a speed of 38.19 MPH.
05:49:08 hrs.	Console mushroom was activated, the train was traveling at 33.01 MPH. The train was 23.51 ft onto the Gallery Place Station platform.
05:49:18 hrs.	The train comes to a complete stop 228.2 ft onto platform.
05:52:23 hrs.	Master Controller was moved from EM position to Auto-Store position.
05:49:24 hrs.	Train keyed down.

Based on CENV download and analysis, Train ID 513 was traveling at approximately 38 MPH before going into emergency braking with an eight-car consist entering Gallery Place Station. The train responded as expected, and its performance was within design specification. No operational anomalies were noted on the VMDS fault log during the reported incident time.

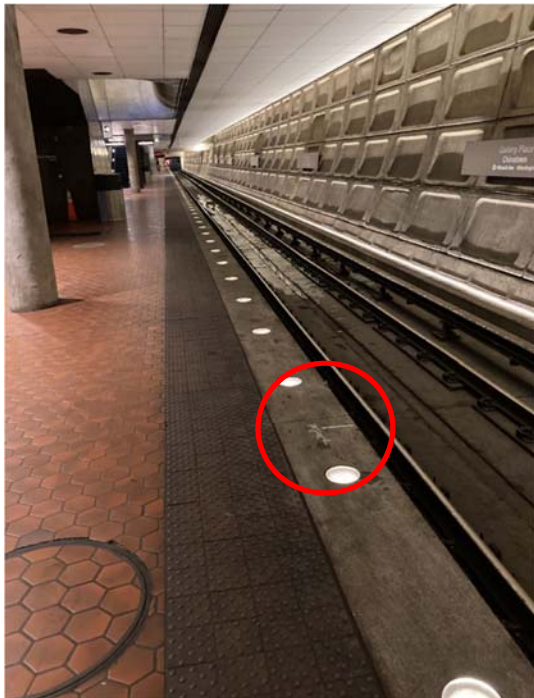
SAFE conducted a site assessment and determined no slip or trip hazard present would have contributed to this event. All platform emergency notification equipment was working as designed. Based on further investigation, SAFE determined the point of train and customer contact; please refer to the description below:

Photo 1 - This is the point of contact location approximately 15 feet away from the platform entrance.

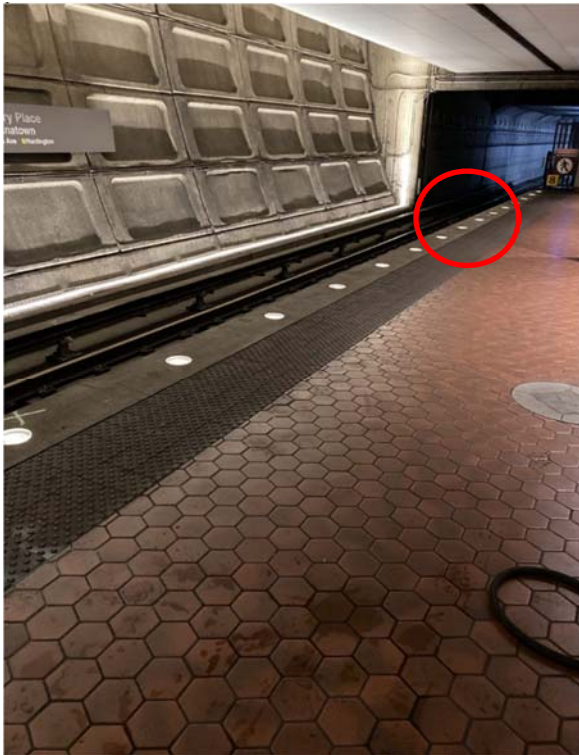
Photo 2- Indication of train and customer contact on approach end Track 2.

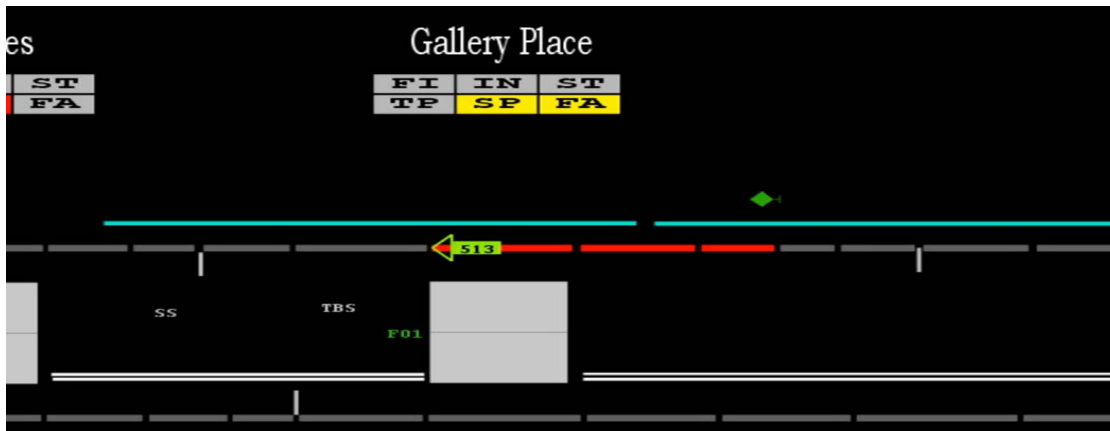
Photo 1: AIMS indication shows Third Rail Power De-energized Track 2 Gallery Place.
