WMSC Commissioner Brief: W-0067 – Improper Movement – Metro Center Station – September 20, 2020

FINAL REPORT OF INVESTIGATION A&I E20359

Metro Center Station – Improper Railcar Movement

September 20, 2020

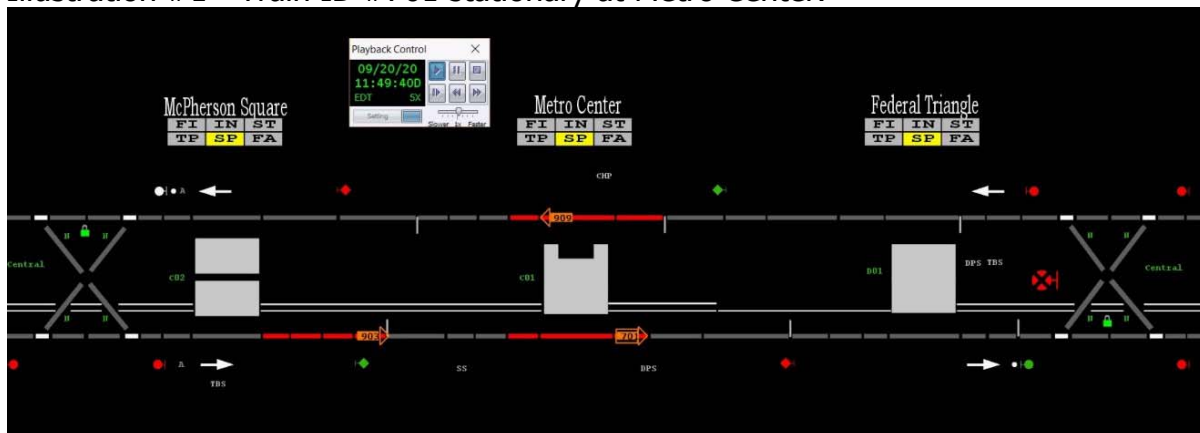
Illustration #1 - Train ID #701 stationary at Metro Center.

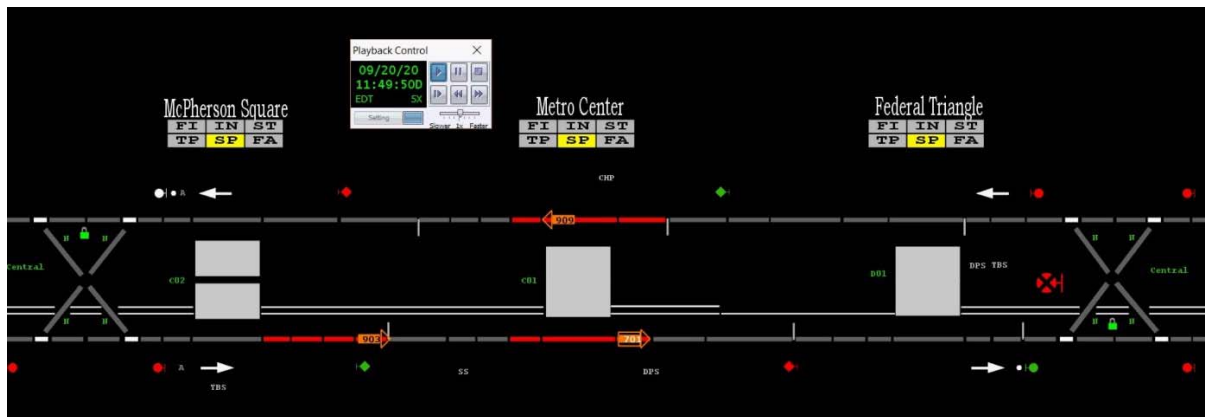
Illustration #2 - Train ID #701 begins to move towards the Federal Triangle Station.

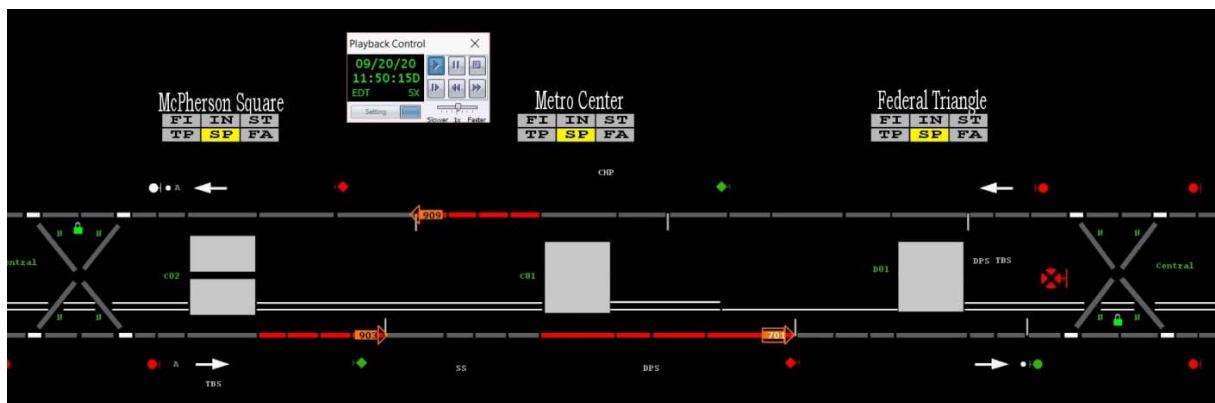
The Train Operator moved their train without having an absolute block while ATP was cut out. This action is not in compliance with MSRP SOP #15.

Illustration #3 - Train ID #701 traveling towards Federal Triangle with ATP cut out and no absolute block.

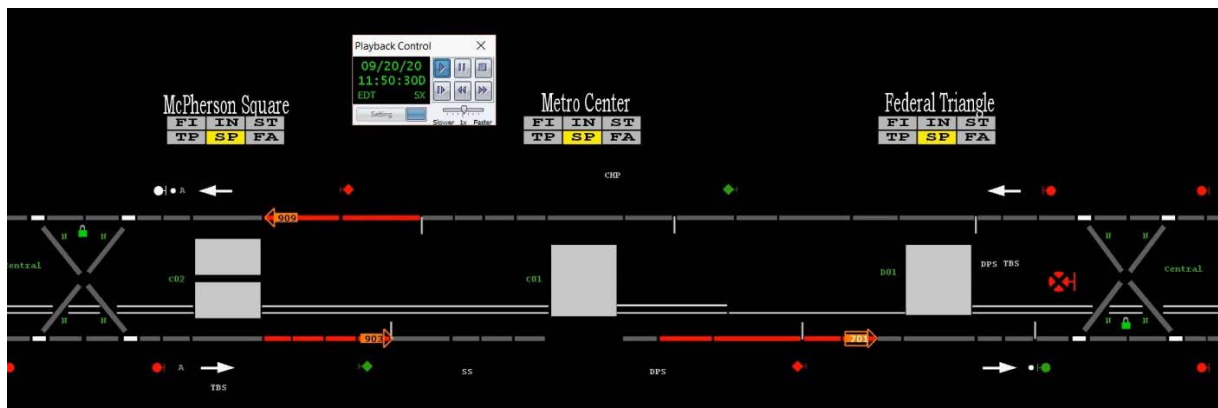
Illustration #4 - Train ID #701 comes to a complete stop to receive absolute block from ROCC.

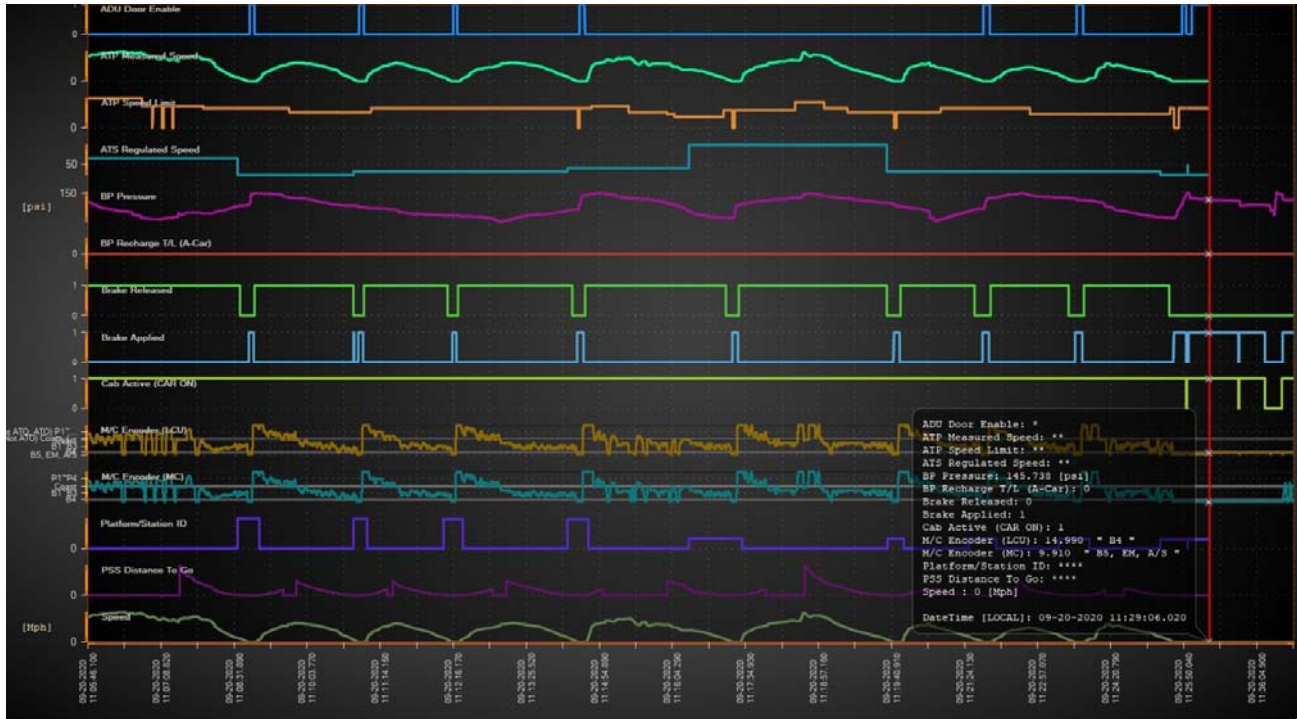
Diagram 1- Event Recorder (ER) graphical analysis.

Time	Description
11:25:47 hrs.	The Train Operator activated the Left Door Open Pushbutton several times. (Doors did not open).
11:29:06 hrs.	The Train Operator cycled ATC Circuit Breaker.
11:47:50 hrs.	The Train Operator moved the Master Controller from Auto Store to Coast (Brakes are released) to B5.
11:48:19 hrs.	The Train Operator moved the Master Controller from B5 to Coast (Brakes are released) to B5 (Signals did not indicate any attempt to take a point of power).
11:49:38 hrs.	The Train Operator activated ATP cut out.
11:49:46 hrs.	Point of power is achieved, and the car begins to accelerate.
11:49:46 hrs. – 11:54:42 hrs.	The car traveled a distance of 3,416.16 feet with speeds under 20 mph.
11:54:42 hrs.	The Train Operator keyed down Car 7344.
