# ANNUAL REPORT ON THE SAFETY OF THE WMATA RAIL SYSTEM IN 2020

WASHINGTON METRORAIL SAFETY COMMISSION

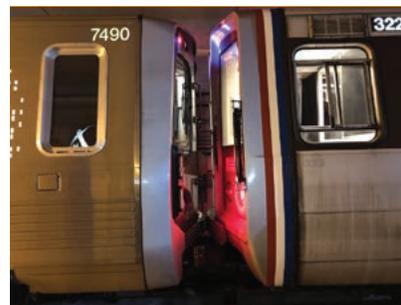
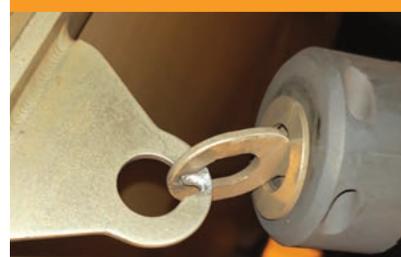
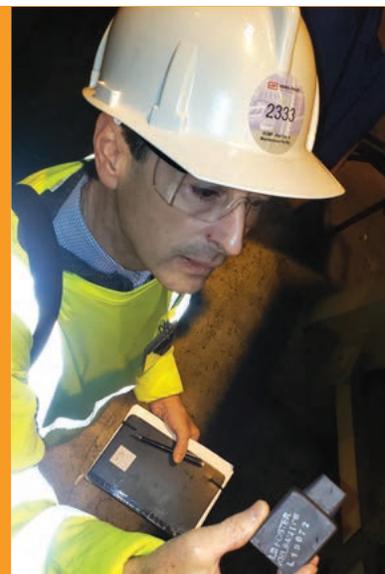
When the WMSC, WMATA's Safety Department, and other investigative personnel arrived at the Greenbelt Rail Yard the morning after the October 9 pull-apart to inspect and evaluate the coupler assemblies, investigators found that the coupler assemblies had been manipulated between the time the railcars had been stored and the time investigators had arrived to conduct their examination.

The WMSC was later told and saw evidence that, at the direction of supervision, a bolt was manipulated outside of the safety event investigation process. Among other evidence, the torque stripe on the bolt had

moved clockwise, indicating that the bolt had been tightened. Any such manipulation of evidence related to a safety event investigation is prohibited by Metrorail Standard Operating Procedure (SOP) 800-01.

Metrorail was required to and later did develop a Corrective Action Plan to institute policy changes to ensure all proper steps are followed to

protect the integrity of all investigations and to provide initial and ongoing refresher training to ensure each Metrorail employee and all relevant contractors understand their roles and responsibilities as those relate to safety event investigations.
