**WMSC Commissioner Brief: W-0068 – Person Struck by Train – Bethesda Station – October 29, 2020**

**FINAL REPORT OF INVESTIGATION A&I E20343**

# Bethesda Station, Person Struck by Train

## November 08, 2020

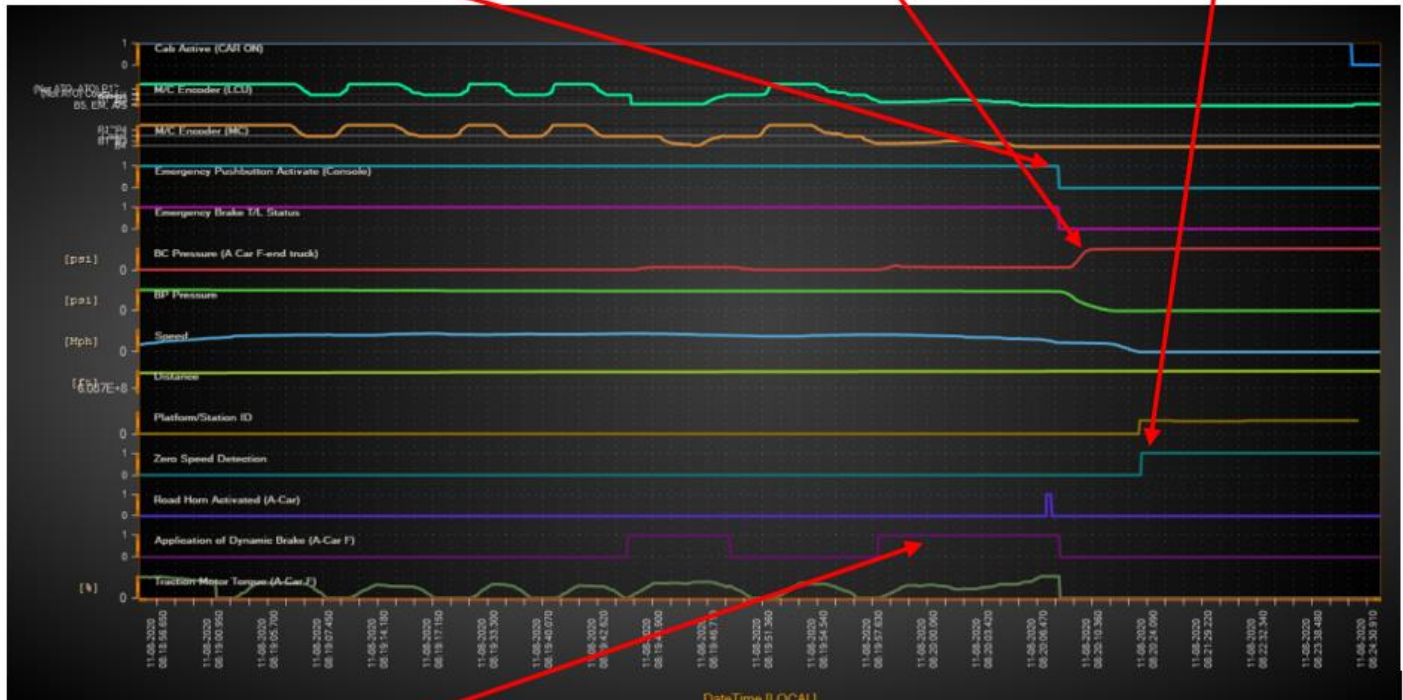
Diagram 1- ER Graphical Analysis

Train initiated emergency brake sequence after emergency pushbutton was depressed

Train Responded as designed, Brake pipe dumped and friction brake applied emergency brakes to stop the train.

Train came to a stop 32 feet away from the estimated point the person was struck.

Proper propulsion and dynamic braking was observed before the incident. During the incident, only friction brake is used due to brakes in emergency (normal operation).

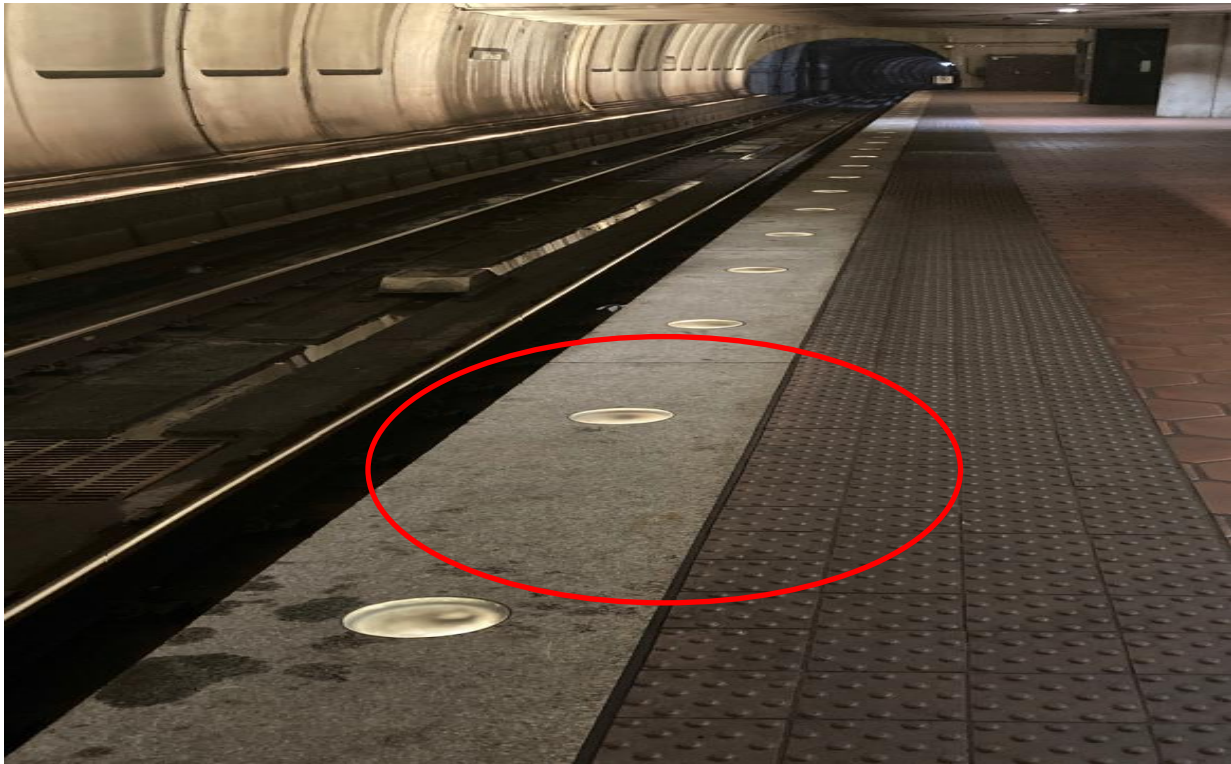
*Photo 1 – The area on the platform where the customer tripped was approximately 93 feet away from the Station platform entrance on Track 1.*

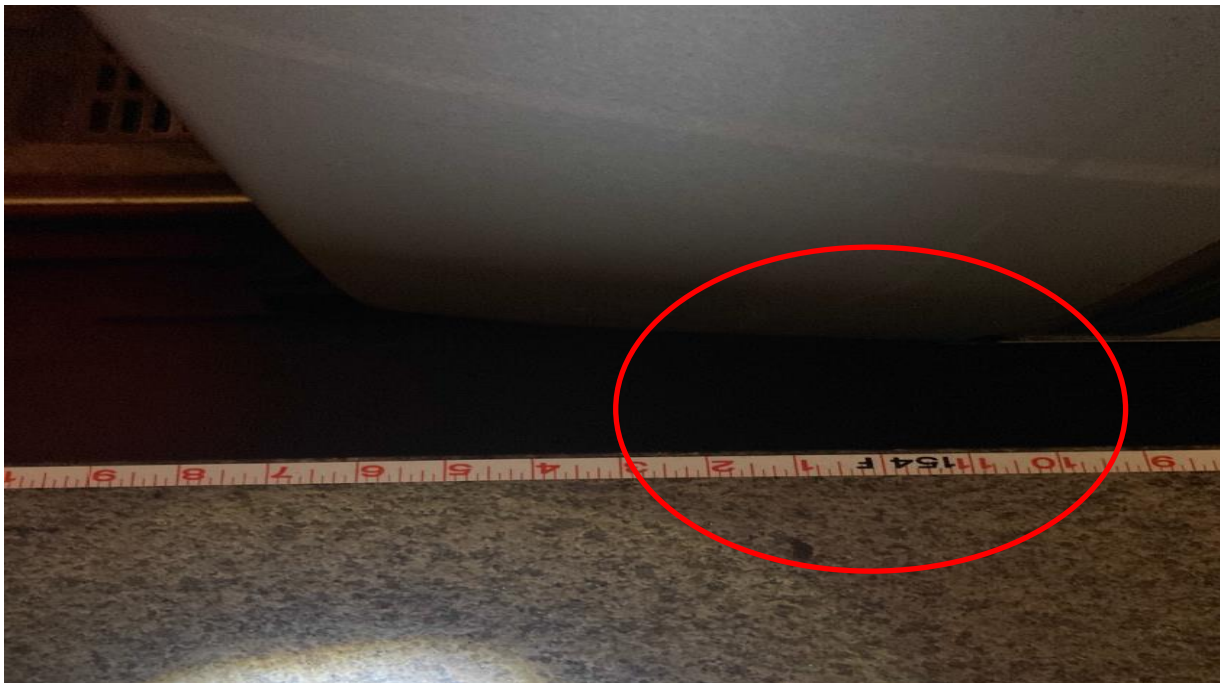
*Photo 2 - Train stopped approximately 154 1/2 feet within the platform limits on Track 1.*

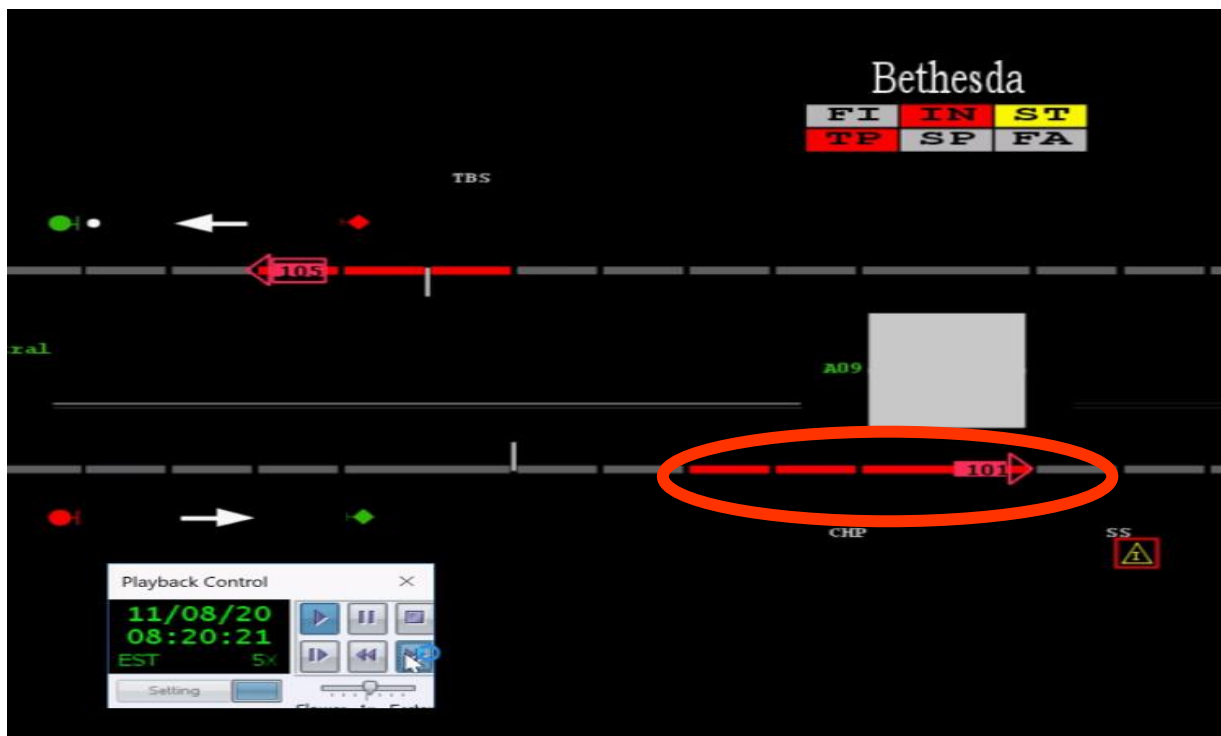
Diagram 2 - Shows Train ID 101 arrived at Bethesda Station, Track 1, which appears to be when they reported the person on the roadway per ARS. The Track is red, which shows that the track that Train ID 101 is on is energized.

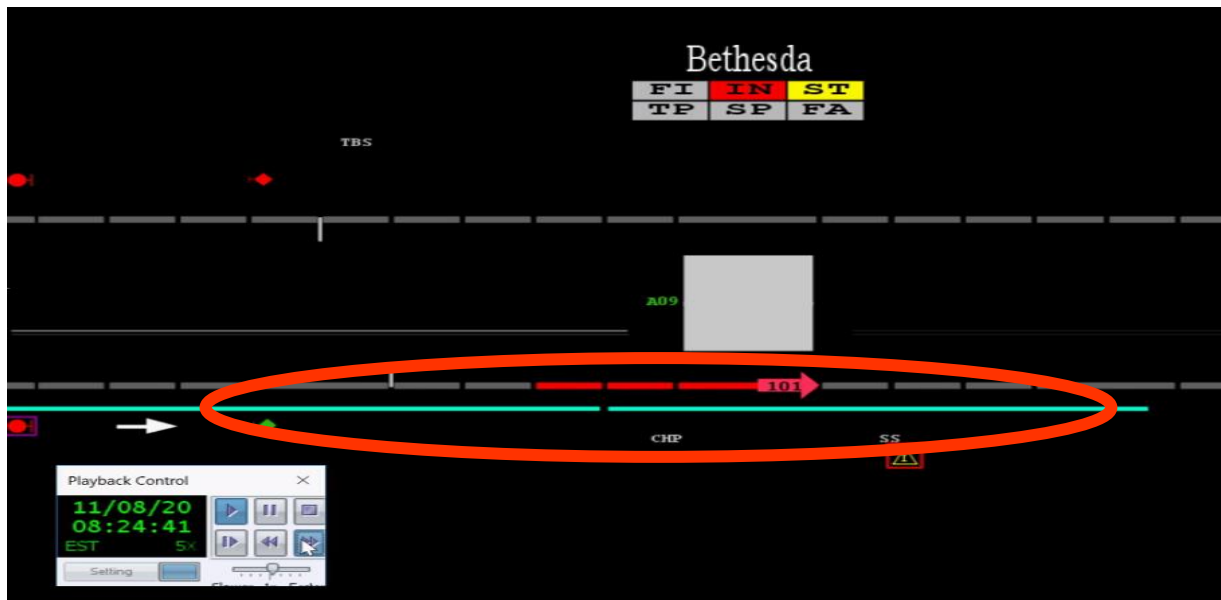
Diagram 3 – The green symbol on the AIMS power display shows that the third rail power was subsequently de-energized at Bethesda Station, Track 1.

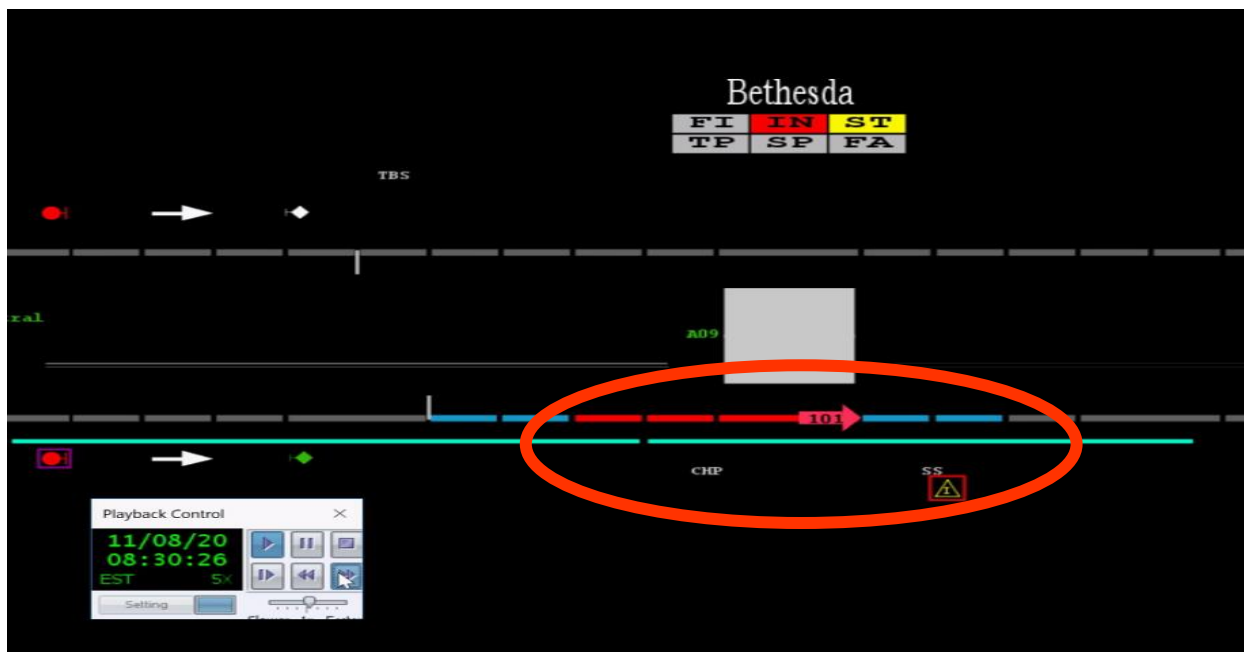
Diagram 4 - Shows prohibit exits, block calls, cancellation of automatic signals, blue block, and human form status are in place at Bethesda Station, Track 1.

- The AIMS display shows prohibit exits, block calls, cancellation of automatic signals, blue block, and human form status are in place at Bethesda Station, Track 1.
