**WMSC Commissioner Brief: W-0069 – Person Struck by Train – Union Station – November 12, 2020**

**FINAL REPORT OF INVESTIGATION A&I E20436**

Union Station – Person Struck by Train

November 12, 2020

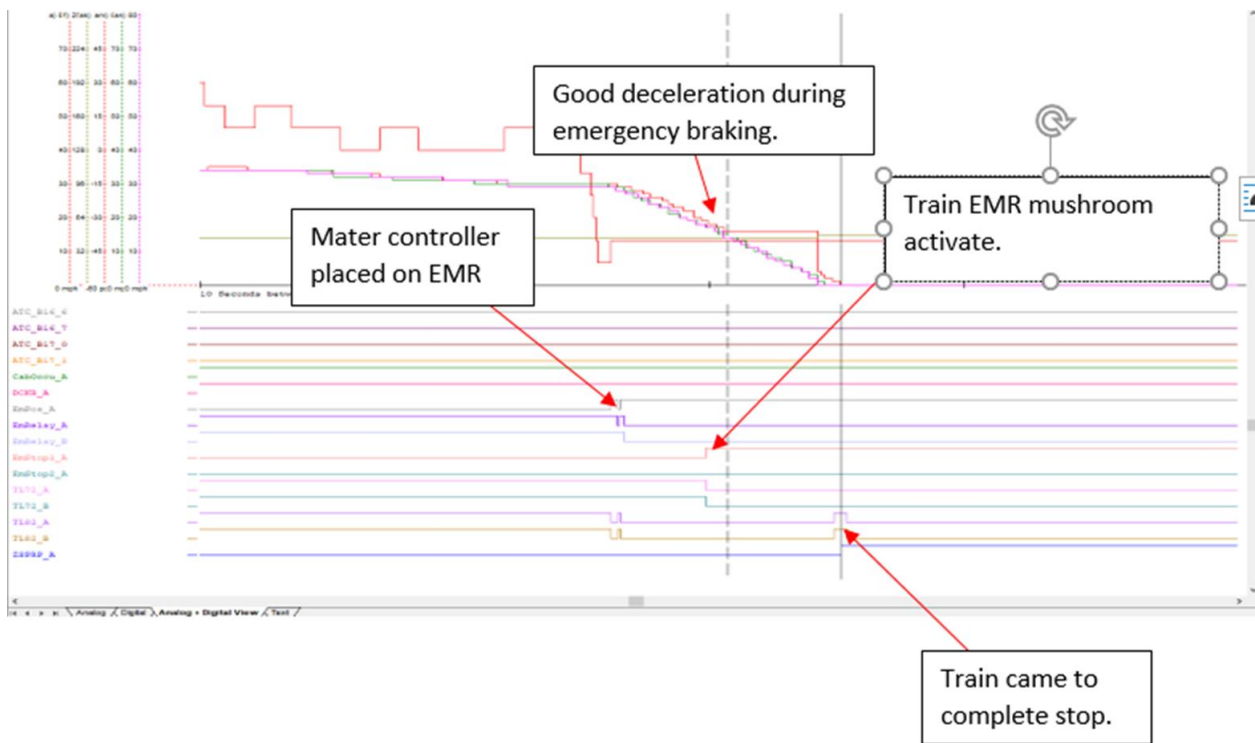
Diagram 1- ER Graphical Analysis

Based on the Vehicle Monitoring System (VMS) data, Train ID 837 entered the Union Station, Track 1, and initiated an emergency brake sequence after the Master Controller was placed in the Emergency Position, with a train speed of 30 MPH. The estimated speed at which the person was struck by the Train was 28 MPH. The Emergency Mushroom was activated with train speed at 19 MPH. The Train came to a complete stop approximately 191 feet after the Train Operator activated emergency braking. Based on Vehicle Program Services (CENV) analysis, there was no data to support any anomalies with the consist that may have contributed to this incident.

Time	Description
22:31:27 hrs.	Non- Revenue Train ID 837 entered Union Station Platform Lead car 6176 Master Controller in a coast position. Train speed 31 MPH.
22:31:33 hrs.	Before entering the platform, the Master Controller is placed in the EMERGENCY POSITON. Train Speed 30 MPH. Train initial emergency sequence.
22:31:34 hrs.	Estimated time person was struck by a train at a speed of 28 MPH.
22:31:37 hrs.	Emergency Mushroom is activated train speed 19 MPH no-slip correction at this time.
22:31:42 hrs.	The train came to a complete stop. The train traveled 191 feet after Train Operator activated emergency braking.
22:31:27 hrs.	Non- Revenue Train ID 837 entered Union Station Platform Lead car 6176 Master Controller in a coast position. Train speed 31 MPH.

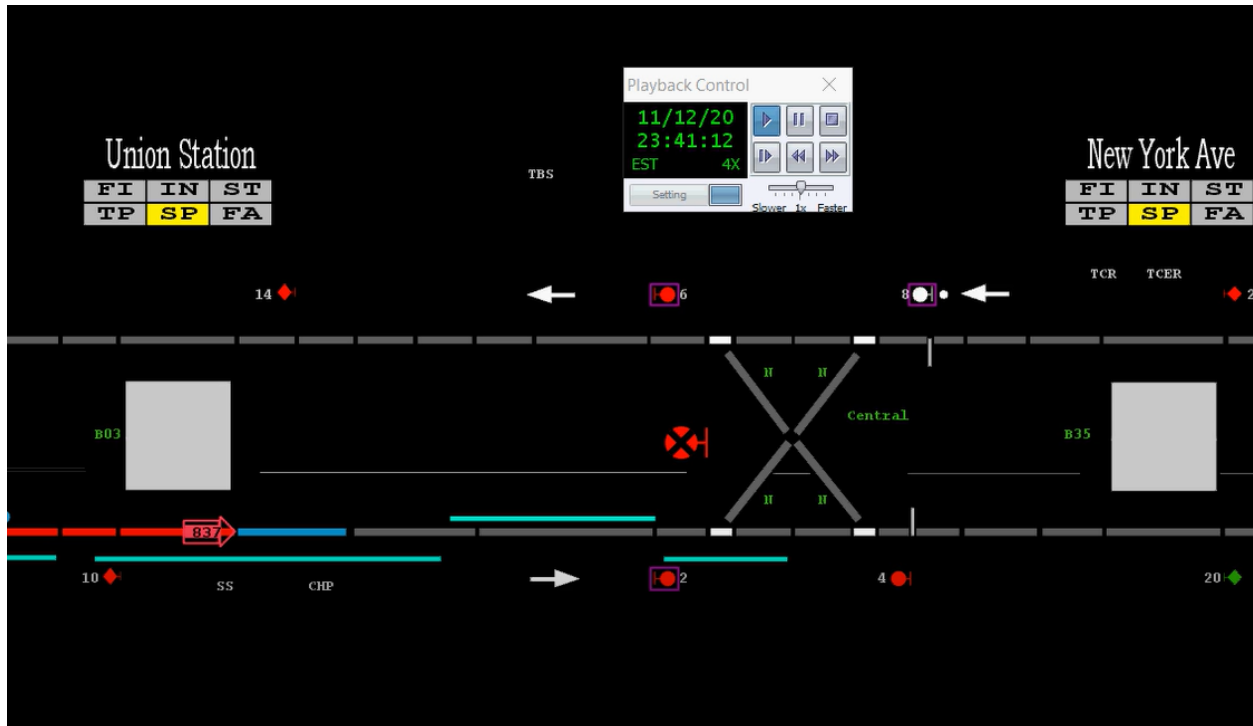
Diagram 1- ER Third Rail Power De-energized at Union Station.

The AIMS playback determined the Button RTC de-energized Union Station third rail power at 22:41 hrs. At 22:44 hrs., the MOC Assistant Superintendent notified the Automatic Train Control (ATC) specialist desk to dispatch ATC to the adjacent interlockings to support single track operations. The MOC Assistant Superintendent requested Power and Plant personnel to provide additional assistance and clean-up efforts.
