## **WMSC Commissioner Brief: W-0071 – Train Rollback – New Carrollton Yard – October 16, 2020**

### FINAL REPORT OF INVESTIGATION A&I E20400

# New Carrollton Yard – Train Rollback of a Class 1 Vehicle

October 16, 2020

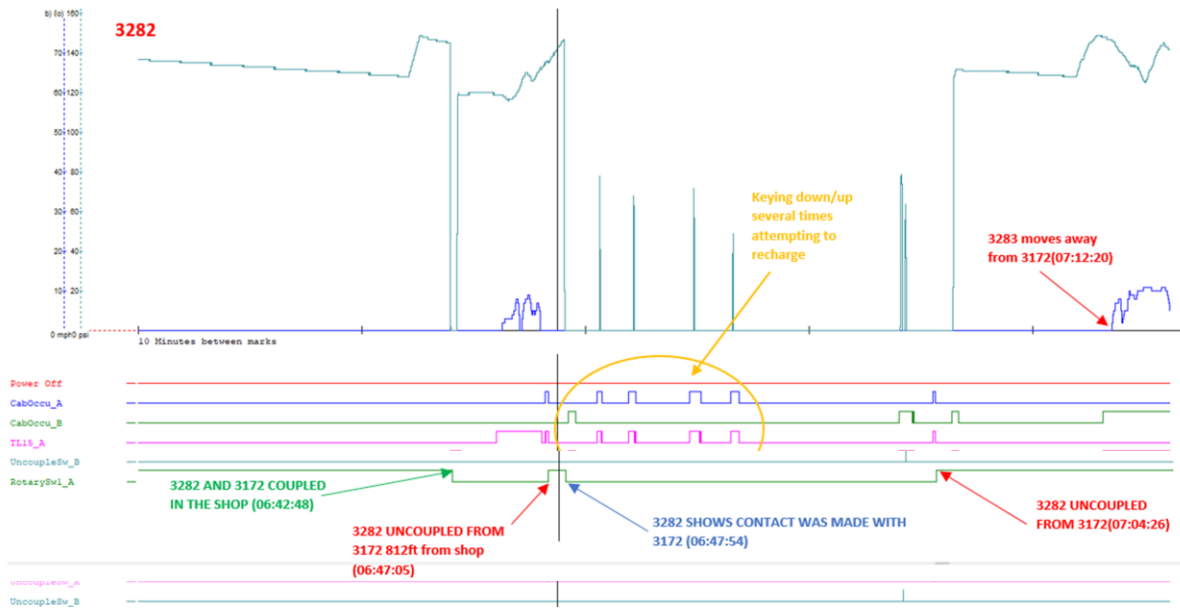
## Data Analysis for Cars 3282 and 3283.

06:47:47 hrs.	Car 3172 was placed in P3 position and brakes released, but no motion was detected by the Vehicle Monitoring System (VMS).
06:47:54 hrs.	Rail car 3282 shows being recoupled, but 3172 does not; this is where car 3282 made contact with car 3172.

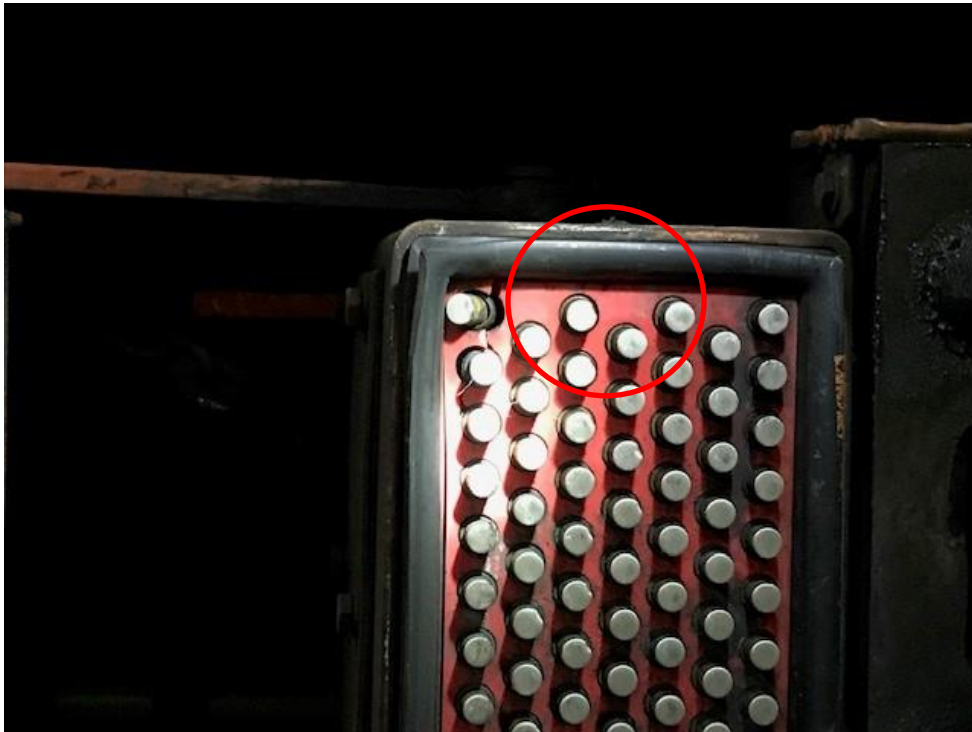
At 06:53 hrs., Train Operator 2 contacted the Interlocking Operator on the telephone to report that rail car 3282 drifted back and recoupled to car 3172 with damage to the coupler pins on car 3282. The Interlocking Operator dispatched the Office of Car Maintenance (CMNT) to the scene. At 07:07 hrs., Train Operator 2 notified the Interlocking Operator that CMNT recommended that rail car 3282 be placed back in the shop. The Interlocking Operator contacted the Rail Operations Control Center (ROCC) and notified the Button Rail Traffic Controller (RTC) and division Superintendent. Train Operator 1 was subsequently removed from service and transported for post-incident testing. The incident train remained in the shop at New Carrollton Yard for post-incident inspection. Upon further inspection, CMNT noticed that the right front electrical coupler head had damaged pins.

The Train Operator 1 was subsequently removed from service and transported for post-incident testing. The incident train remained in the New Carrollton rail yard, pending post-incident inspection. Upon further inspection, CMNT noticed that the right front electrical coupler had damaged pins.

Photo 1: Damaged pins on the coupler head.
