WMSC Commissioner Brief: W-0072 – Red Signal Overrun – Brentwood Yard – October 29, 2020

FINAL REPORT OF INVESTIGATION A&I E20417

Date of Event:	10/29/2020
Type of Event:	Red Signal Overrun
Incident Time:	20:15 hrs.
Location:	Brentwood Yard, Signal B99-138
Time and How received by SAFE:	20:45 hrs. – SAFE On-Call Phone
WMSC Notification Time:	21:26 hrs.
Rail Vehicle:	Train ID 703 L6126-6127.6163-6162.6195-6194T
Injuries:	None
Damage:	None
SMS I/A Incident Number:	20201029#89846

Brentwood Yard – Red Signal Overrun

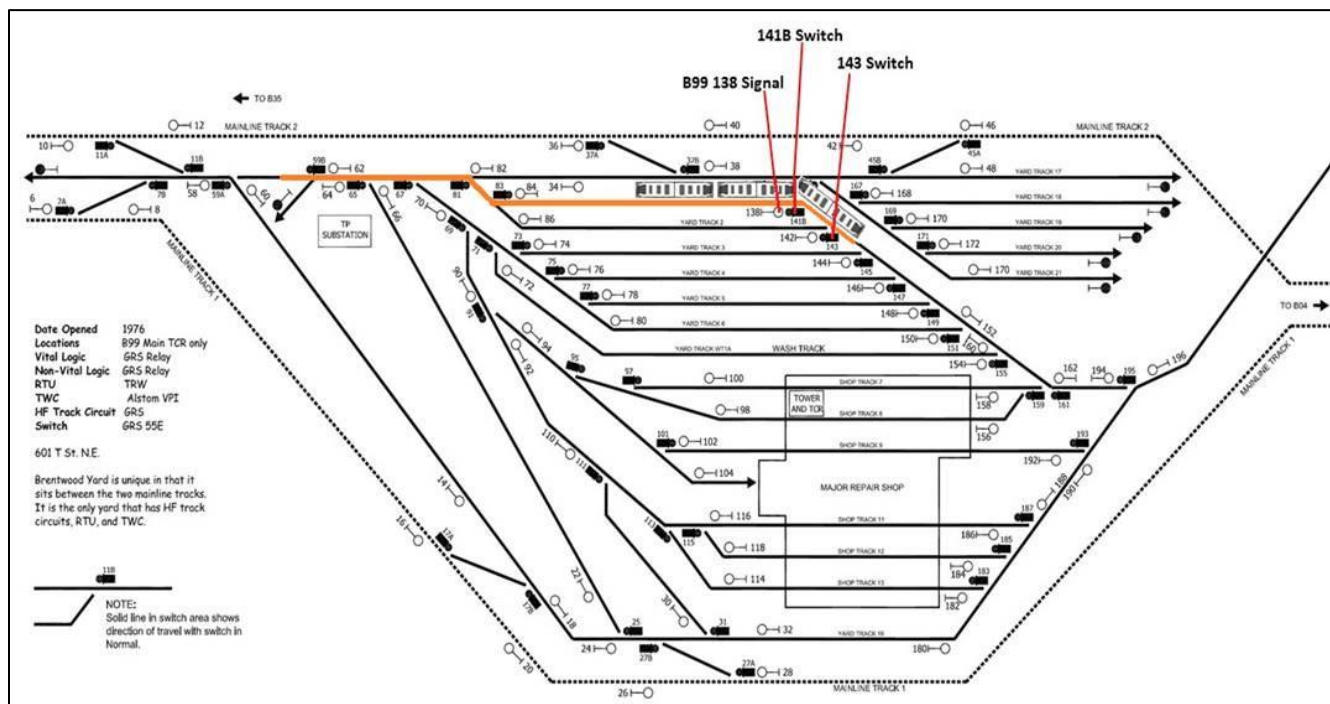
Figure 1: Track Diagram of Brentwood Yard, with impacted signal and switch identified.

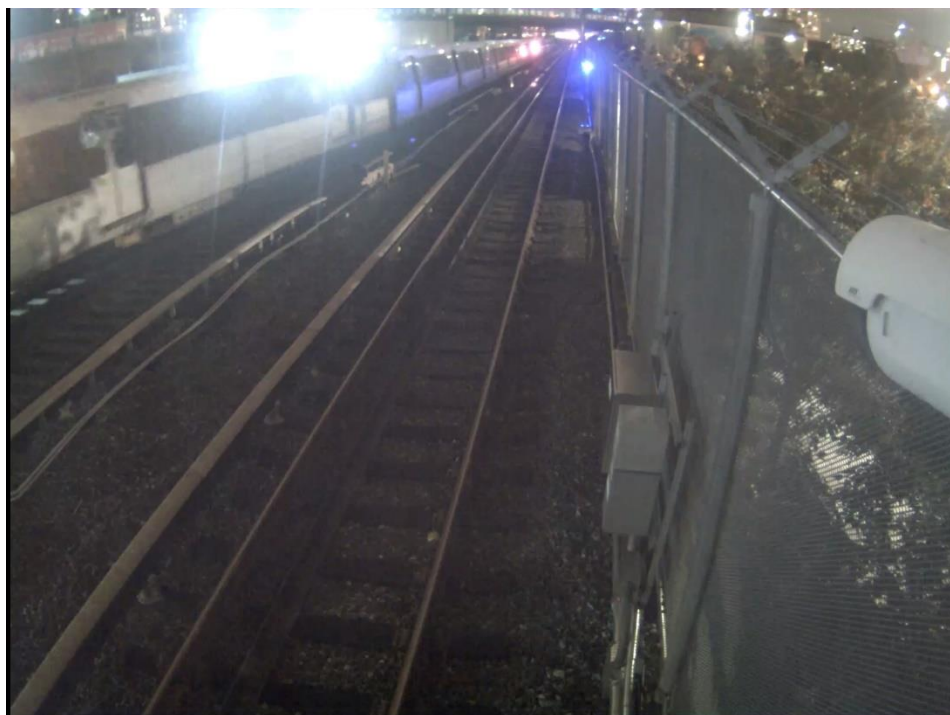
Based on CCTV, SAFE determined the Train ID 703 did not make any safety stops on approach to Signal B99-138, Track #1, from approximately 20:19:43 hrs. to 20:20:27 hrs.

Photo 1: CCTV footage showing weather was clear and not raining during the incident. CCTV also verified the Train Operator did not make the required safety stops.

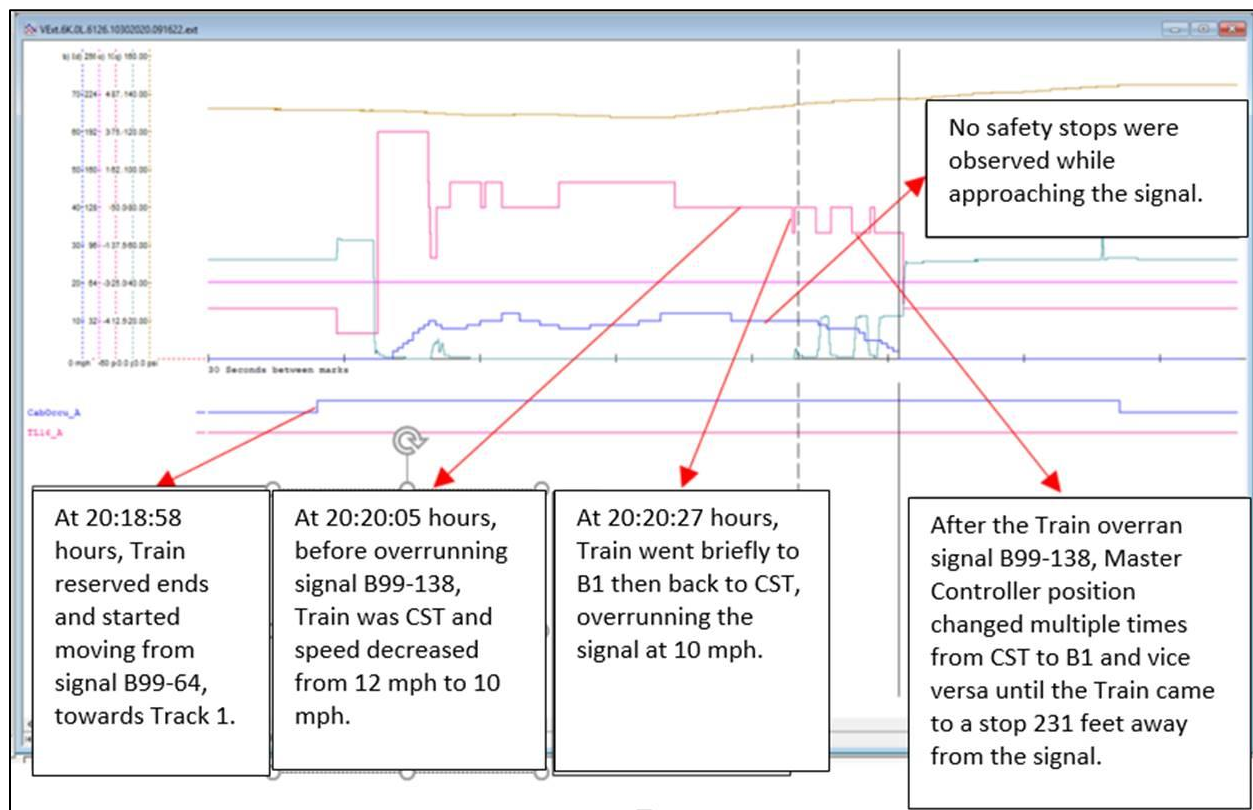
Vehicle Program Services (CENV) review of the Vehicle Monitoring System (VMS) showed that Train ID 703 failed to complete the required safety stops, overran Signal B99-138, Track# 1, and stopped the consist 231 feet beyond Signal B99-138.

Time	Description
20:18:58 hrs.	The Train Operator of Train ID 703 reversed ends and started moving from B99-64 towards Track #1.
20:20:05 hrs.	Before overrunning signal B99-138, Train was on coast and speed decreasing from 12 to 10 mph.
20:20:05 hrs. - 20:20:27 hrs.	CENV analysis did not show the Train Operator performed safety stops while the train was approaching signal B99-138.
20:20:27 hrs.	The Train Operator of Train ID 703 train went briefly to B1 then back to coast, overrunning the signal B99-138 at 10 mph.
20:20:27 hrs. - 20:20:48 hrs.	After Train Overran B99-138, the Master Controller position changed multiple times from coast to B1 and vice versa until the train came to a stop 231 feet away from the signal.

Figure 2: ER Graphical Analysis

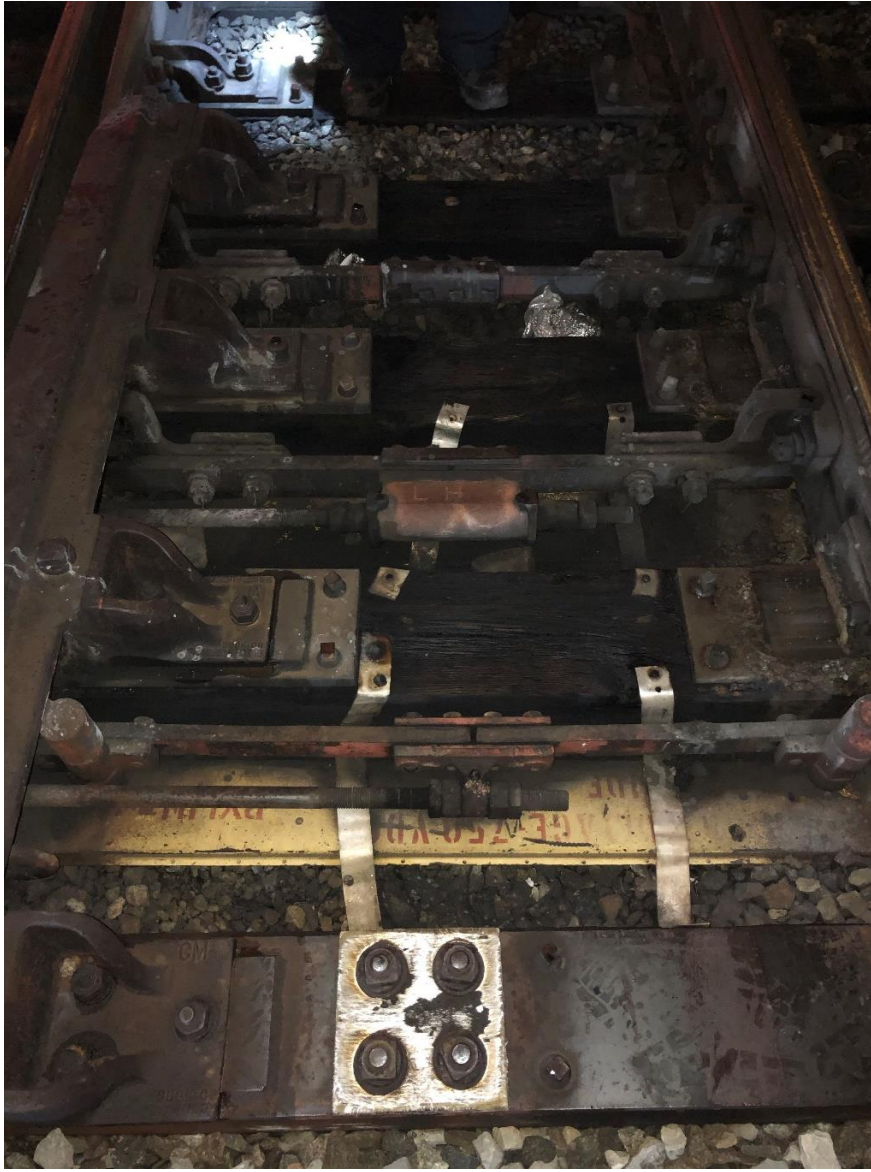
ATCM was notified by Maintenance Operations Center (MOC) to perform an inspection for a possible trailed switch. Upon arrival, they found the incident train positioned on top of Switches 141B and 143. ATCM advised MOC and ROCC that once the incident train is clear of the switches, they can perform the tests. Before RTRA moved the incident train, ATCM checked all relays associated with both switches. All logic was correct for a normal move through both switches; nothing showed out of correspondence. Switch 143 (M6) passed obstruction, switch point opening, and hand-crank cut out test. Switch 141B (55E) passed the obstruction, switch point opening, point detector, and hand-crank cut out tests. ATCM placed both switches back in service, and ATCM informed MOC and ROCC of the test results.

Photo 2: ATCM Photo – Switch 141B with switch cover removed and showing no signs of damage.

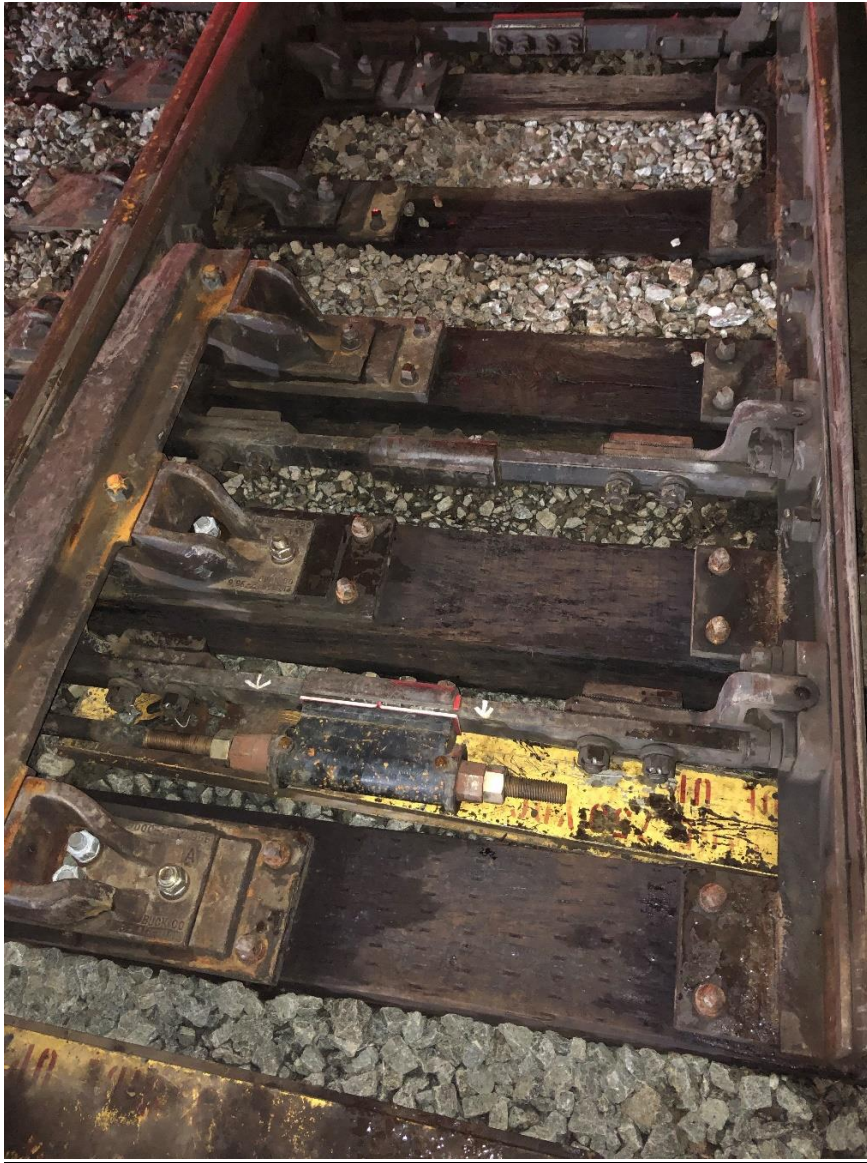
Photo 3: ATCM Photo – Switch 143 with switch cover removed, showing no signs of damage.

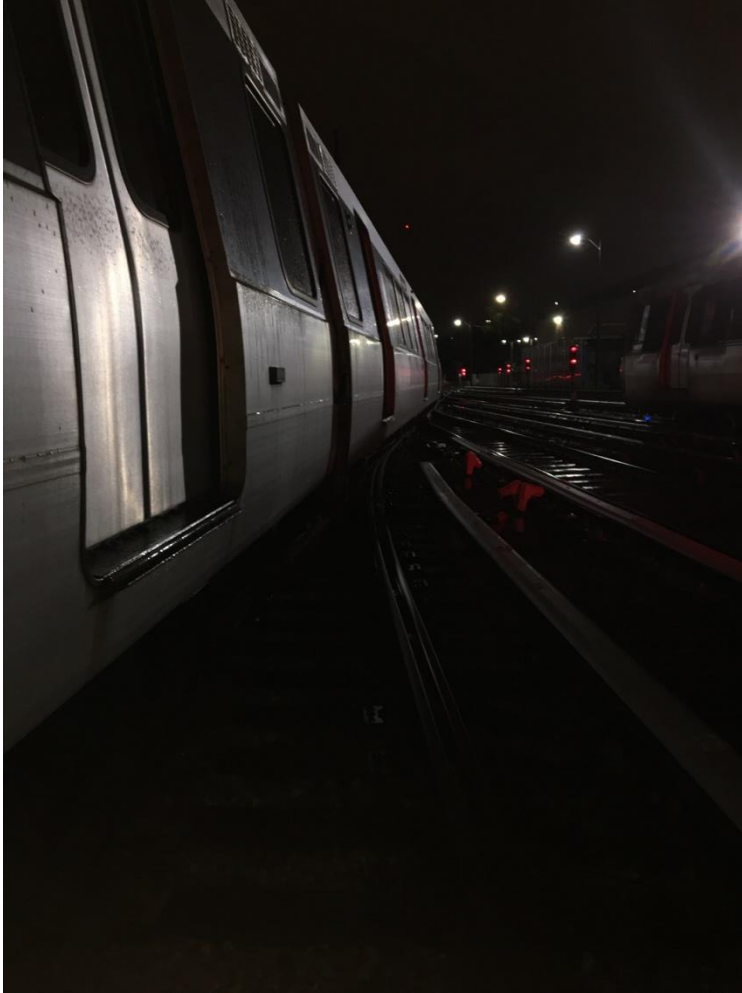
Photo 4: Perspective of consist location after overrunning the B99-38 signal, which is behind the point of where the photos was taken.

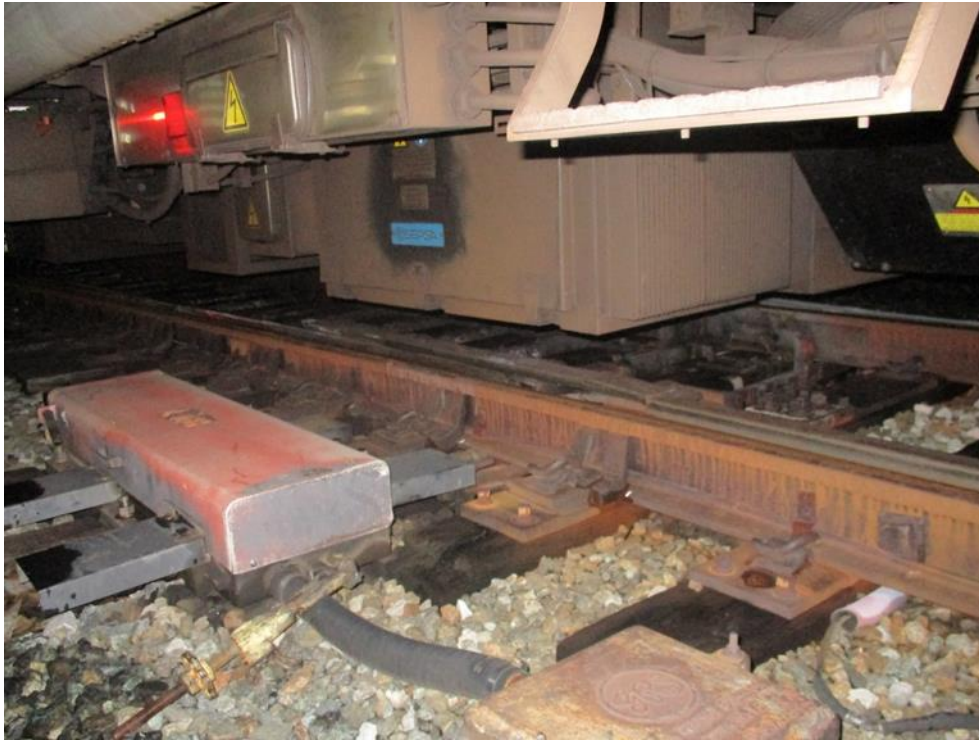
Photo 5: Incident train traveled through Switch 141B after passing Signal B99-138 (Red), Track #1.

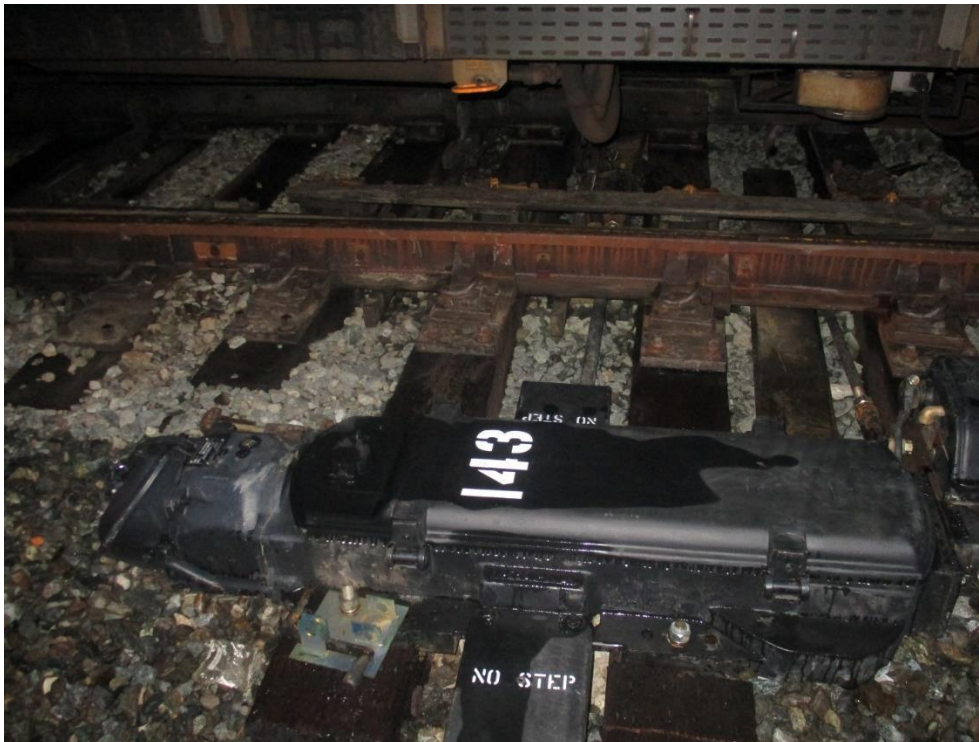
Photo 6: Incident train traveled through Switch 143 after passing Signal B99-138 (Red), Track #1.

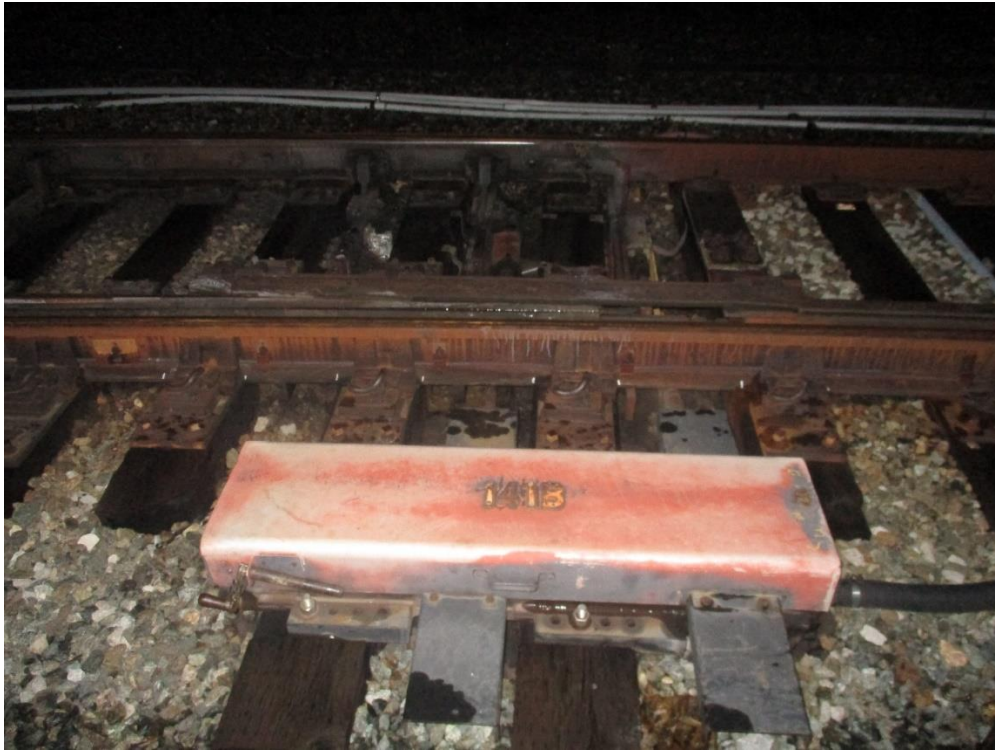
Photo 7: Switch 141B after RTRA moved the incident train. ATCM found no damage.

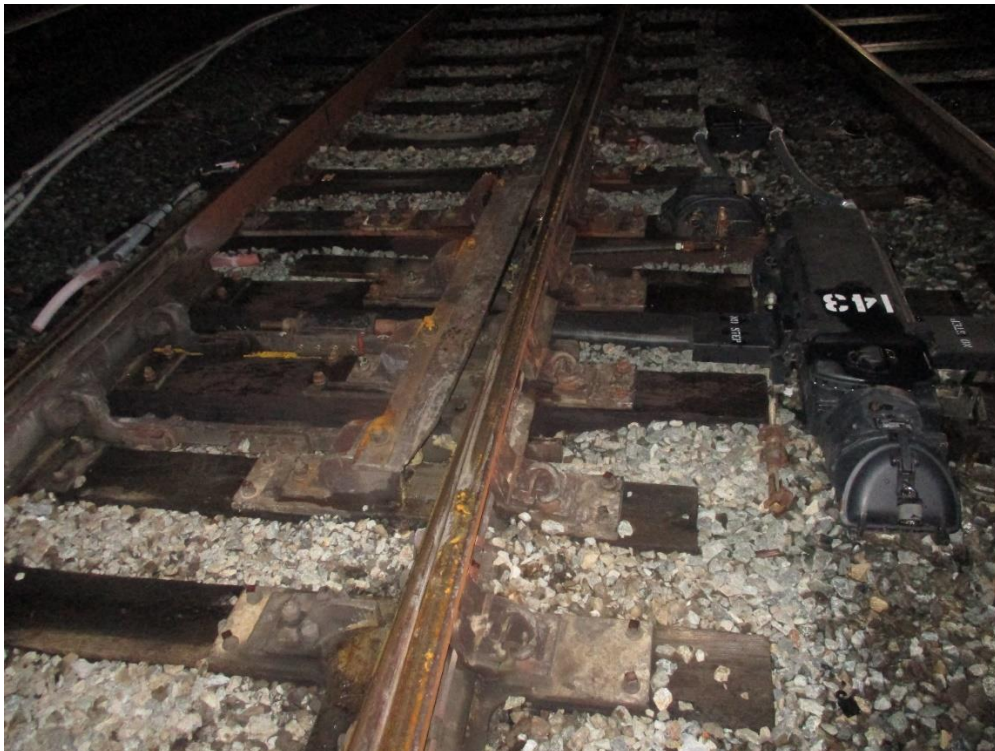
Photo 8: Switch 143 after RTRA moved the incident train, ATCM found no damage.

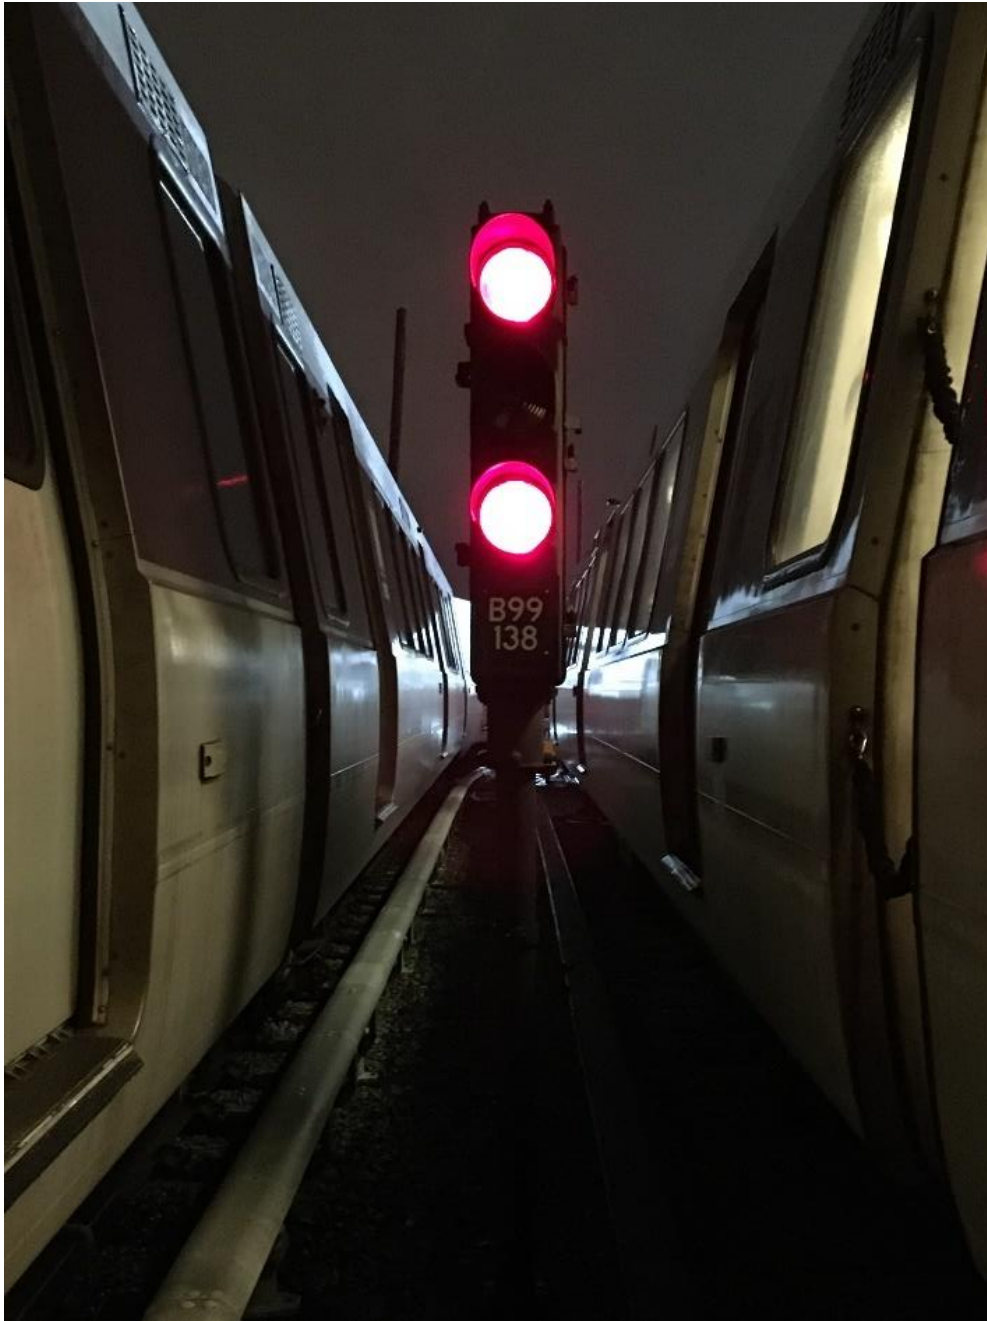
Photo 9: Signal B99-138, Track #1. Incident consist (left) stationary 231 feet past signal.
