WMSC Commissioner Brief: W-0073 – Red Signal Overrun – Greenbelt Yard – November 23, 2020

FINAL REPORT OF INVESTIGATION A&I E20453

Greenbelt Yard – Red Signal Overrun

Date: 11/23/2020 Time: 05:35 hrs.
Final Report Rev.1 – Red Signal Overrun
E20453

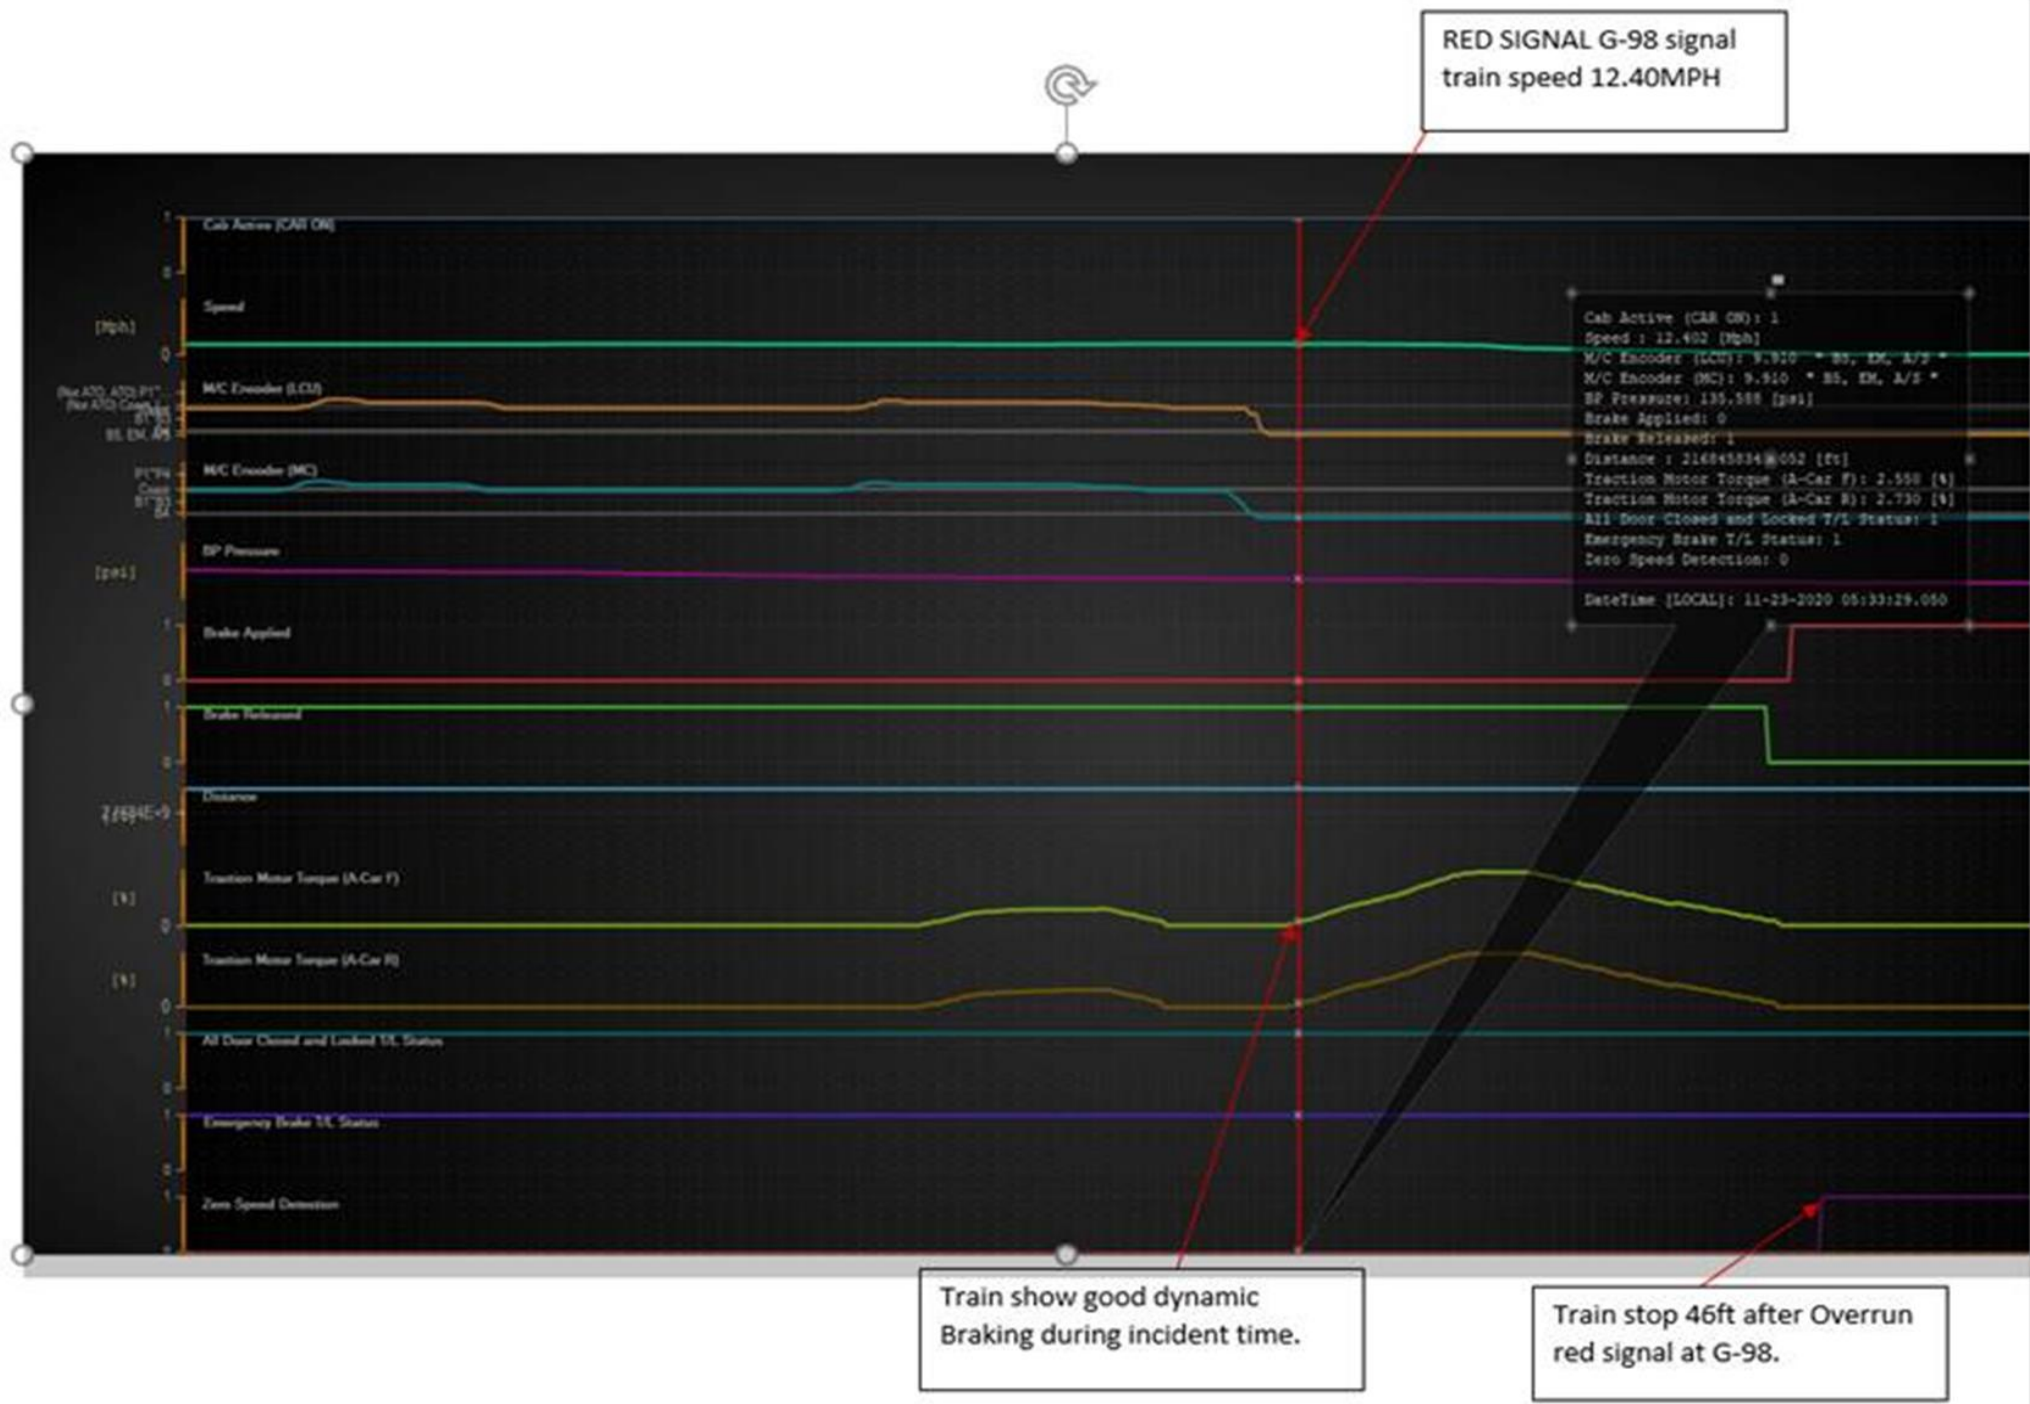
Diagram 1- ER Graphical Analysis

05:32:38 hrs.	Lead car 7232 stop at Vehicle crossover heading north.
05:33:06 hrs.	Lead car 7232 passed E99-186 signal Lunar (train speed 11.84 MPH) Master Controller Position "Coast." Distance from E99-98 approximately 413 Ft.
05:33:29 hrs.	Lead car 7232 passed RED SIGNAL at E99-98 (Train speed at 12.40. Master Controller Position "B5").
05:33:35 hrs.	Car stop and Master Controller is placed in "B5" (Distance travel Approx. 46 Ft. Past red signal).

- Lead car 7232 passes RED SIGNAL at E99-98 (Train speed at 12.40. Master Controller Position "B5").
- The Train Operator overran the E99-98 signal by Approx. 46 Ft.
