WMSC Commissioner Brief: W-0074 – Improper RWP – Red Line near Rockville Station – November 26, 2020

FINAL REPORT OF INVESTIGATION A&I E20467

Rockville Station – Improper Roadway Worker Protection

November 26, 2020

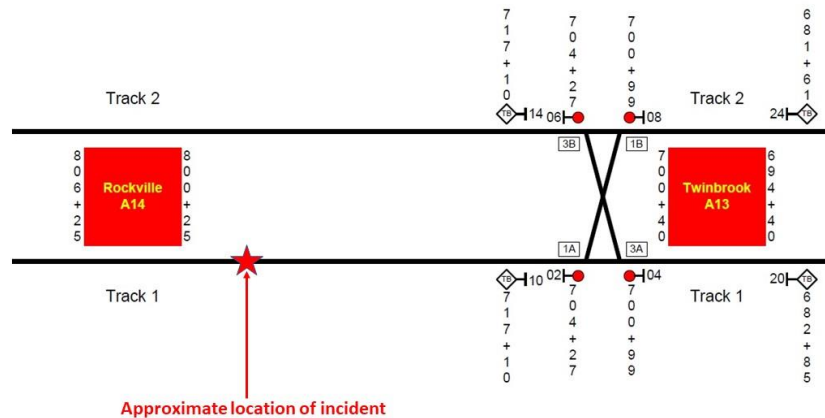
Field Sketch/Diagram

Between Rockville and Twinbrook Stations, Track #1, CM 788+00 – 795+00

Based on a review of the RWP Quick Access Guide, the TRPM personnel traversed a Restricted View Red-Hot Spot from CM 705+00 to 711+00.
