## **WMSC Commissioner Brief: W-0075 – Improper RWP – Takoma Station Interlocking – October 20, 2020**

**FINAL REPORT OF INVESTIGATION A&I E20406**

Takoma Station – Improper Roadway Worker Protection

October 20, 2020

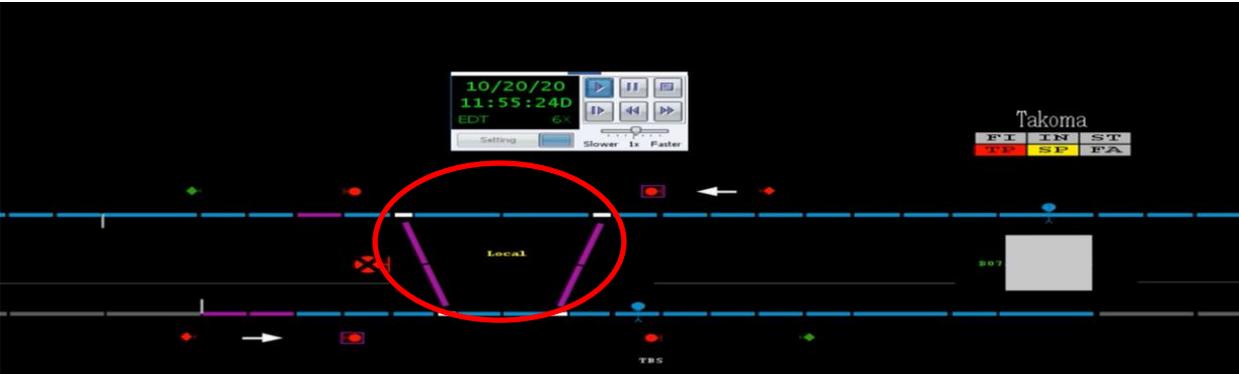
Diagram 1: AIMS indication displaying that the LCP Operator has “Local” control of the interlocking.

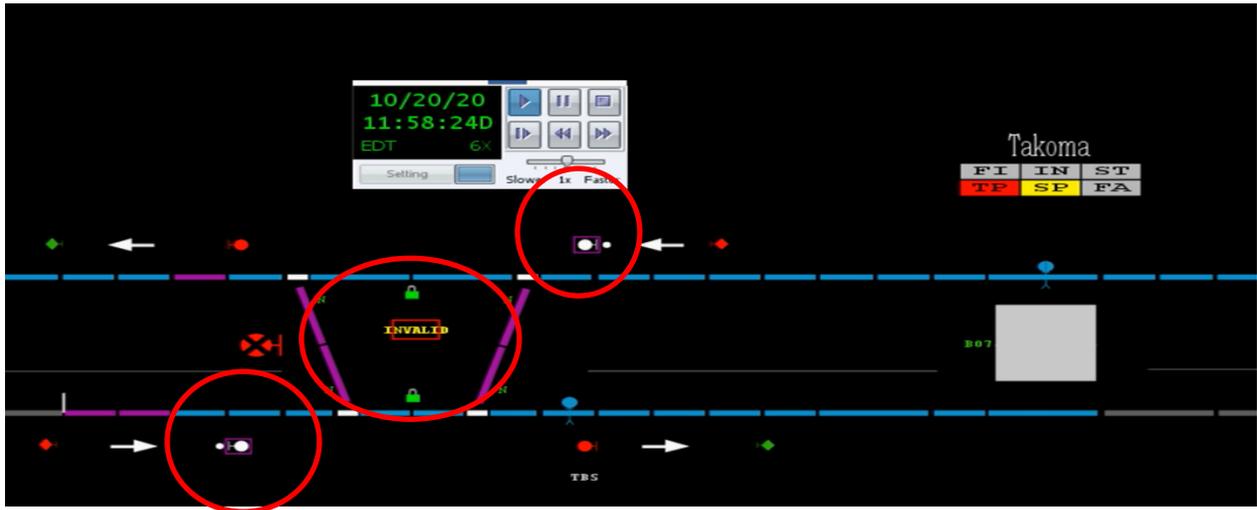
11:57:06 hrs.	The AIMS displayed Takoma Station interlocking in an "Invalid" state. [AIMS]  TRST attempted to contact the RWIC to traverse their work location to no avail. [Radio]

Diagram 2: AIMS displaying the interlocking in an “Invalid” state indicating the control key has been turned, allowing for ROCC to take control.

Note: Lunars are set at B07-02 and B07-08 signals.

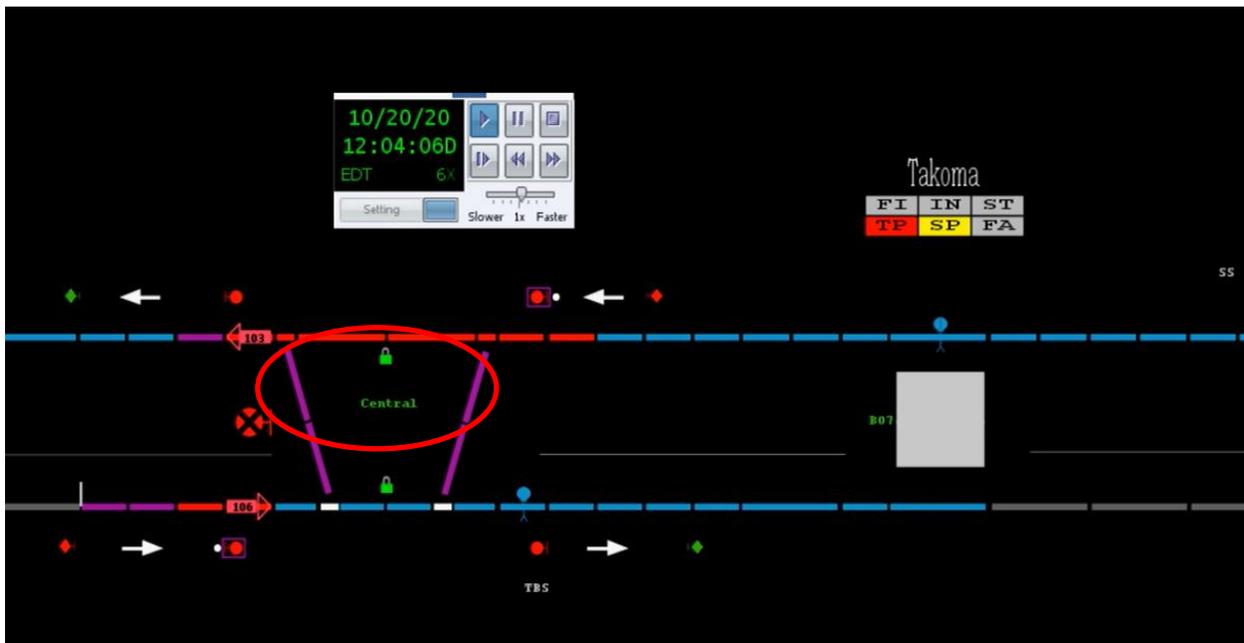
12:04:12 hrs.	The Button RTC took control over the interlocking at Takoma Station and instructed the RWIC to clear the roadway and board Train 106, Track 1 on approach to B07-02 signal. [AIMS] and [Radio]

Diagram 3: AIMS displaying ROCC in control of the interlocking.
