**WMSC Commissioner Brief: W-0076 – Improper Roadway Worker Protection – Near Suitland Station – September 17, 2020**

#### FINAL REPORT OF INVESTIGATION A&I E20355

# Suitland Station – Improper Roadway Worker Protection

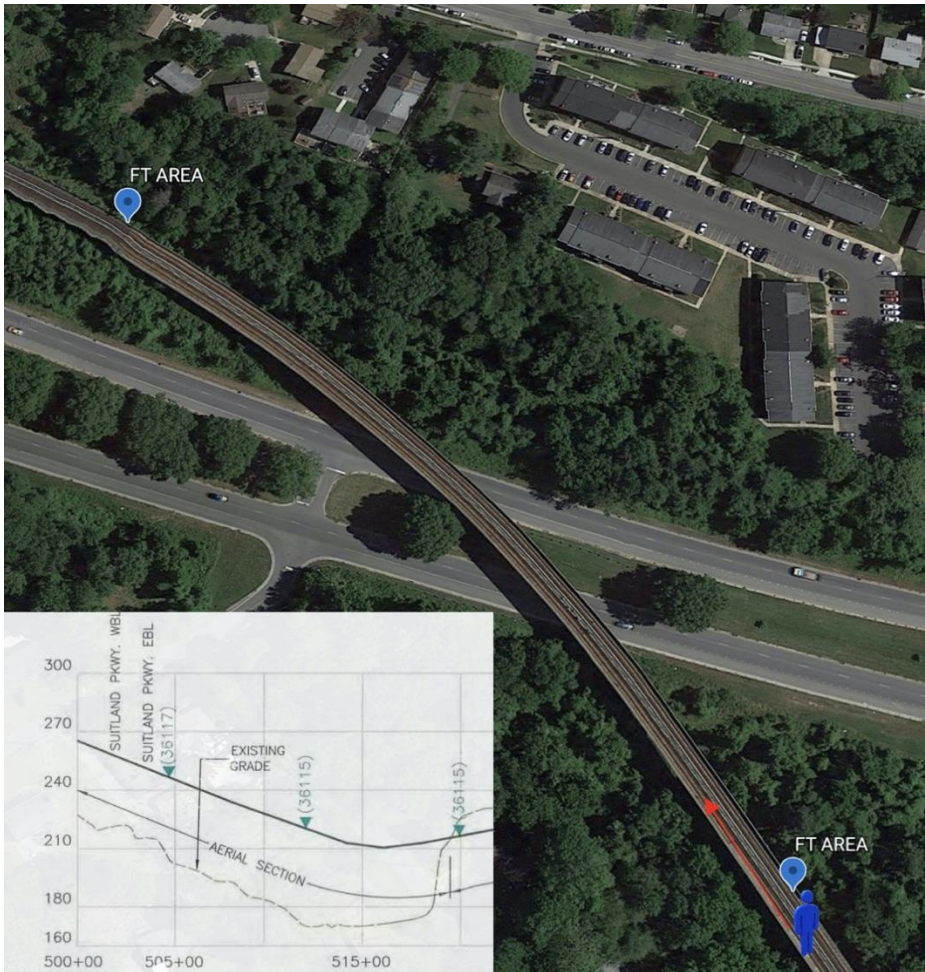
## Field Sketch/Schematics

Between Suitland and Branch Ave Station, Track 2

Hot Spot: Restricted Curve [Aerial Structure]

Red hot spot area: CM F2-510+00 to F2-497+00

Train Drop off on Track 2 CM F2-504+00

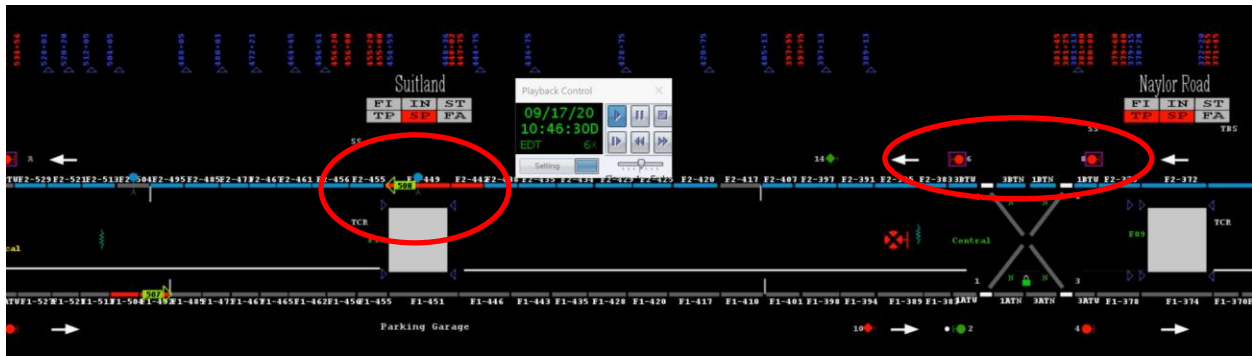
Photo 1: AIMS display indicating FT RWP for TRST at 10:46 hrs. Prohibit exits and red signals in place at F06-06 and F08-08 signals. TRST instructed to notify the Radio RTC when Train ID 508 clears their location on the mainline.

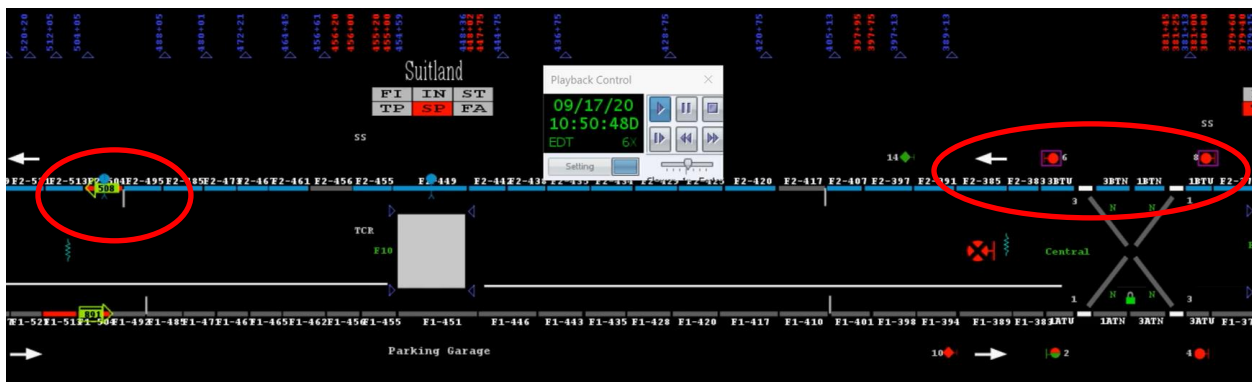
Photo 2: Train ID 508 dropping off ATCM personnel at CM F2-504+00. Naylor Road interlocking remains placed under FT RWP.

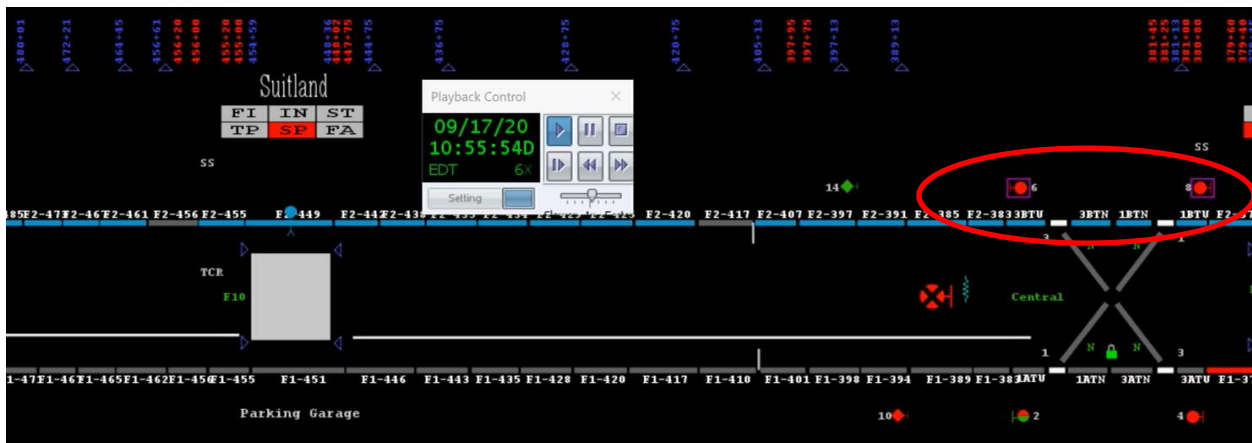
Photo 3: ATCM personnel removed from service. Naylor Road interlocking placed under FT RWP.
