WMSC Commissioner Brief: W-0077 – Improper Roadway Worker Protection – West Hyattsville Tie Breaker Station – September 28, 2020

FINAL REPORT OF INVESTIGATION A&I E20366

West Hyattsville Station – Improper Roadway Worker Protection

September 28, 2020

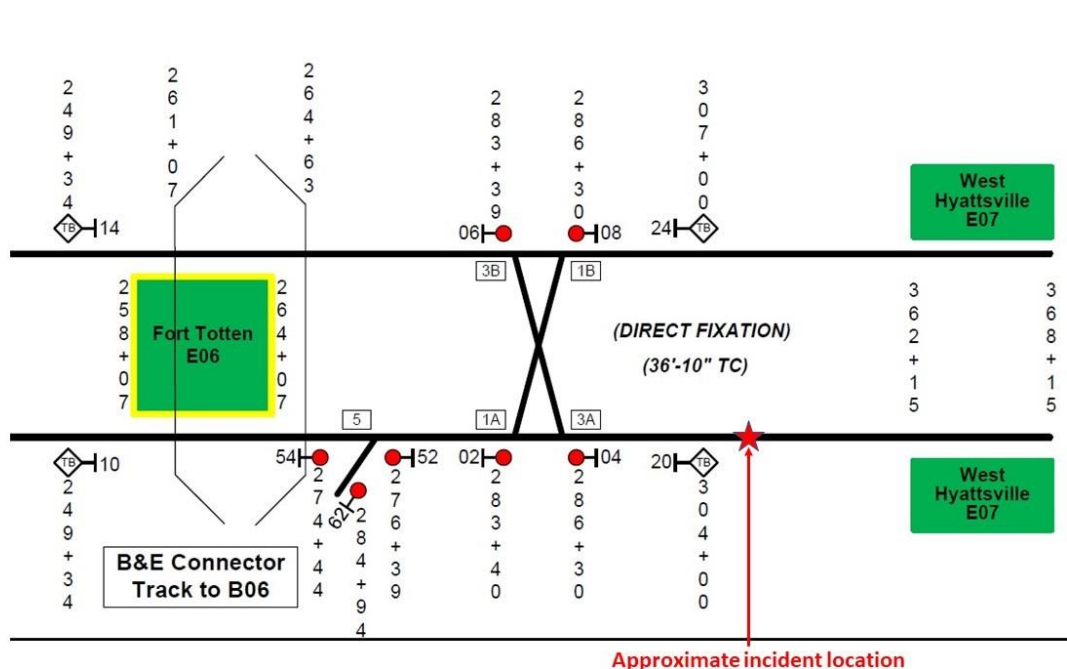
Field Sketch/Diagram

Near West Hyattsville Station, Track #1, CM 313+80

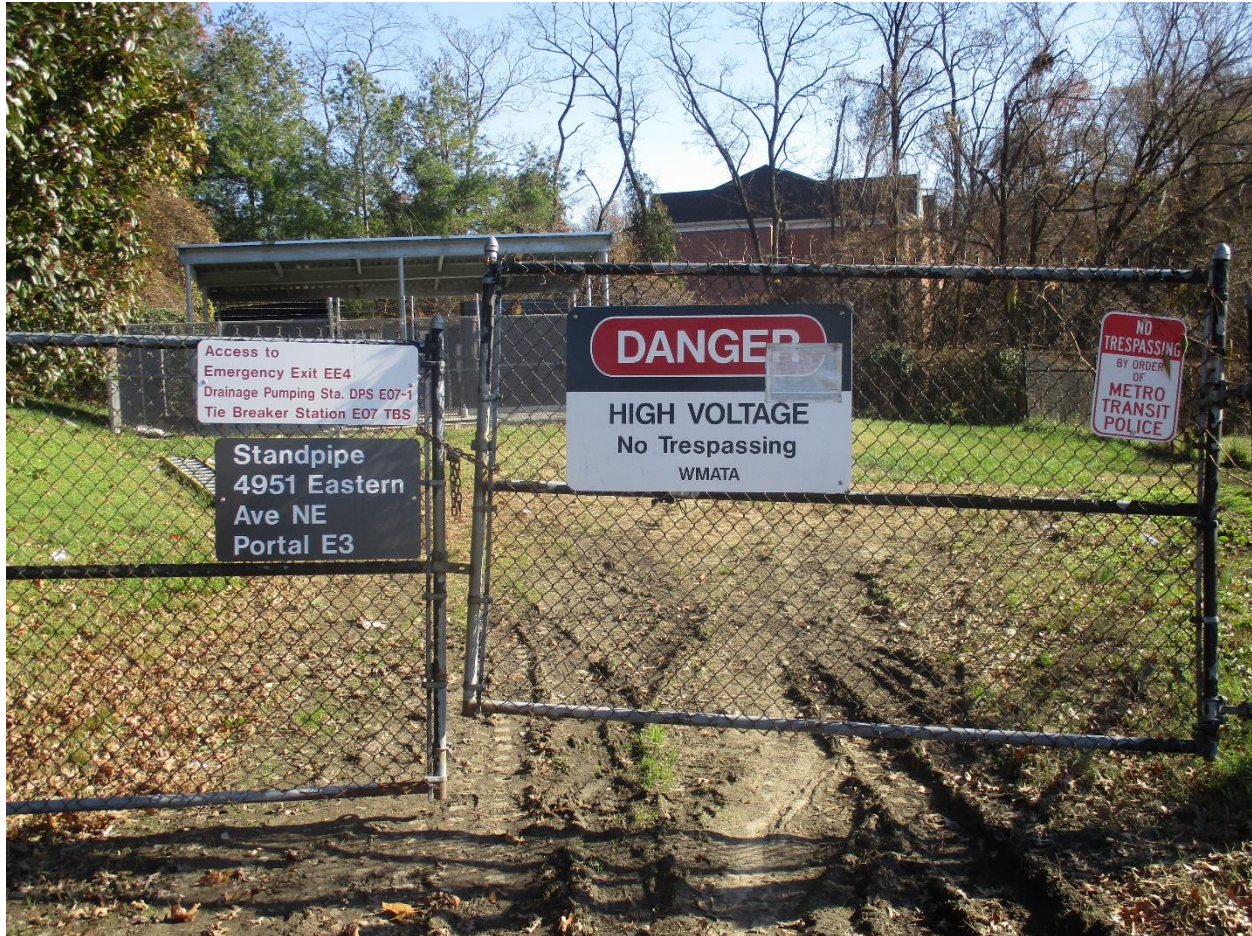
Photo 1: Entrance Gate to TBS #7.

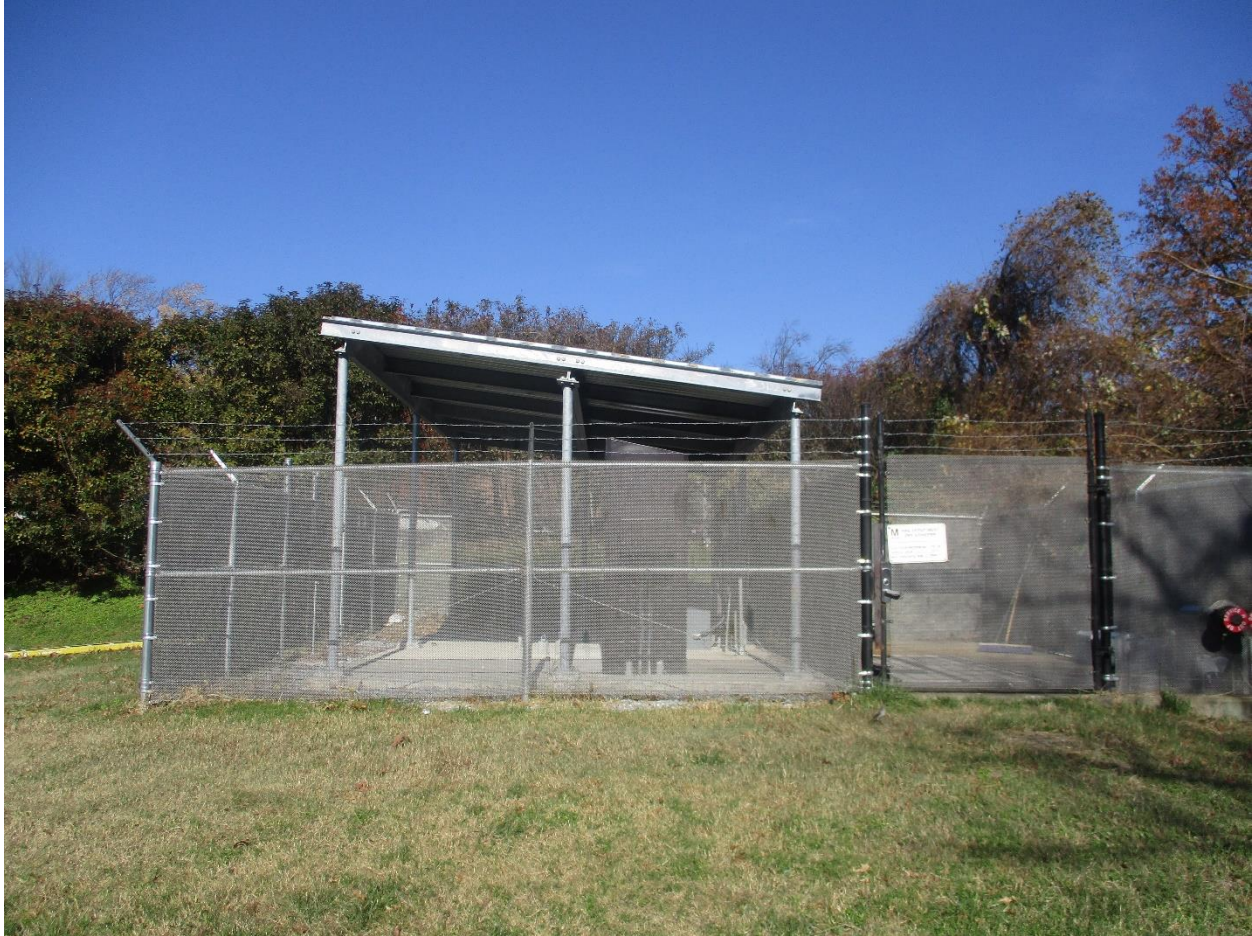
Photo 2: Access gate to WMATA Roadway and TBS #7.
