WMSC Commissioner Brief: W-0078 – Person Struck by Train – L’Enfant Plaza Station – December 15, 2020

FINAL REPORT OF INVESTIGATION A&I E20494

L'Enfant Plaza – Person Struck by Train
December 15, 2020

L'Enfant Plaza Station, Track 1

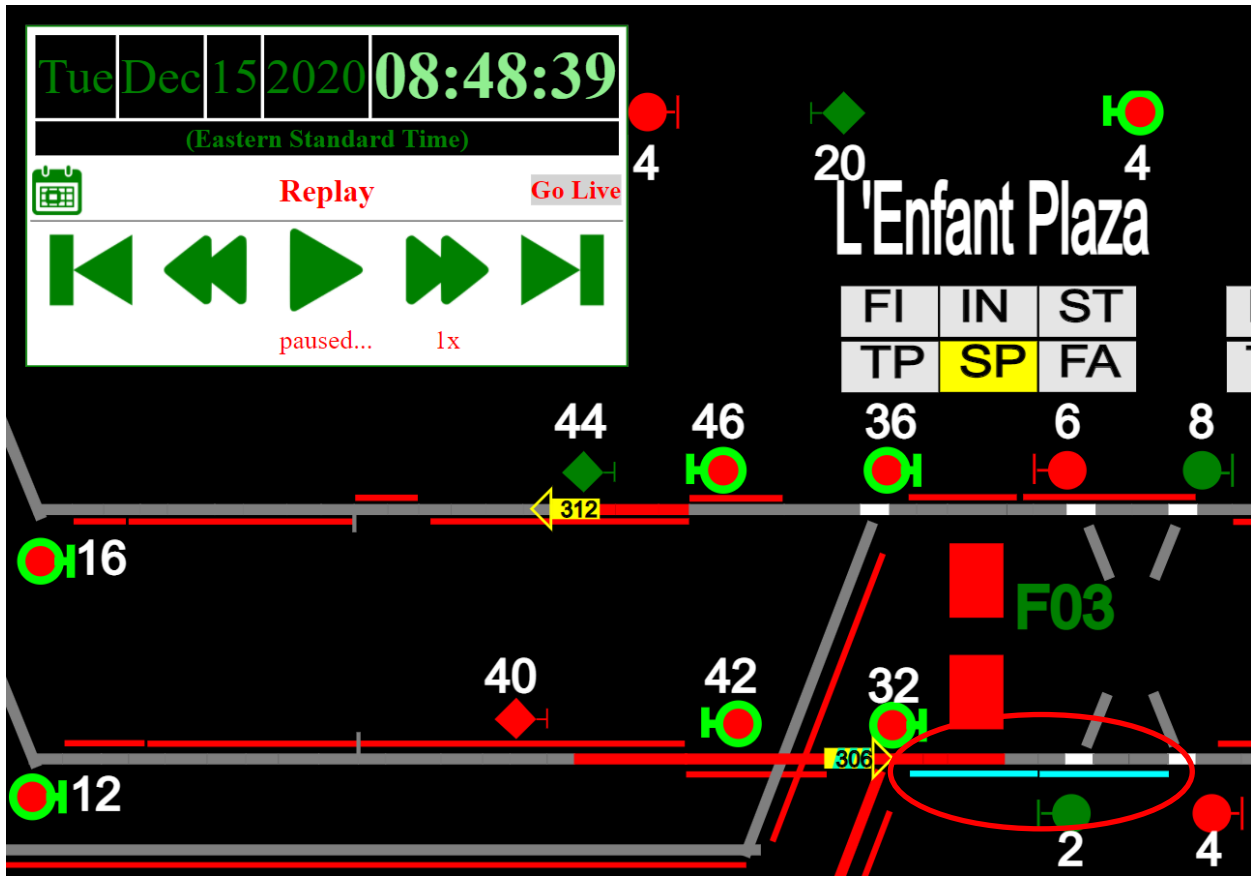
Figure 1: AIMS – 08:48:39 hrs. Third rail power was de-energized L'Enfant Plaza Station, Track 1.

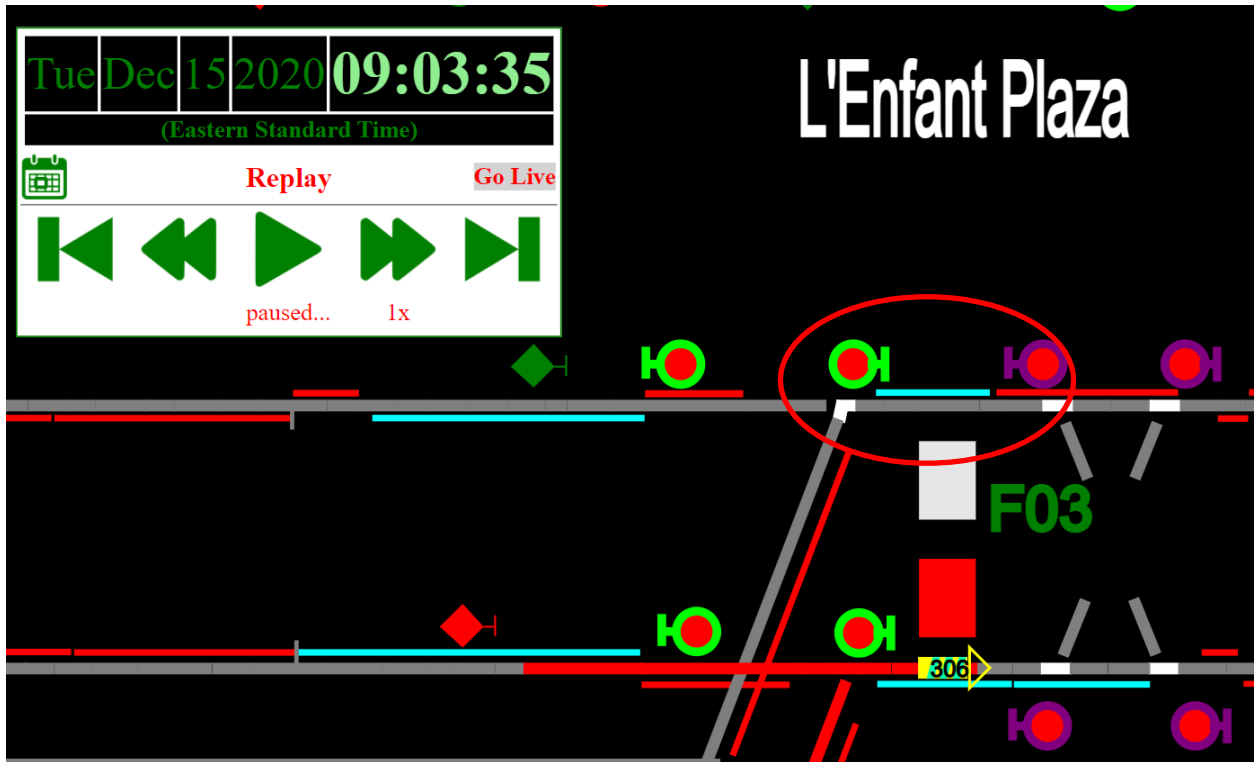
Figure 2: AIMS Photo – 09:03:35 hrs., Third rail power was de-energized at L'Enfant Plaza Station, Track 2

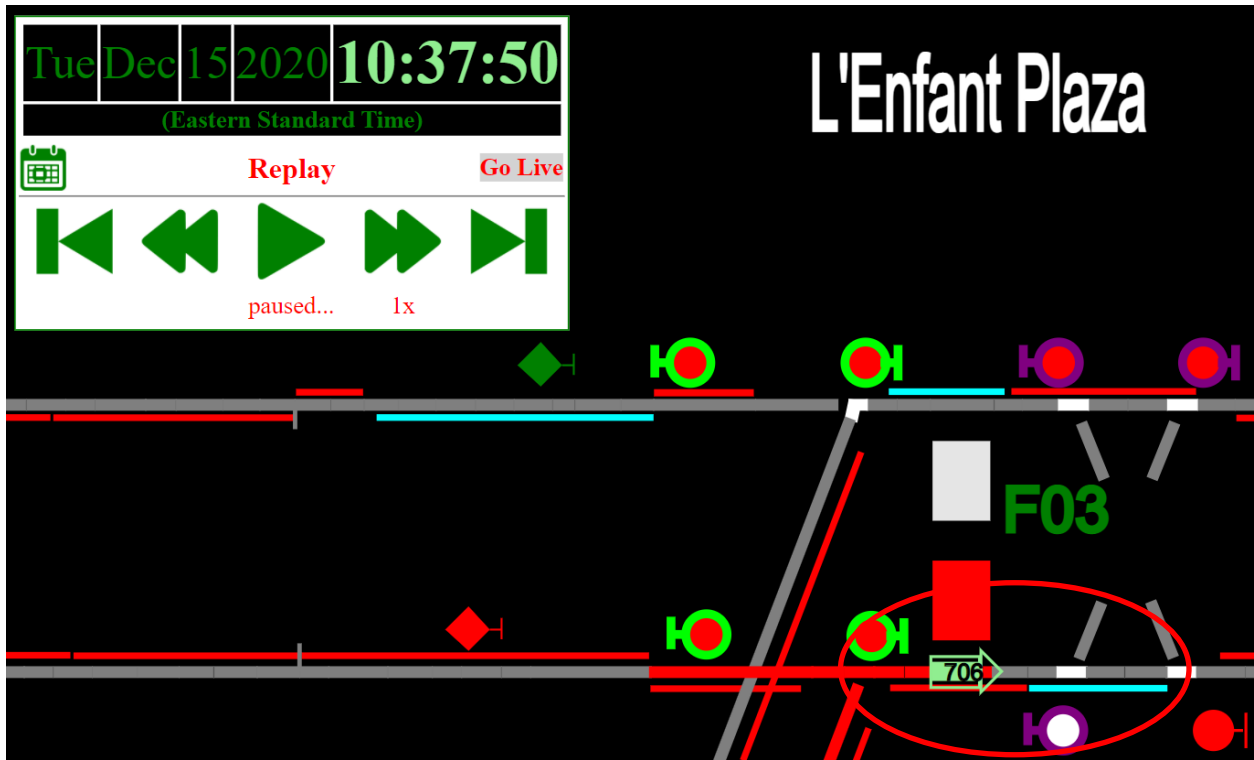
Figure 3: AIMS Photo – 10:37:50 hrs. Third rail power was momentarily re-energized at L'Enfant Plaza Station, Track 2, to clear now Train ID 706 from the scene.

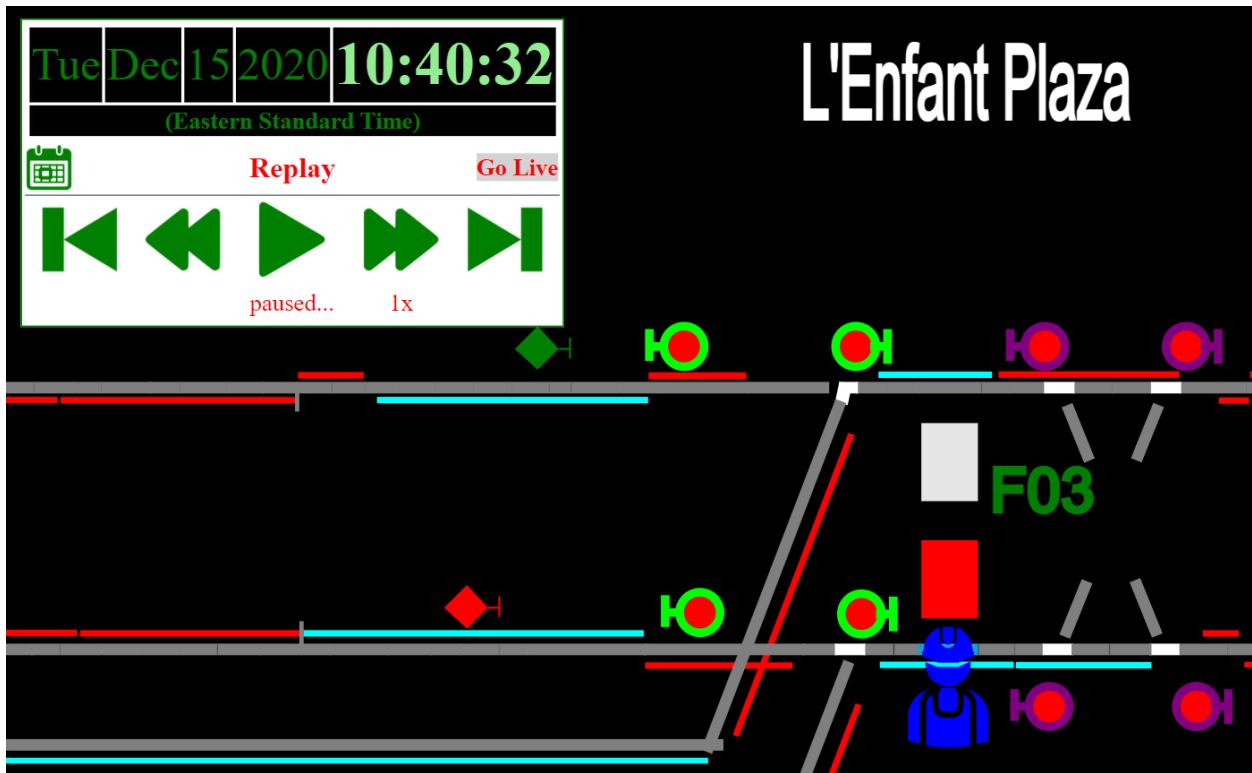
Figure 4: AIMS Photo – 10:40:32 hrs. MTPD entered the roadway to continue investigating the incident.

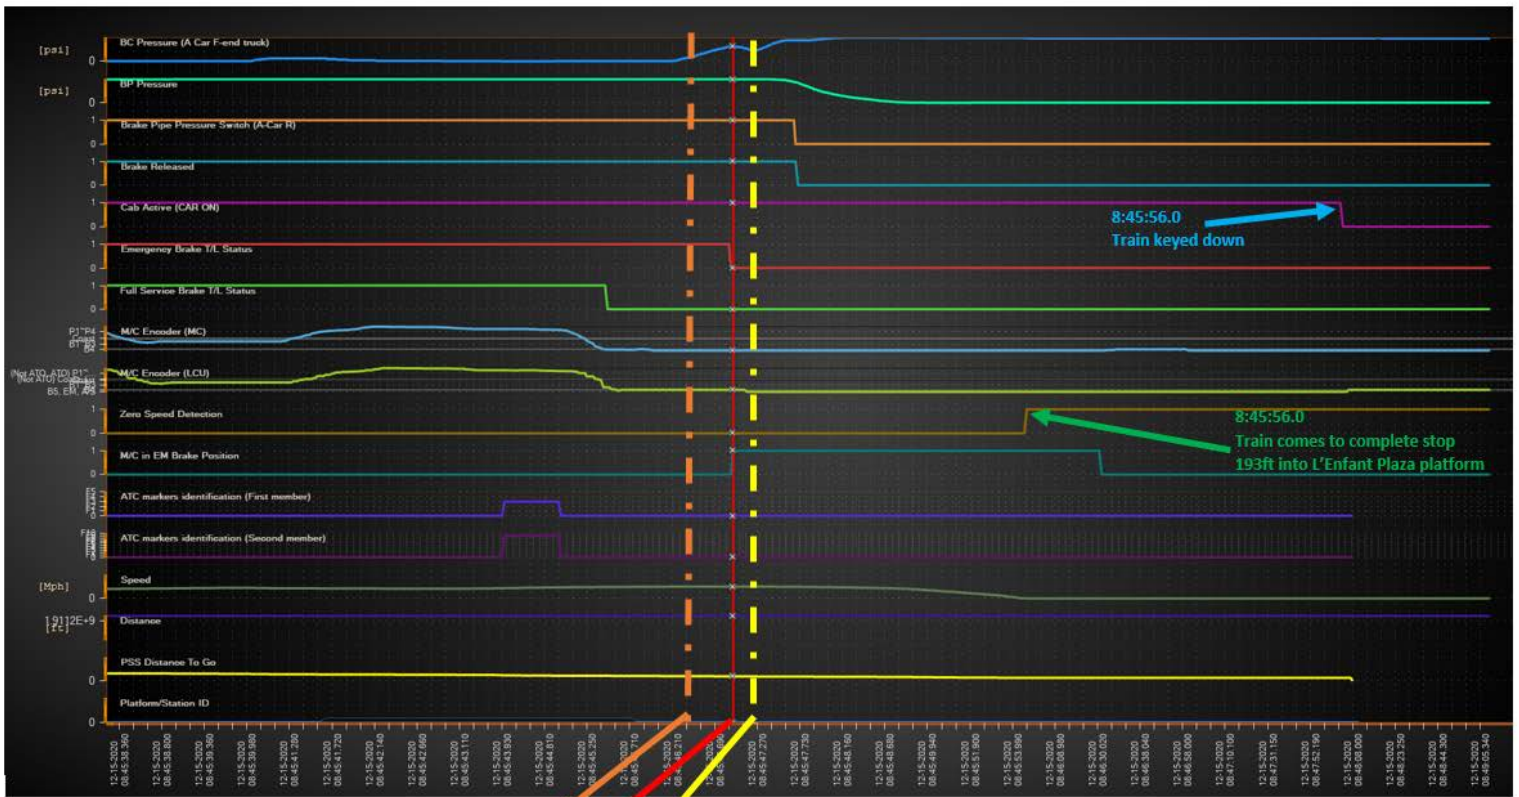
ER Data Graph/Sequence of Events

Based on CENV analysis, there was no data to support any anomalies with the consist that may have contributed to this incident.

8:45:46.4 Train #306 Enters L'Enfant Plaza, Track #1, Speed = 29.8 MPH, M/C in B5

8:45:46.9 M/C moved to EMER position, EMR T/L de-energizes, Speed = 29.8 MPH

8:45:47.2 Train makes Contact with person on the Wayside, Speed = 29.8 MPH, MC in the EMER position, 34 ft. onto platform
