WMSC Commissioner Brief: W-0079 – Pull-Apart – outside Union Station – October 9, 2020

Prepared for Washington Metrorail Safety Commission meeting on May 18, 2021

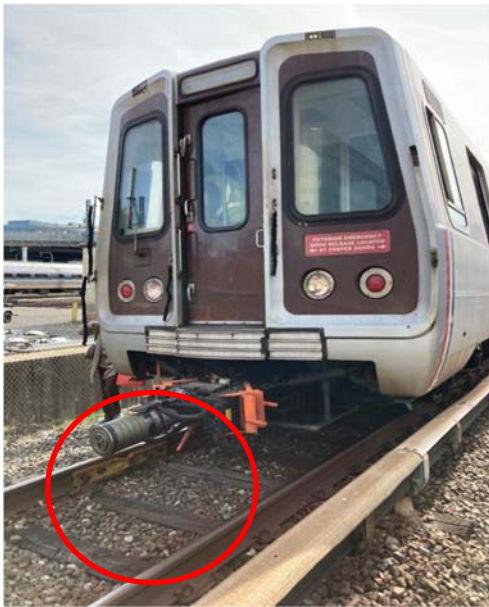
Figure 7: Car 6079 – Front view of pull-apart (Spring pack with Automatic Couplers connected)

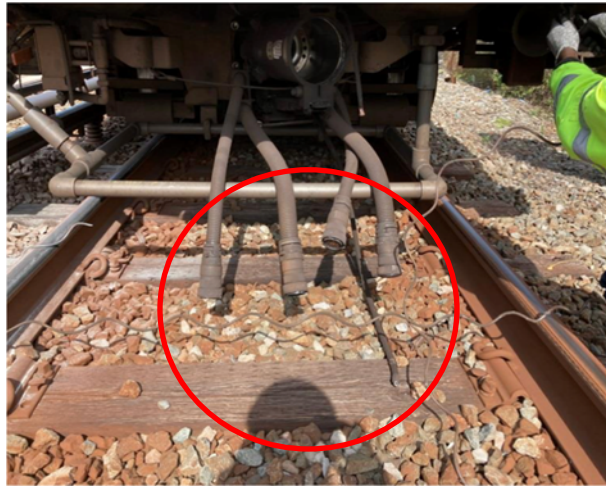
Figure 8: Trainline wiring/cables from Car 6075

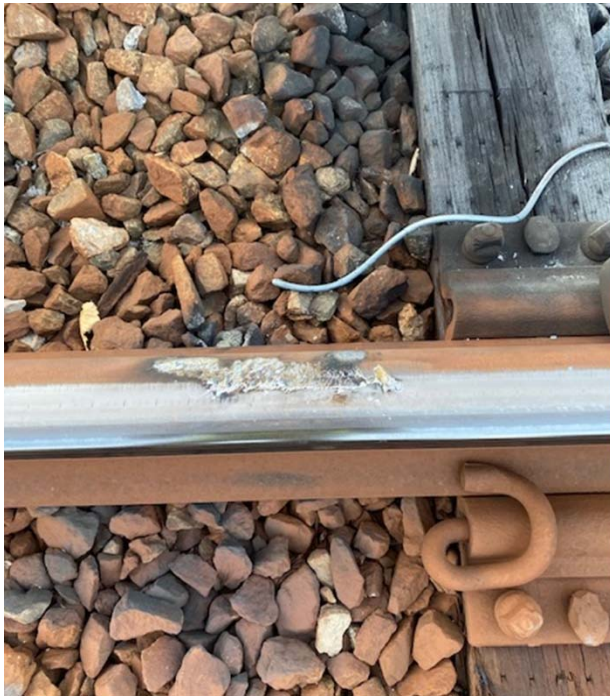
Figure 11: Observed burn marks on the running rail near the pull-apart location.

SAFE also observed that the front mechanical coupler centering spring from Car 6075 made contact with the running rail, most likely causing the smoldering tie reported by the Train Operator.

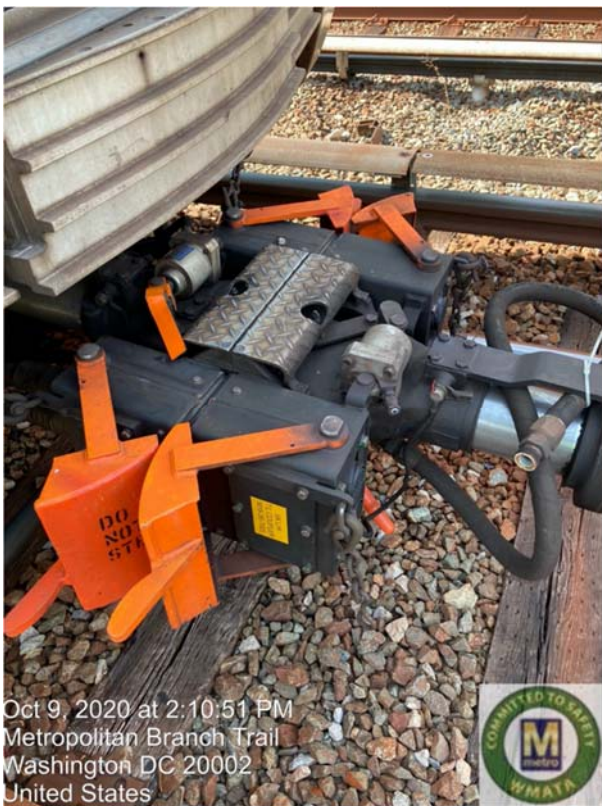
Figure 12: Car 6075 mechanical coupler still attached to Car 6079.

With CENV, CMNT Assistant General Superintendent, and CMNT technicians, SAFE inspected the affected consist and associated hardware. During this time, SAFE identified an intact and undisturbed torque stripe on the buffer tube bolt. The coupler head from Car 6075 was observed attached to Car 6079.

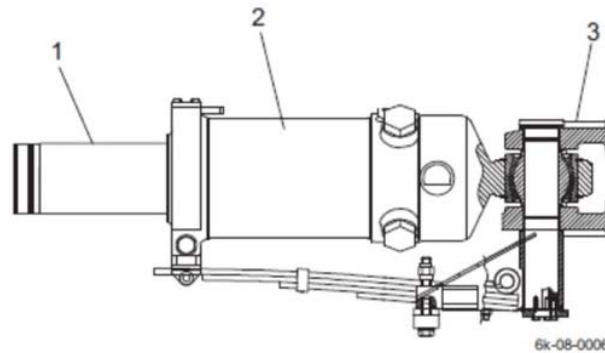
On October 9, 2020, the pull-apart incident involved the draft gear of the F-End Automatic Coupler and occurred when the “drawbar” (1) separated from the “buffer” tube (2).

Figure 13: F-End Automatic Coupler: 1) Drawbar; 2) Buffer tube

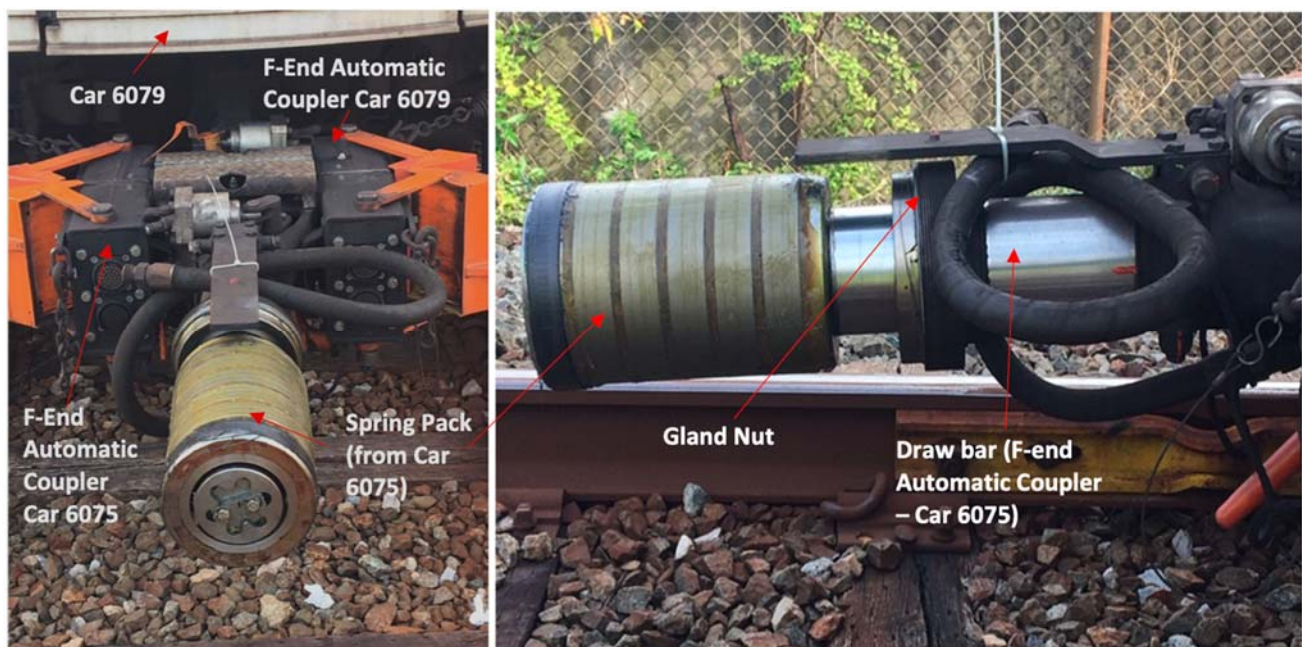
Figure 14a: Car 6079 – Front view of pull-apart (Spring pack with Automatic Couplers connected)

Figure 14b: Car 6079 – Side View of pull-apart (Spring Pack & Drawbar of car 6075)

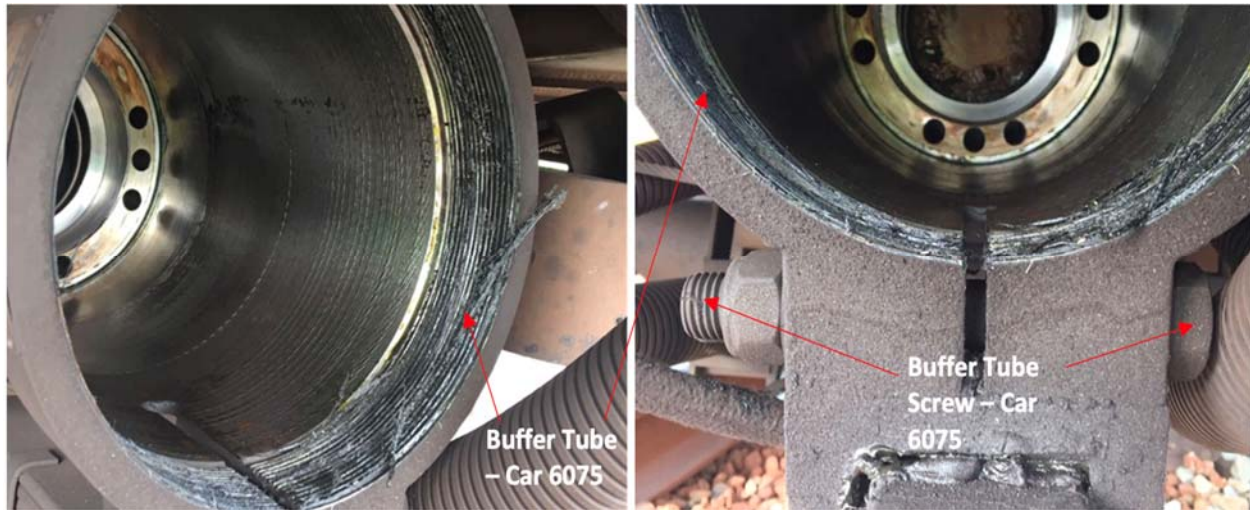
Figure 15a: Left – Car 6075 – F-End Buffer Tube

Figure 15b: Right – Car 6075 – F- End Buffer Tube and Buffer Tube Screw

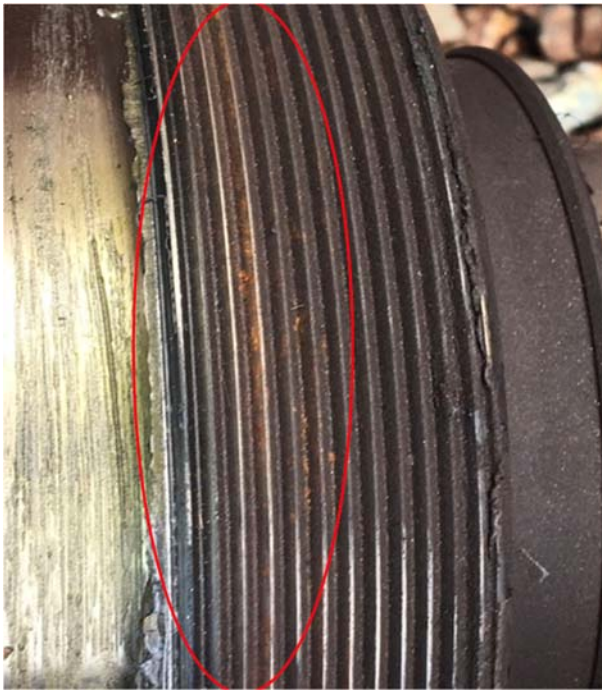
Figure 16: Rust on the gland nut.

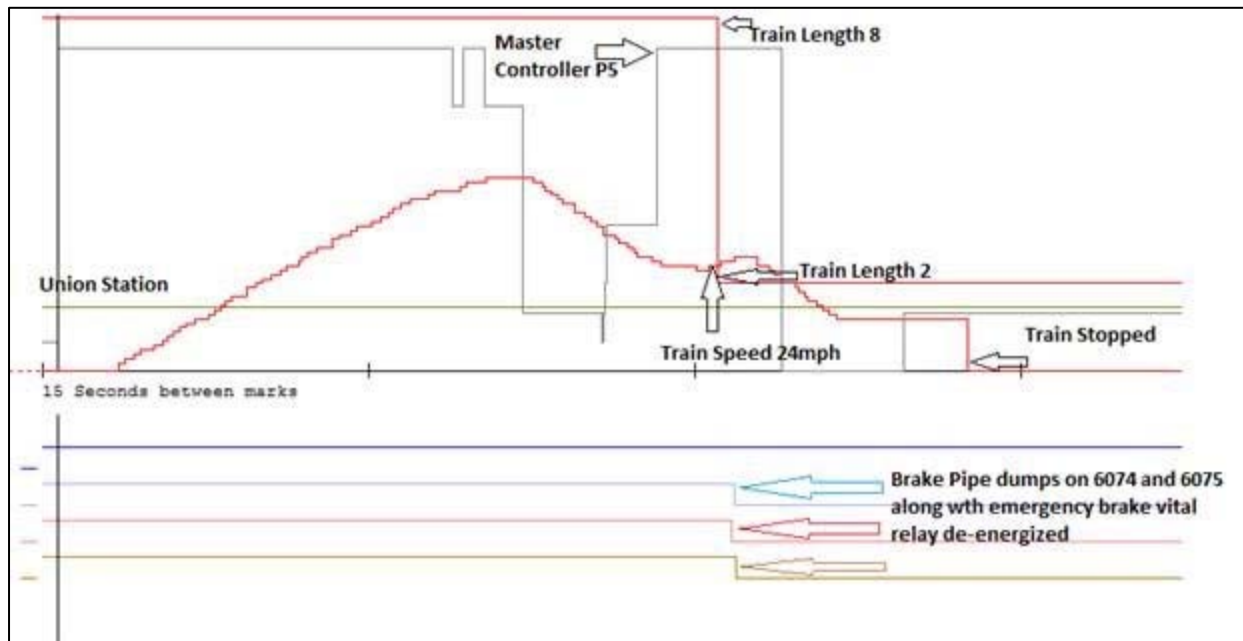
Figure 18: Graph of VMS data.

The VMS data does not indicate any train operation anomaly that could cause the reported incident.

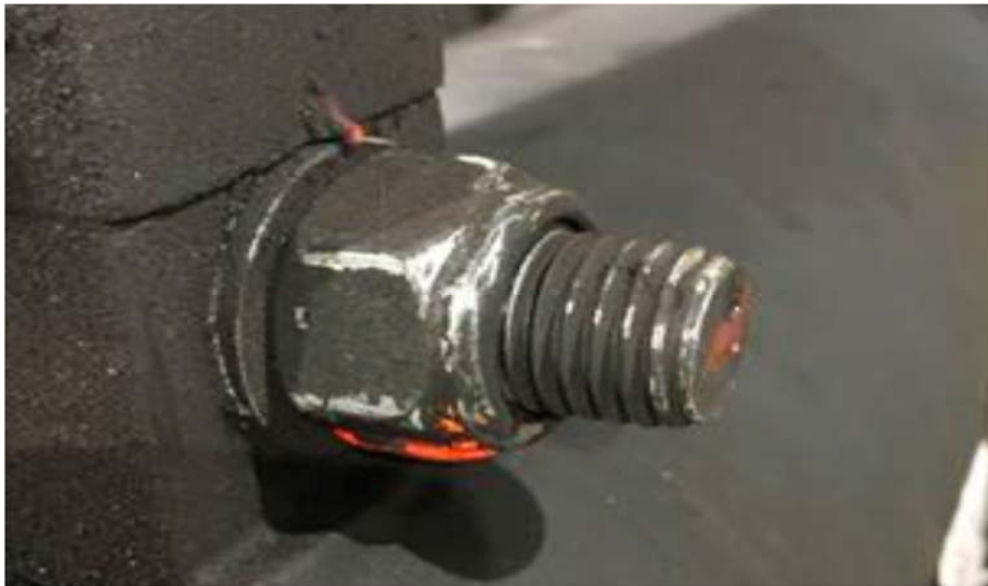
The buffer tube was placed in the MRO shop horizontal stand fixture. It was noticed that the buffer tube clamp locking bolt (A4-80) torque stripe on the bolt and the nut was misaligned (see below).

Figure 19: Torque marks after the buffer tube was delivered in the MRO shop.

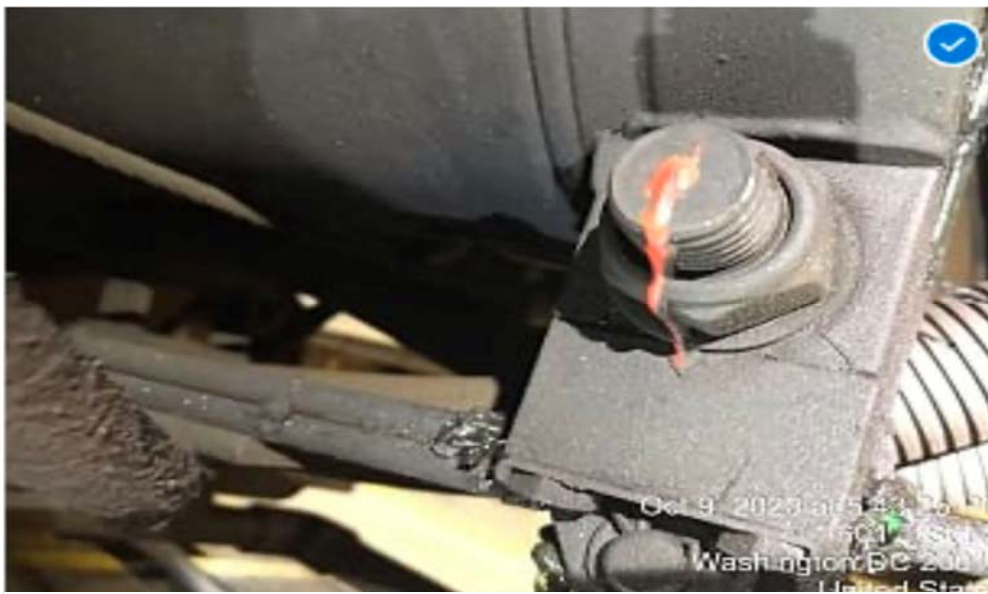
Figure 20: Torque mark on the same bolt pictured above prior to mechanical forces were applied.

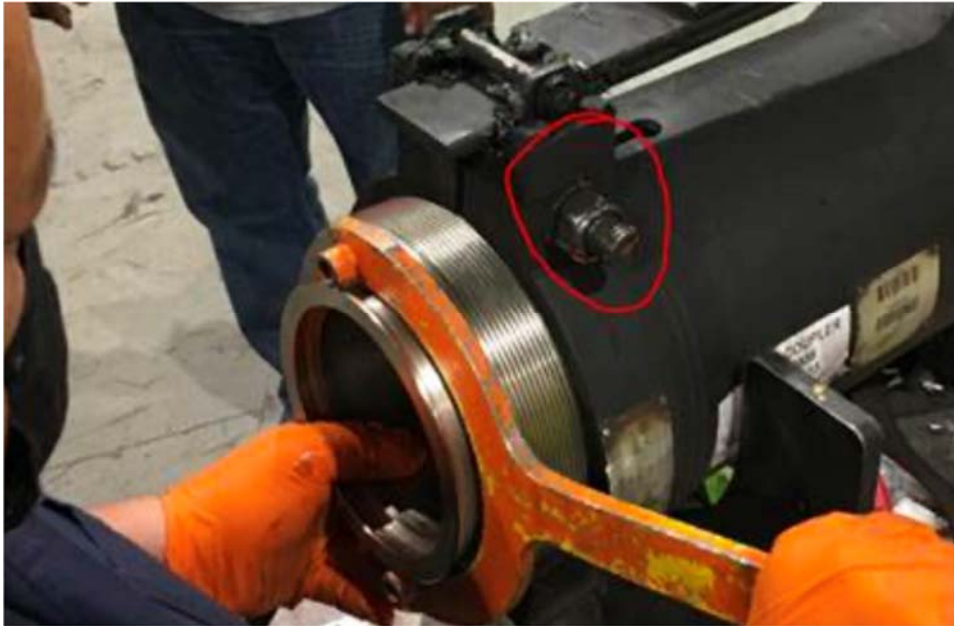
Without touching the bolt, an attempt to install the gland nut in the buffer was conducted; however, it was not possible due to the tightened bolt.

Figure 21: Actuation of gland nut with tightened bolt.

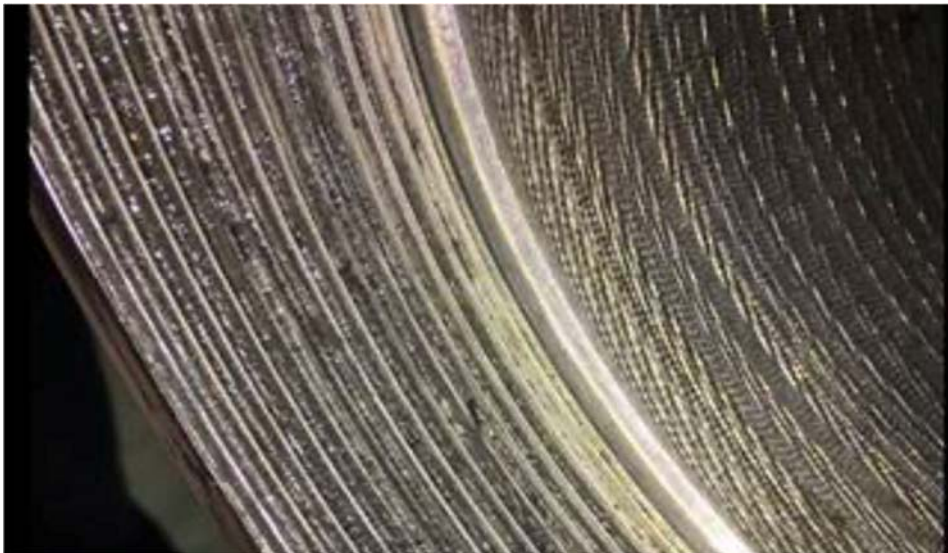
Next, the state of the buffer tube and draft gear gland nut threads were inspected. The locking bolt and nut were removed to release the clamp, and the buffer tube threads were cleaned. A new gland nut was installed into the buffer tube. No anomalies were noted.

Figure 22: Buffer tube thread.

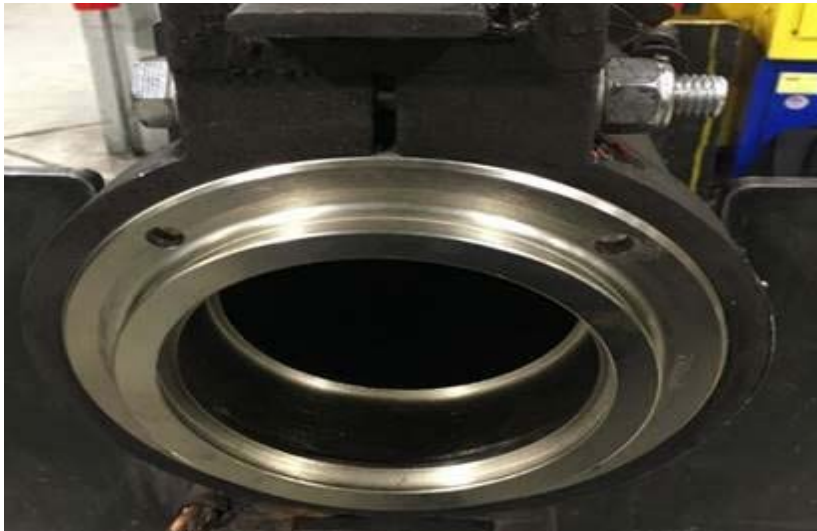
It was observed that the Gland Nut in the draft bar displayed signs (debris, brake dust, rust) of ambient exposure (out of the buffer tube) except for the last two or three threads (see below).

Figure 25: Locking bolt and nut installed

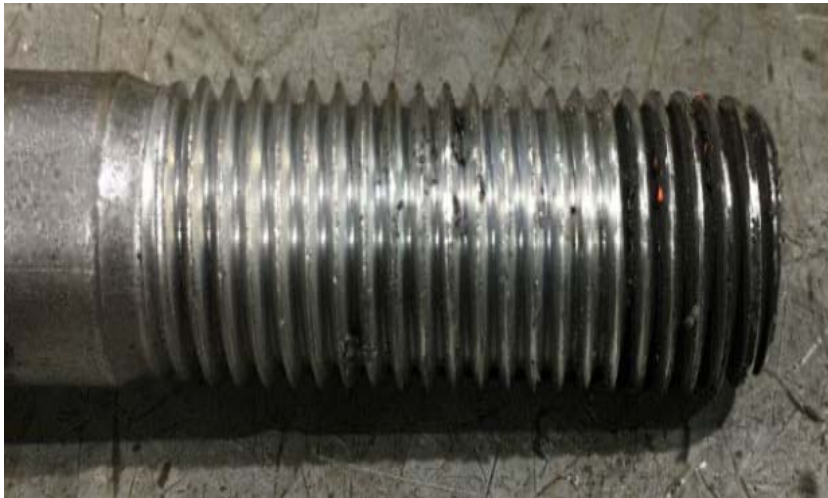
The buffer tube lock bolt and nut (A4-80) threads displayed no apparent damage or signs of bad thread deformation as well (see below).

Figure 26: A4-80 locking bolt
