## **WMSC Commissioner Brief: W-0080 – Pull-Apart – outside Glenmont Station – November 24, 2020**

*Prepared for Washington Metrorail Safety Commission meeting on May 18, 2021*

**FINAL REPORT OF INVESTIGATION A&I E20464**

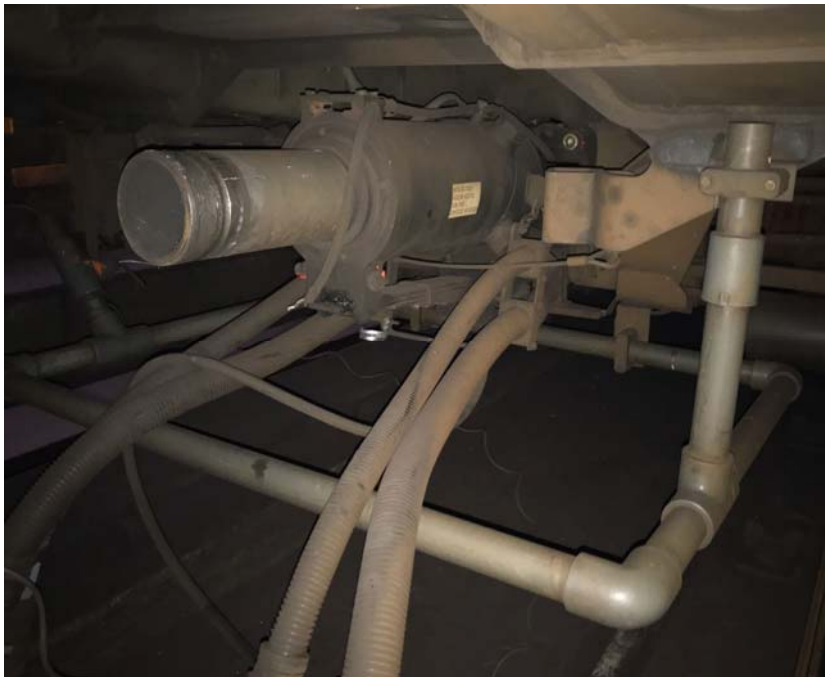
Figure 5 – 6177 rear portions of front mechanical coupler.

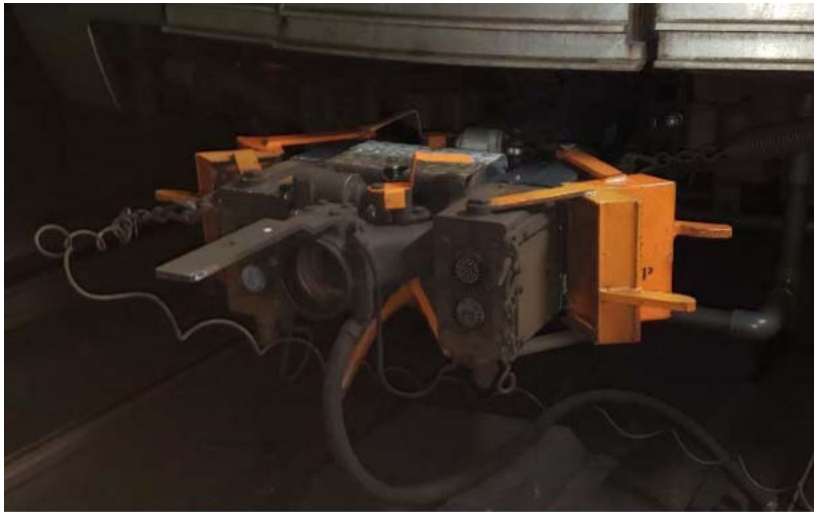
Figure 6 – Pull-apart car 6150.

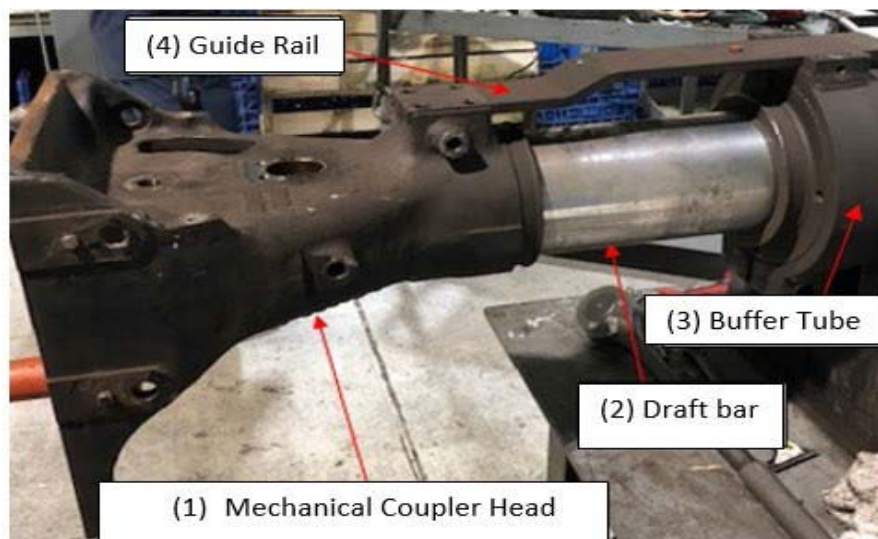
Figure 7 – Front-End Mechanical Coupler

The November 24, 2020, Pull-Apart incident involved the draft bar of the front mechanical coupler and occurred when the "Front Mechanical Coupler Head" (1) and the "Guide Rail" (4) separated from the "Draft Bar" (2) and "Buffer tube" (3). (See Figure 8).

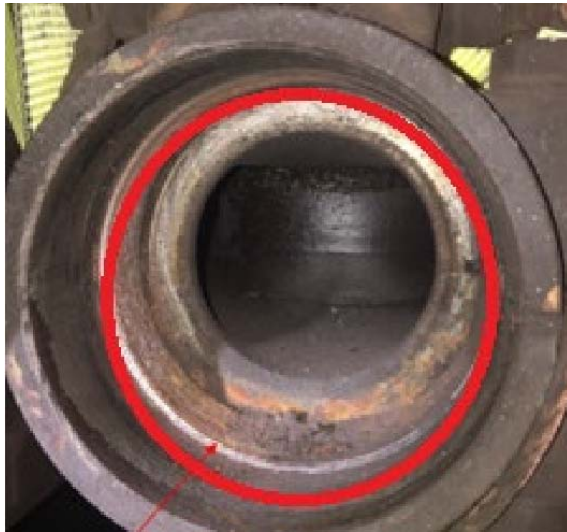
The threads on the mechanical coupler head of car 6177 showed corrosion signs (see Figure 9) and debris accumulation, which indicated exposure to ambient conditions. The drawbar had sustained damage on the first 4-5 threads, which became more apparent when the drawbar was cleaned for inspection (see Figure 10).

*Figure 8: Corrosion and contaminants were found on the threads of the mechanical coupler head on car 6177.*

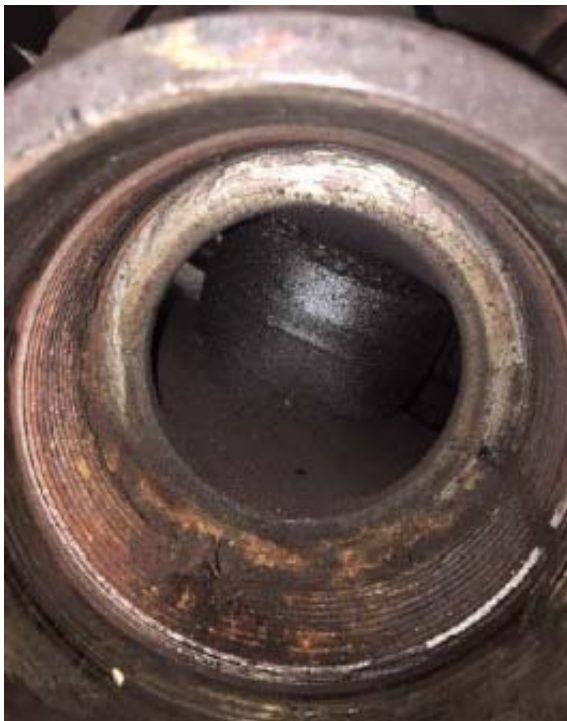
*Figure 9: Corrosion and contaminants were found on the threads of the mechanical coupler head on car 6177.*

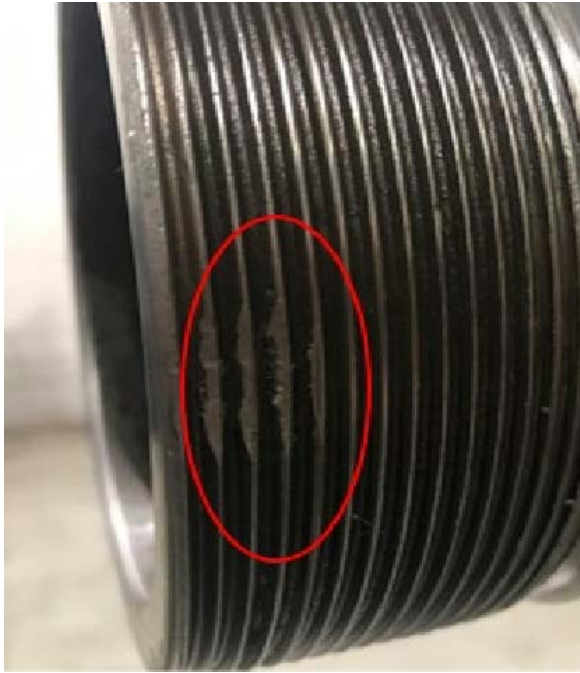
*Figure 10: Damaged threads were found on the draft bar on car 6177.*

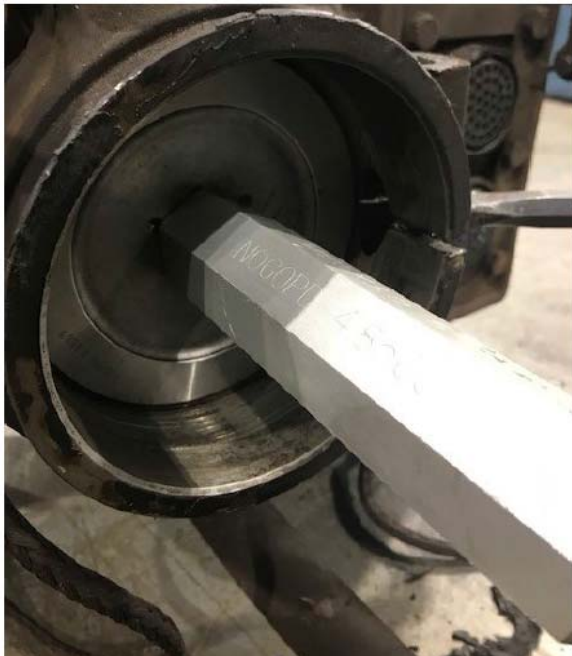
Dellner Technicians used Go/No-Go thread gauges to test the internal and external threads' conditions on the mechanical coupler head and the drawbar. After confirmation of failed test, the mechanical coupler head and draft bar were both condemned.

*Figure 11 - While using the Dellner supplied Go/No-Go thread gauges on the mechanical coupler head threads, it was determined the threads were worn. The coupler head must be condemned.*

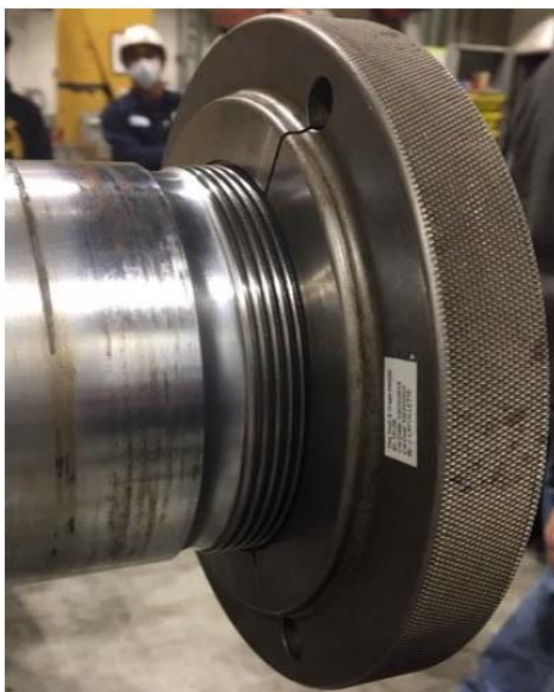
*Figure 12 – While using the Dellner supplied Go/No-Go thread gauges on the draft bar threads, it was determined that the threads were worn. The draft bar must be condemned.*

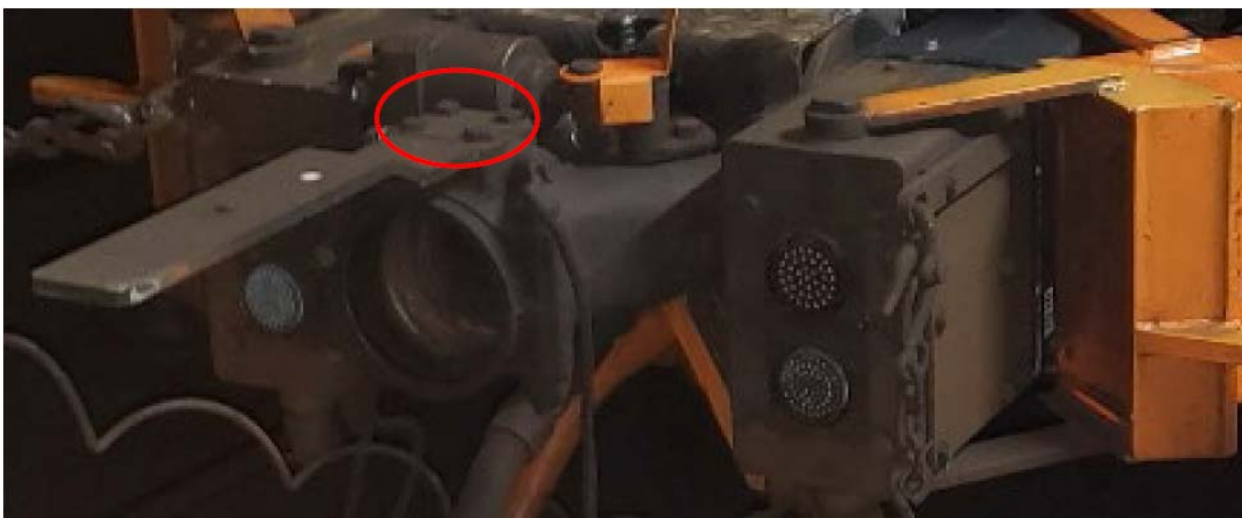
*Figure 13 - A torque test was performed on the four guide rail bolts. The resulting torque was measured at 5 ft/lbs. Dellner documentation states torque should be 27 ft/lbs. The inspection of the coupler/drawbar revealed a lack of torque stripes on guide rail fasteners.*

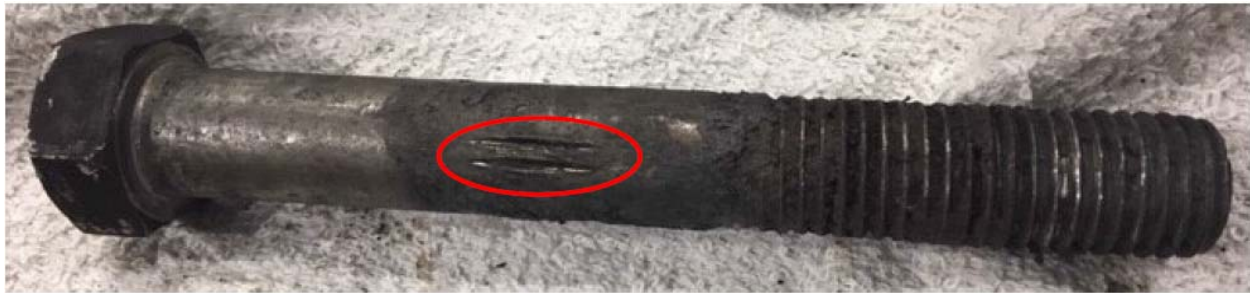
The pinch bolt that secures the mechanical coupler on the drawbar was missing a torque stripe, and two (2) wear marks were observed on the shoulder of the bolt, which appears to have been caused by the threads of the draft bar. Additionally, the four bolts that secure the guide rail were found to be torqued below the required fastening torque.

Figure 14 – A visual inspection revealed marks on the mechanical coupler head “pinch bolt” and identified that it did not have a torque stripe. Once removed, the bolt had two parallel indentations, which appear to have been caused by the threads of the draft bar.
