**WMSC Commissioner Brief: W-0081 – Derailment – Outside Silver Spring Station – July 7, 2020**

FINAL REPORT OF INVESTIGATION A&I E20244

Date of Event:	7/7/2020
Type of Event:	Derailment
Incident Time:	11:20 hrs.
Location:	Silver Spring Station, Track 1
Time and How received by SAFE:	11:26 hrs. - SAFE Email Notification
WMSC Notification Time:	7/7/2020 at 12:49 hours – Email
Rail Vehicle:	Train ID 108, L7502-03x7561-60x7592-93x7567-66T
Injuries:	None
Damage:	\$413,981.12

Silver Spring - Derailment

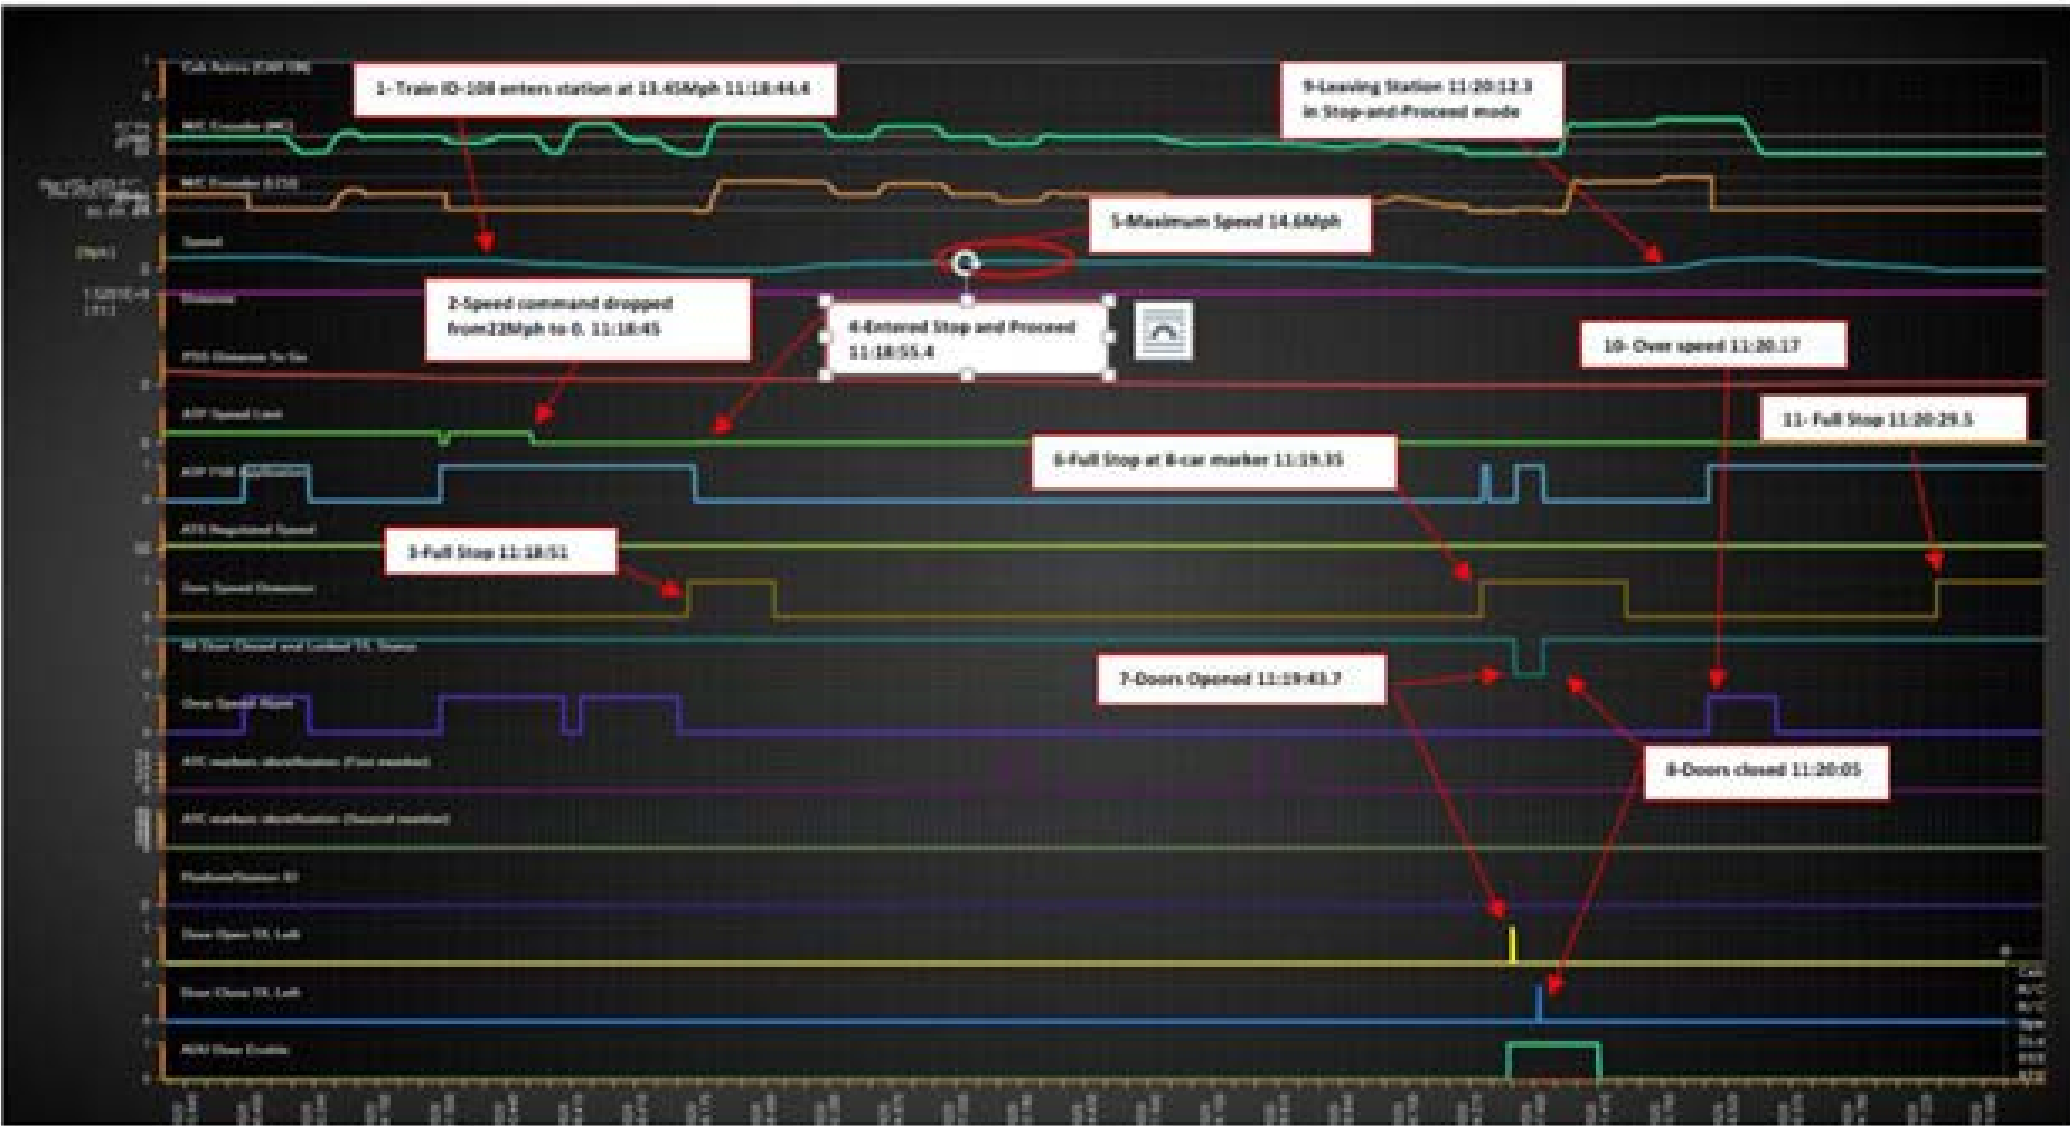
Diagram 2- ER Graphical Analysis.

11:20:23 hrs.	The consist had a speed of 11.66 mph at the time at the POD location.

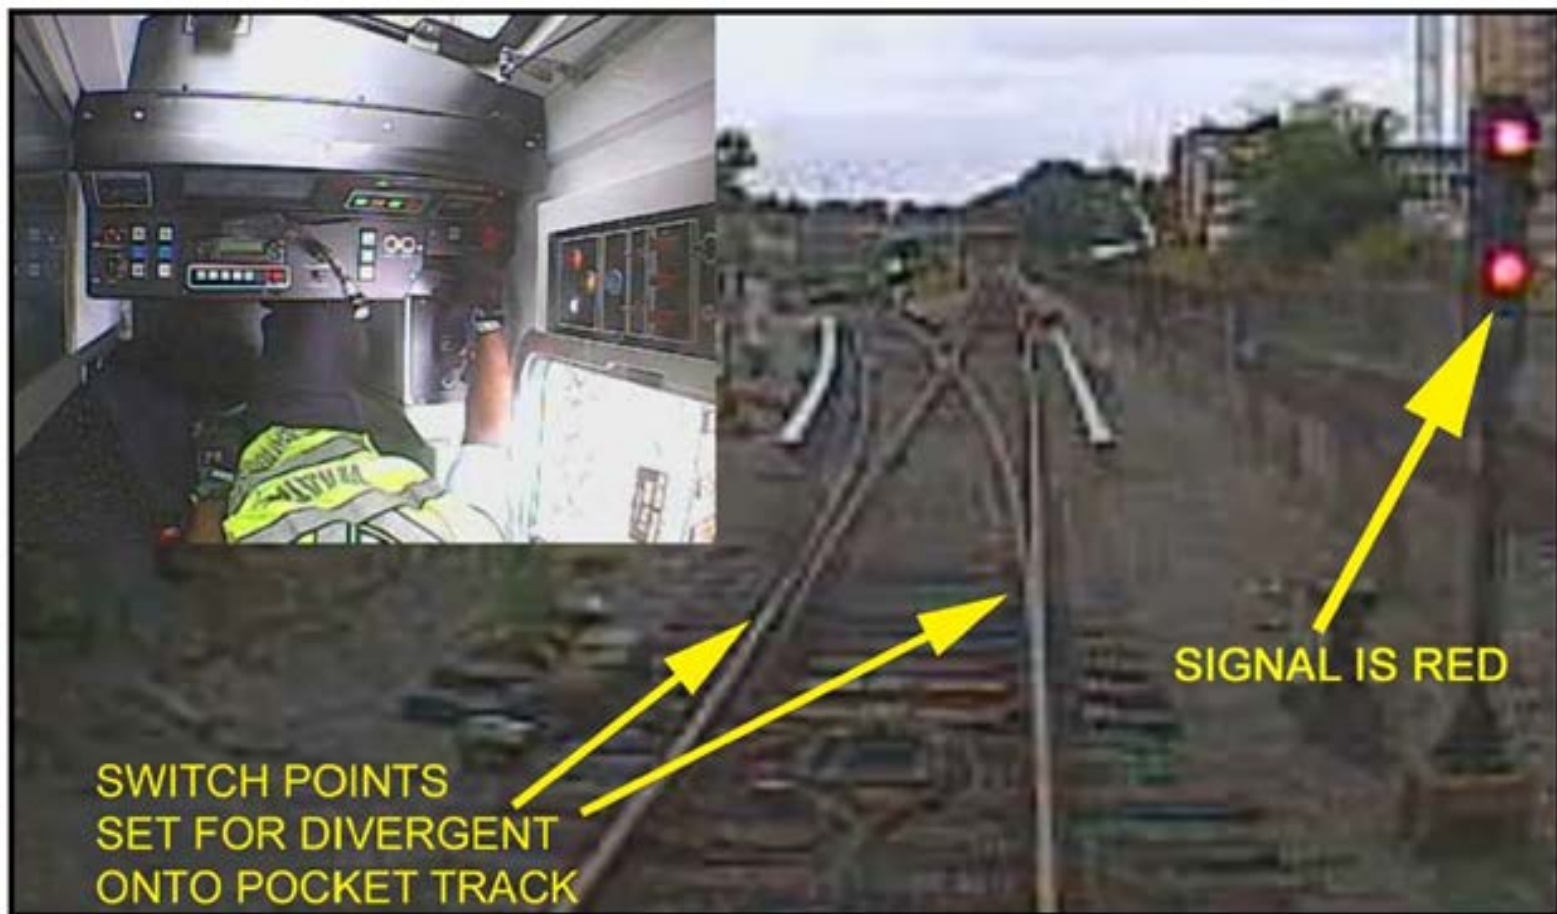
Photo 1 - At 11:20:12 hrs. Train ID 108 overruns Red Signal B08-26.

NOTE: Based on forward-facing camera video footage review, the consist overran Signal B08-26 displaying a red aspect. The train responded as expected, and its performance was within design specification. No operational anomalies were noted on the VMDS fault log during the reported incident time.

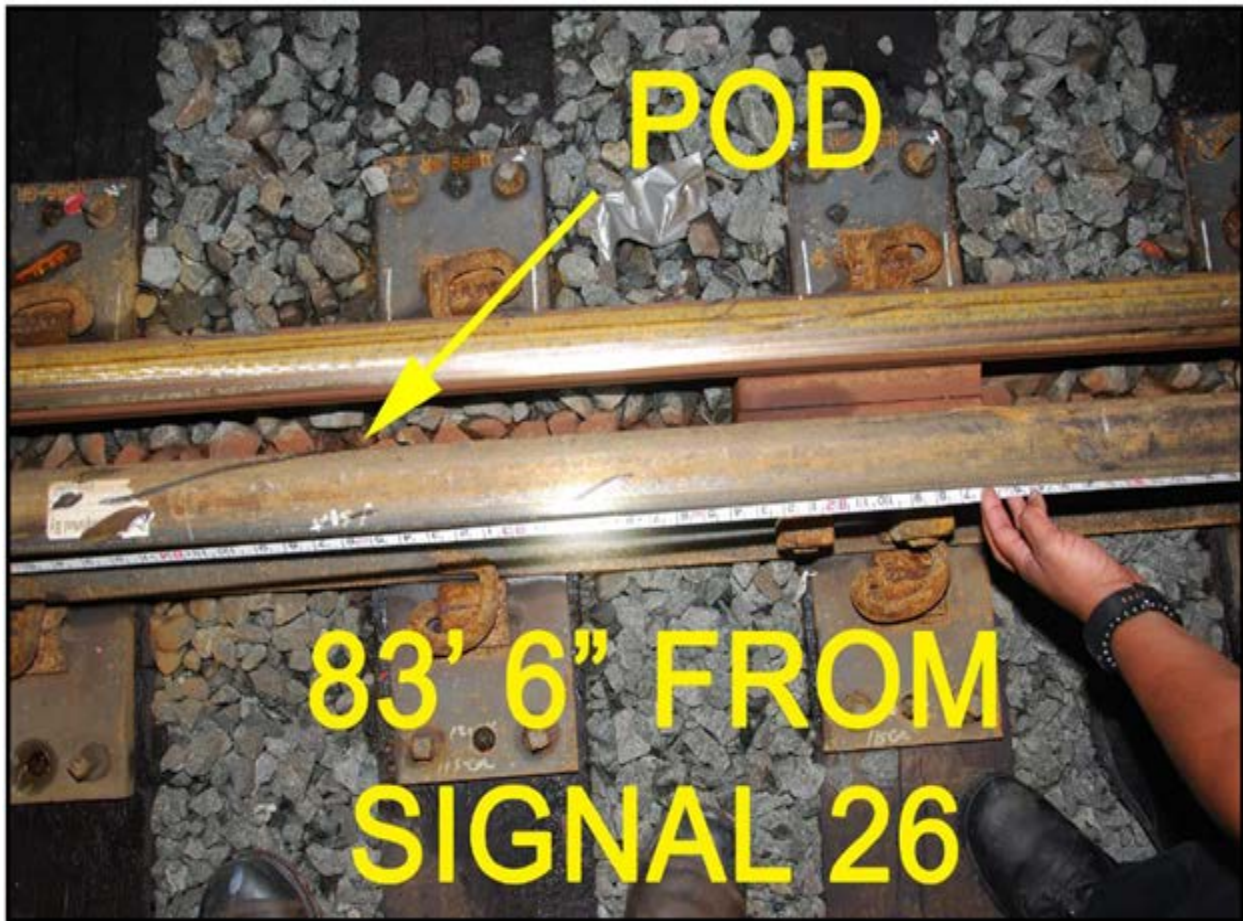
Photo 2 - POD is 83'6" from Signal B08-26.

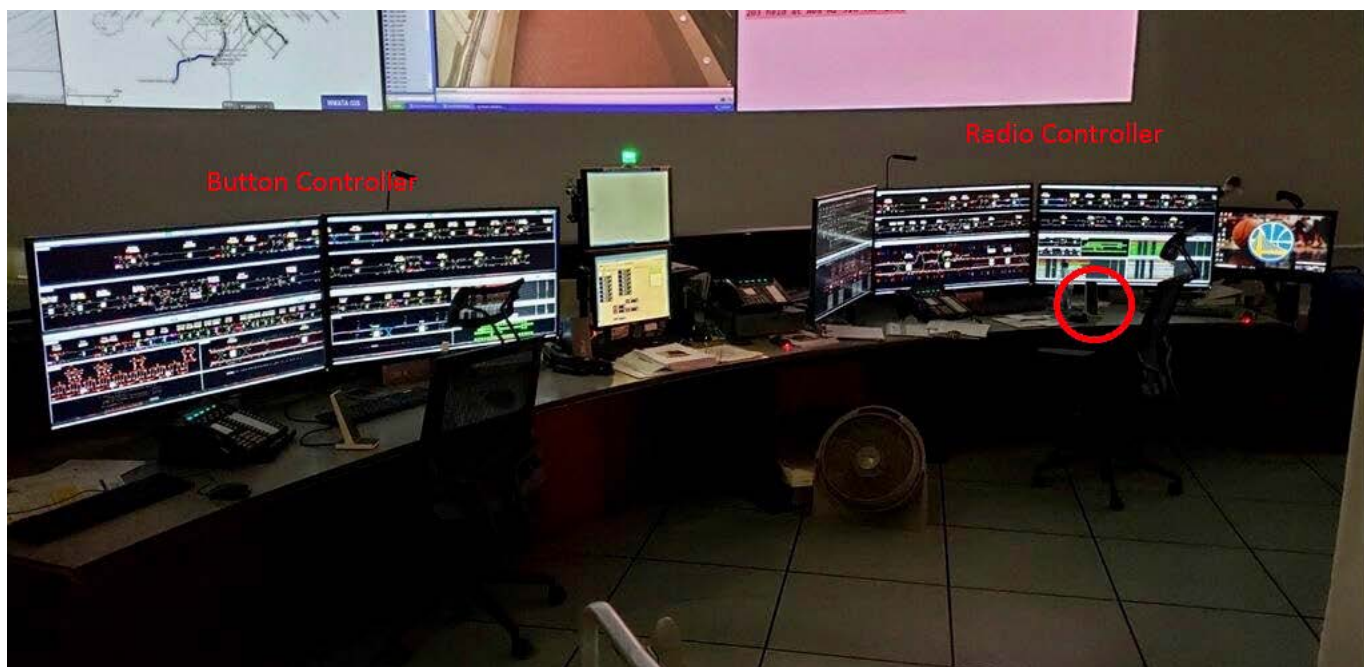
Normally, the RTC's are positioned with the Radio Controller to the right of the console and the Button Controller to the left of the console. The microphone device the RTC utilizes to communicate over the radio is circled in red.

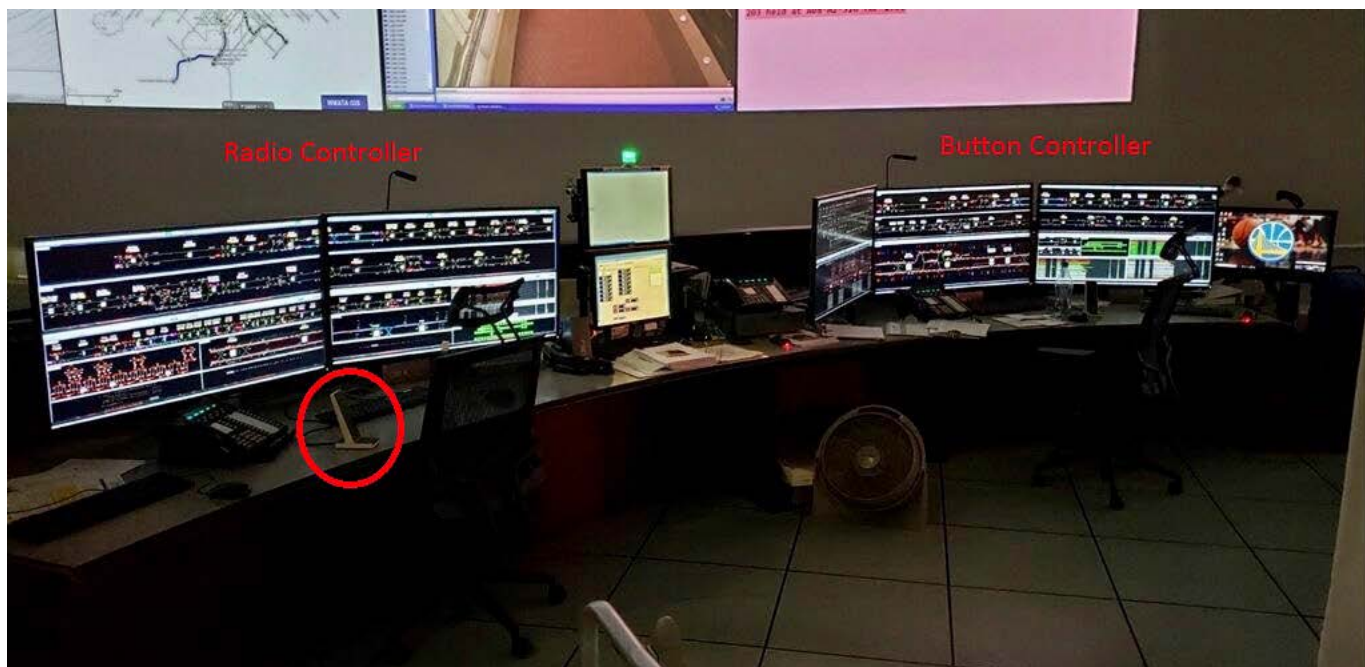
On the day of the incident, the Radio RTC and the Button RTC swapped positions due to the defective microphone where the Radio Controller normally is positioned. The Radio RTC sat to the left of the console utilizing the microphone circled in red.

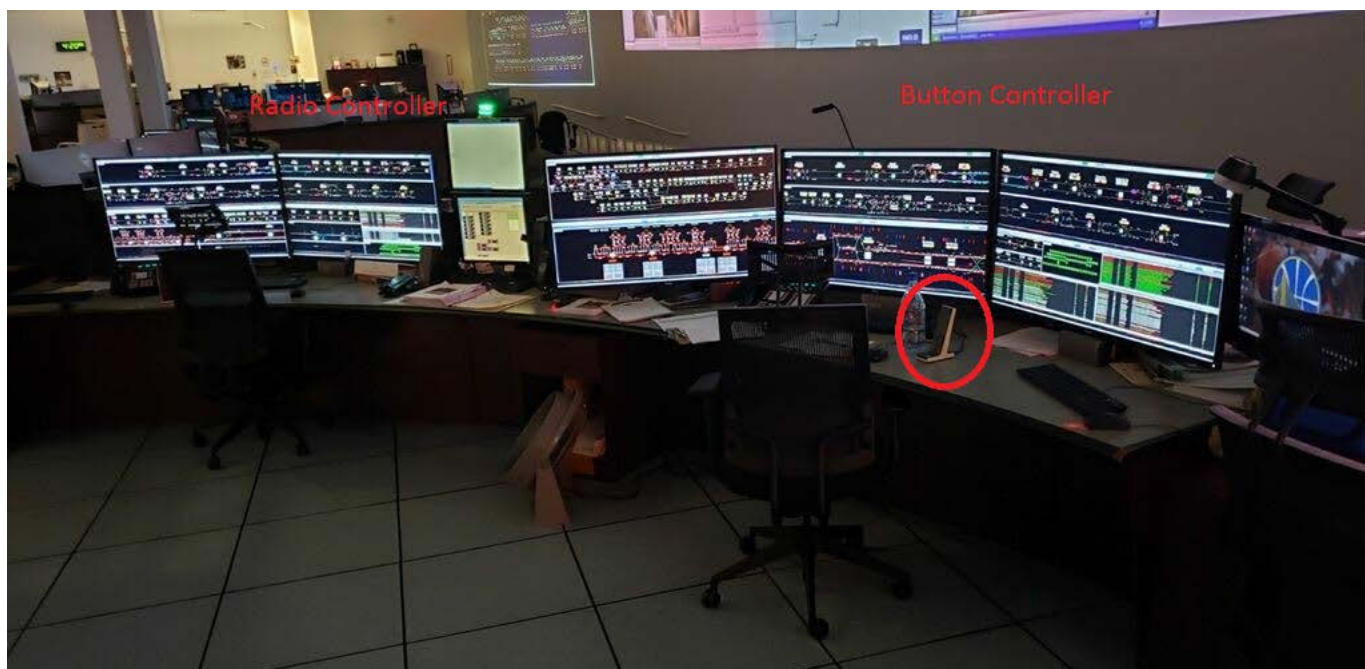
At the time of the incident, Radio RTC stepped away from the console leaving the Buttons RTC to perform the duties of the Radio Controller and the Button Controller simultaneously. The microphone Button RTC was utilizing is circled in red and is the reported microphone that had intermittent communication.

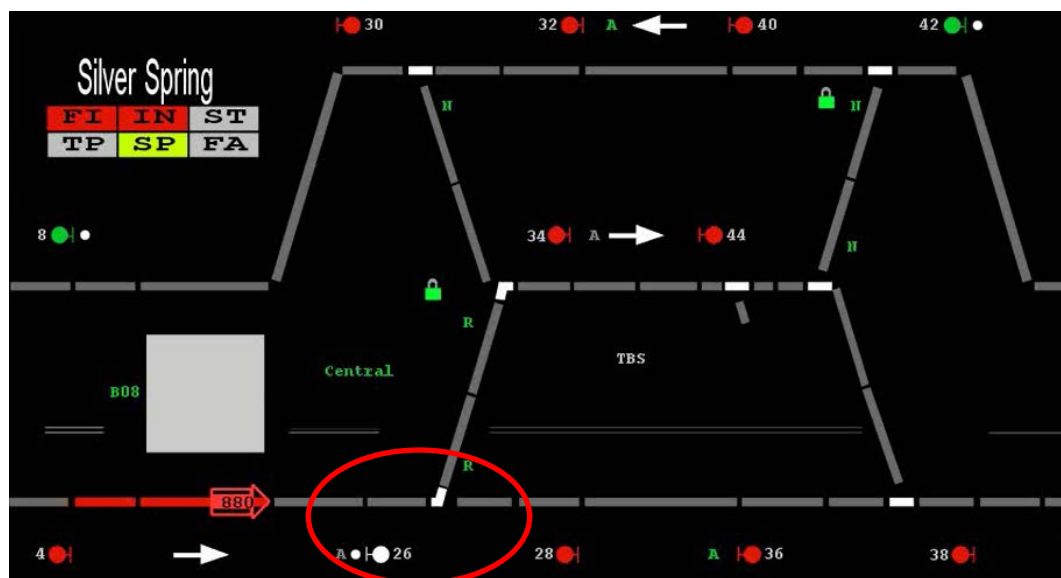
Diagram 4 - A manual route set at B08-26 Signal for Train ID 880 to enter Silver Spring Pocket Track.

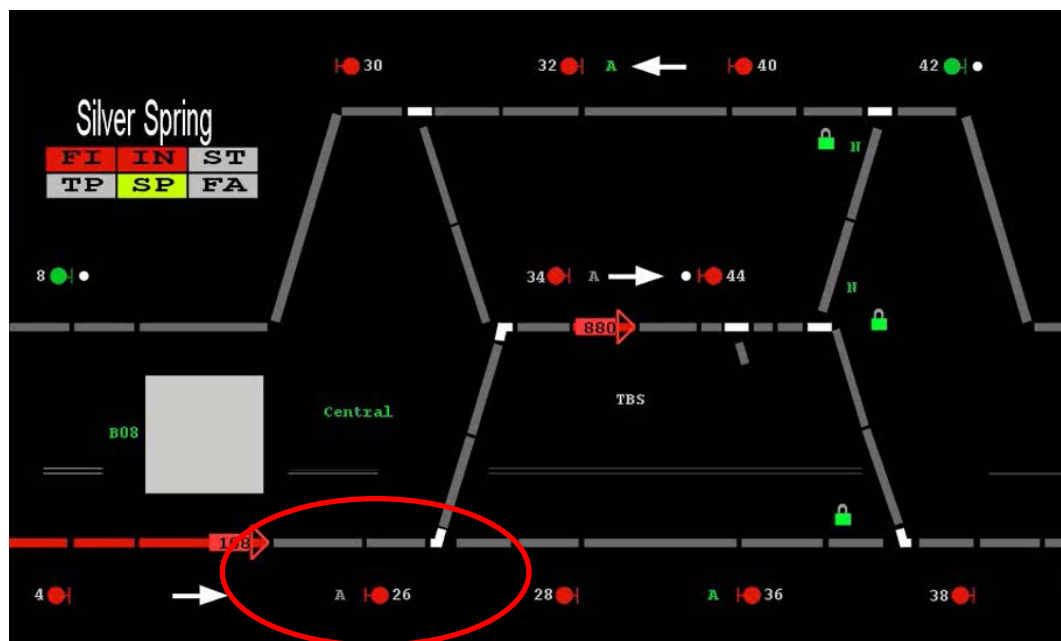
Diagram 5 - Train ID 880 secured in Silver Spring Pocket Track with Train ID 108 in approach to Silver Spring platform. B08-26 signal displaying a Red aspect.

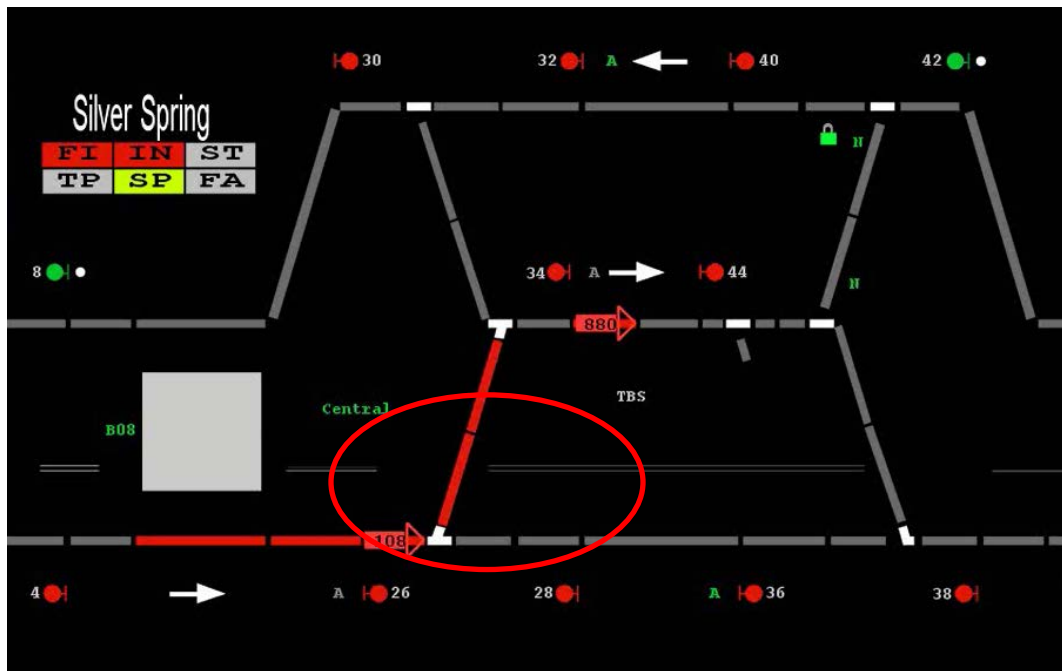
Diagram 6 - Train ID 108 overrun B08-26 signal displaying a Red aspect.

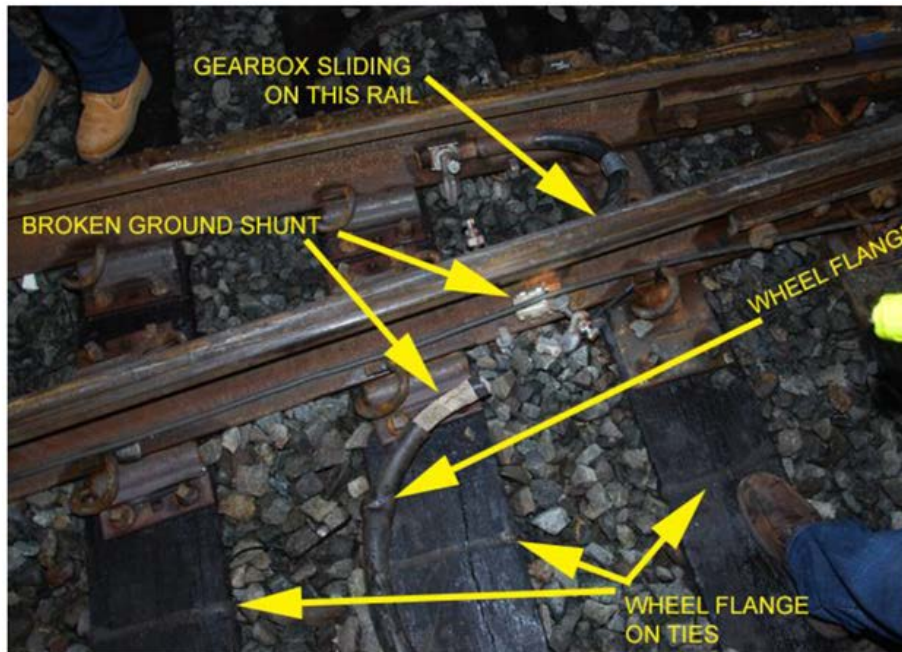
CENV conducted a visual inspection of the tracks, cross ties, tie bolts, tie plates, and found a broken roadway equipment cable and only minor damage to the ties and the bolts. Measurements were taken to determine the POD and POR. Minor damage was found at the derailment site, as seen in the photos below. All damages noted were caused after the train derailed.

Photo 1 - Broken roadway ground shunt clamp and tie damage.

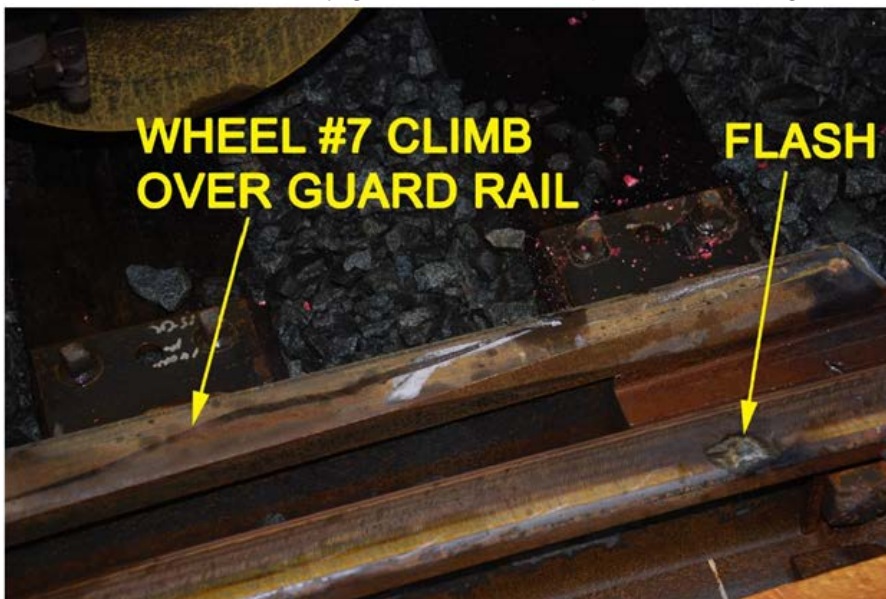
Photo 2 - POD wheel #7 climbed over the guard rail, and collector shoe contacted the running rail.

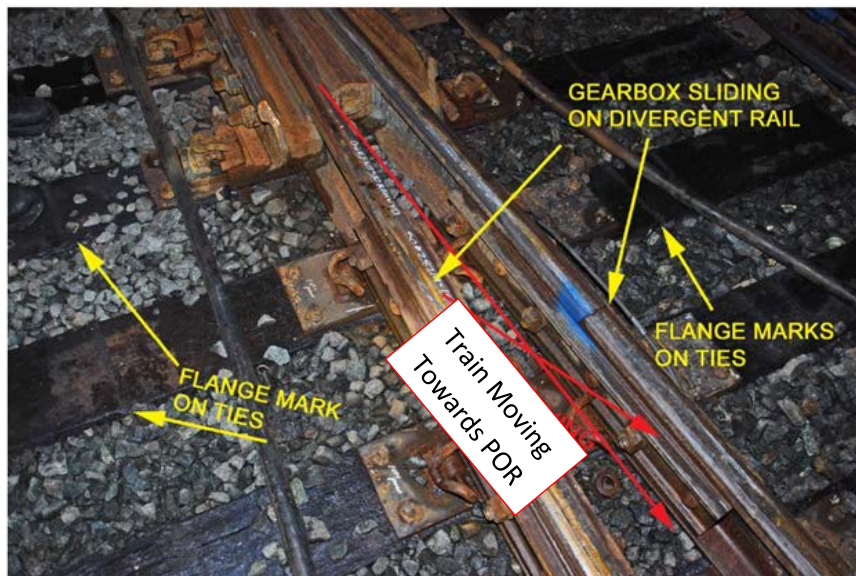
Photo 3 - Under Car Equipment impressions on the trackbed.

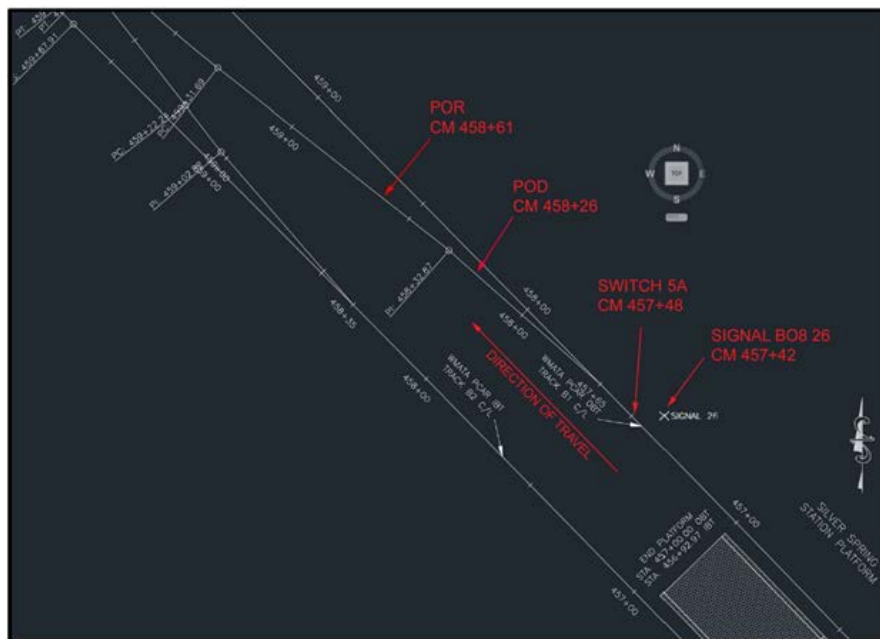
Diagram 3 – Derailment area overview.

POD was 83 feet 6 inches from Signal B08 26. See the below figure. Switch 5A is located at Chain Marker (CM) 457+58, placing the POD at CM 458+26. The POR was measured from Signal B08-26 and is located at CM 458+61, 118'4" from Signal B08-26. The POD and POR of the Rear Truck shows that car 7503 traveled 35'2" after the Rear Truck had derailed.

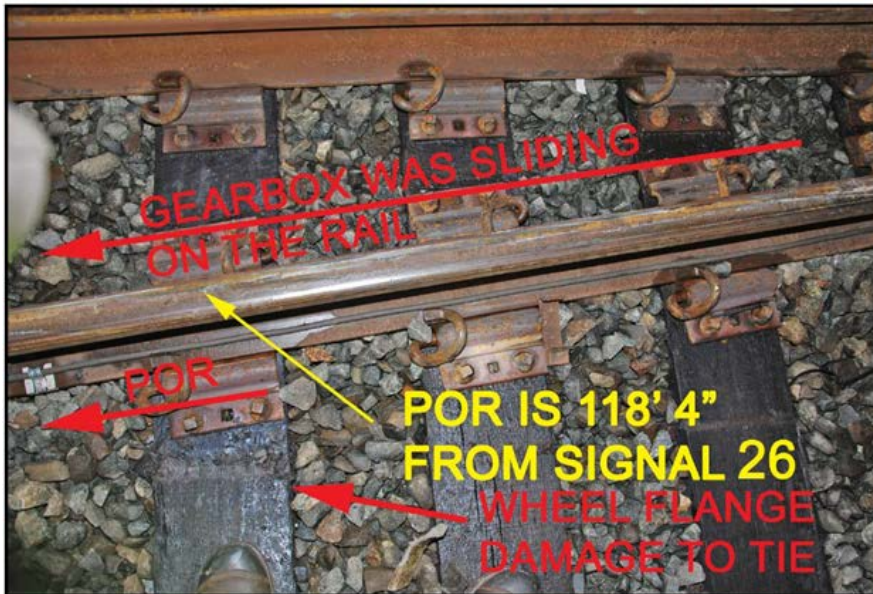
Photo 4 - POR distance measured with reference to Signal B08-26.

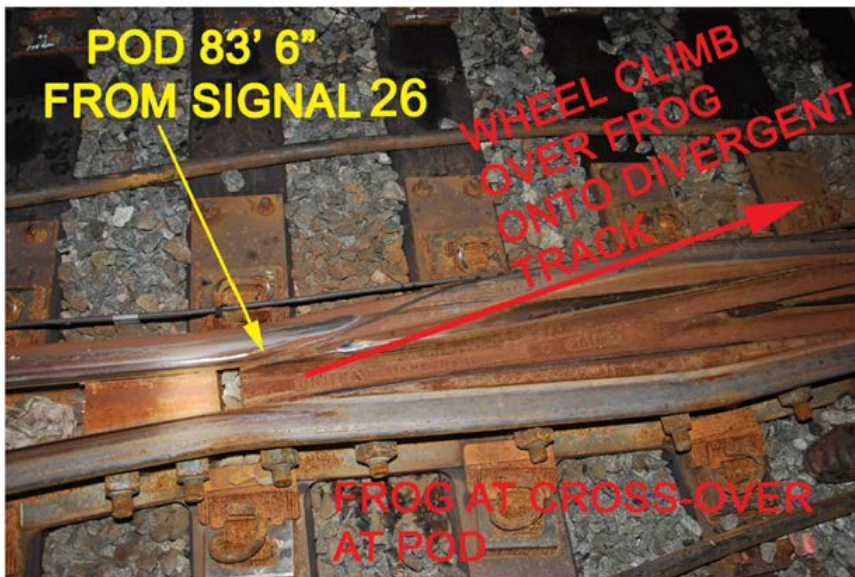
Photo 5 - Wheel climb marking of car derailed rear truck of car 7503

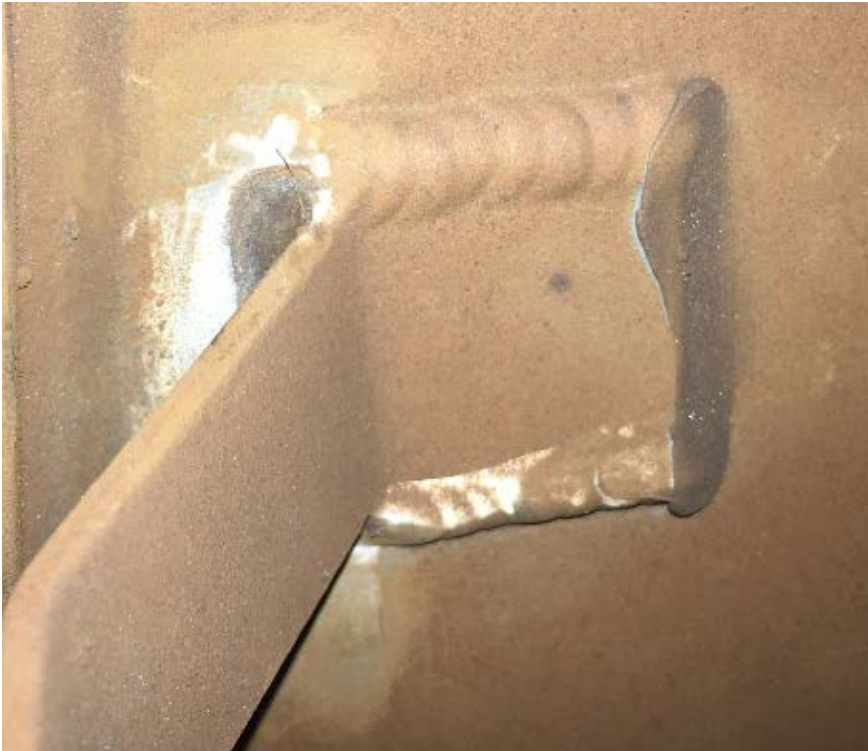
- R7560 – micro [hairline crack] on pneumatic piping support bracket above wheel # 1. See Figure 1.
- R7567 – broken plug at Front Emergency Pipe Control Unit (EPCU) – See Figure 2.

Car 7560: Hairline crack on pneumatic piping support bracket above wheel 1.

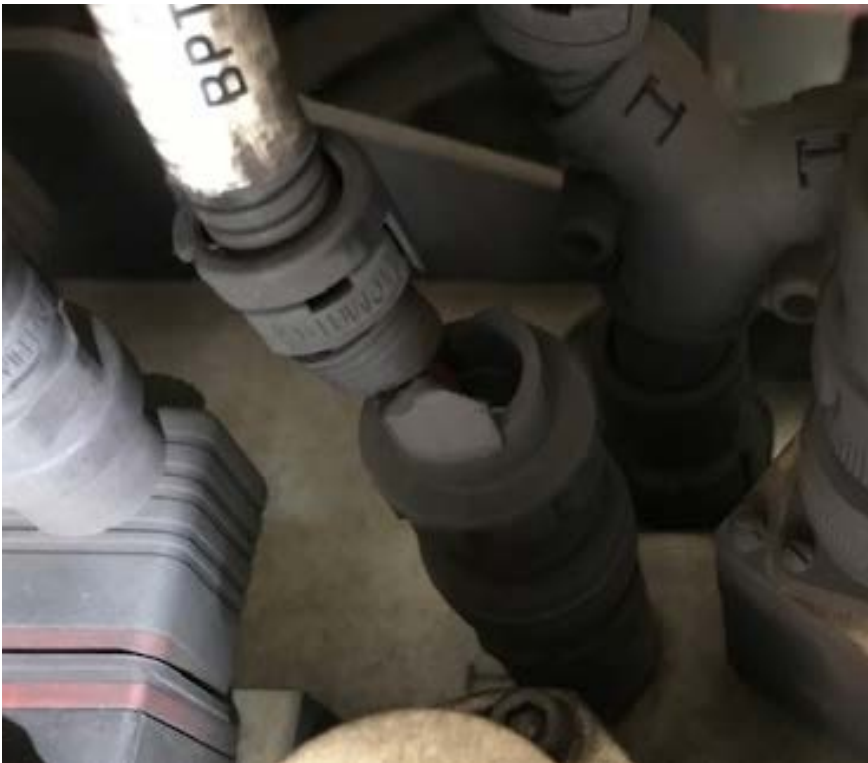
Car 7567 Broken plug at Front EPCU.
