## **WMSC Commissioner Brief: W-0083 – Fatality – Navy Yard Station – December 16, 2020**

*Prepared for Washington Metrorail Safety Commission meeting on June 29, 2021*

**FINAL REPORT OF INVESTIGATION A&I E20497**

Navy Yard – Person Struck by Train  
December 16, 2020

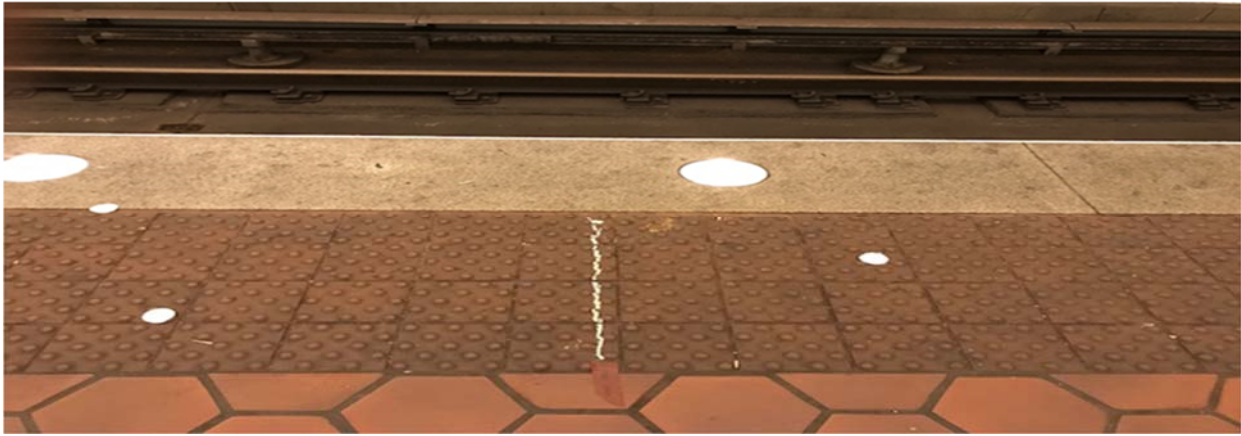
On Wednesday morning, December 16, 2020, an unidentified person transitioned to the platform level via the escalator and appeared to be in a disoriented state and unsteady on their feet. The unidentified person sat on a bench and later stood to their feet at 06:44:45 hrs. After standing, the unidentified person wandered near the edge of the platform and subsequently fell to the roadway approximately 215 feet from the 8-car marker at 06:45:37 hrs.

*Photo 1 – Location where the person fell off the platform, approximately 215 feet from the 8-car marker.*

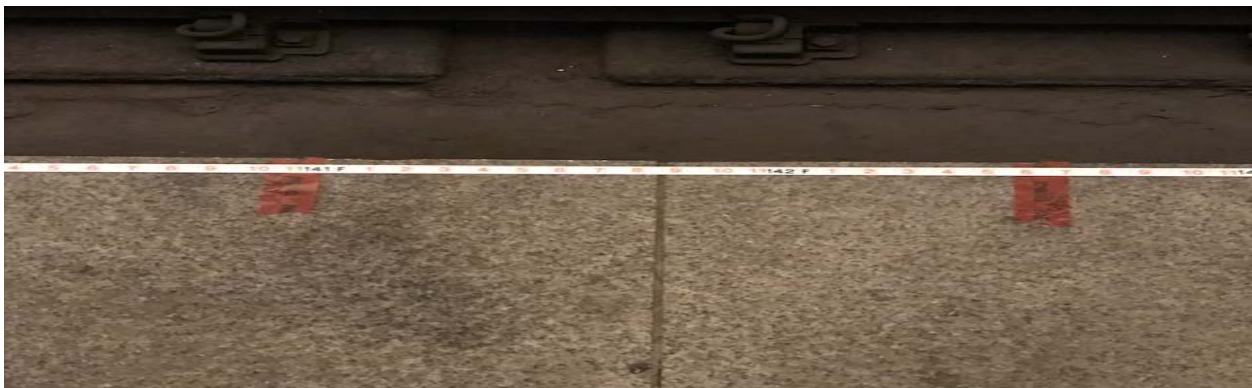
Based on CCTV playback and CMOR IIT data, the Train Operator of Train ID 505 subsequently struck the unidentified person at 06:45:53 hrs. At 6:45:57.05 hrs., the consist came to a complete stop 142 feet from the 8-car marker.

*Photo 2 – Train Operator of Train ID 505 came to a complete stop approximately 142 feet from the 8-car marker.*

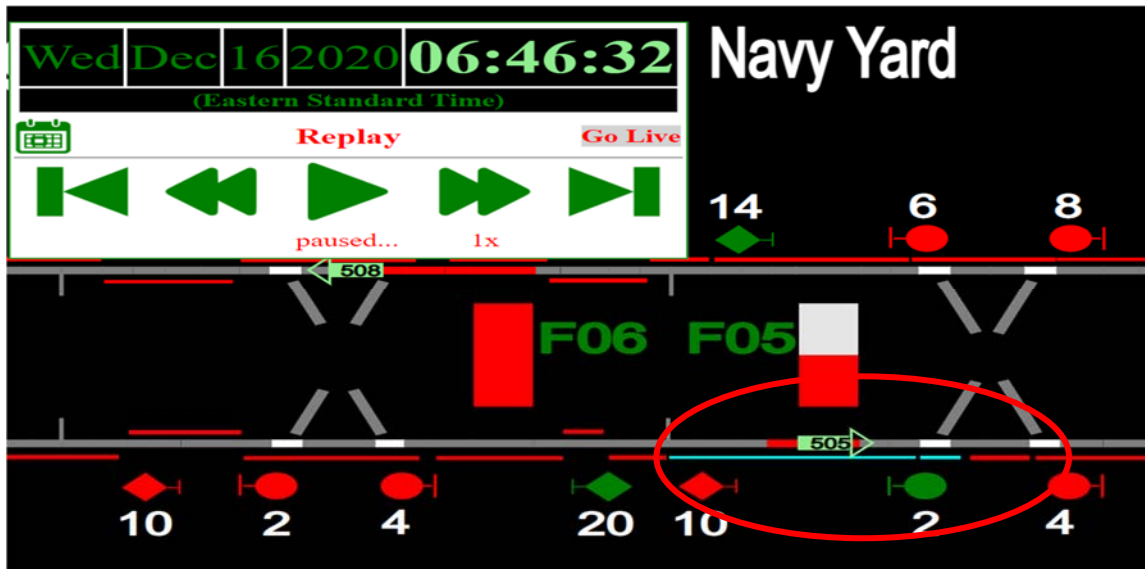
Photo 3: AIMS indication shows third rail power de-energized at Navy Yard Station, Track 1.

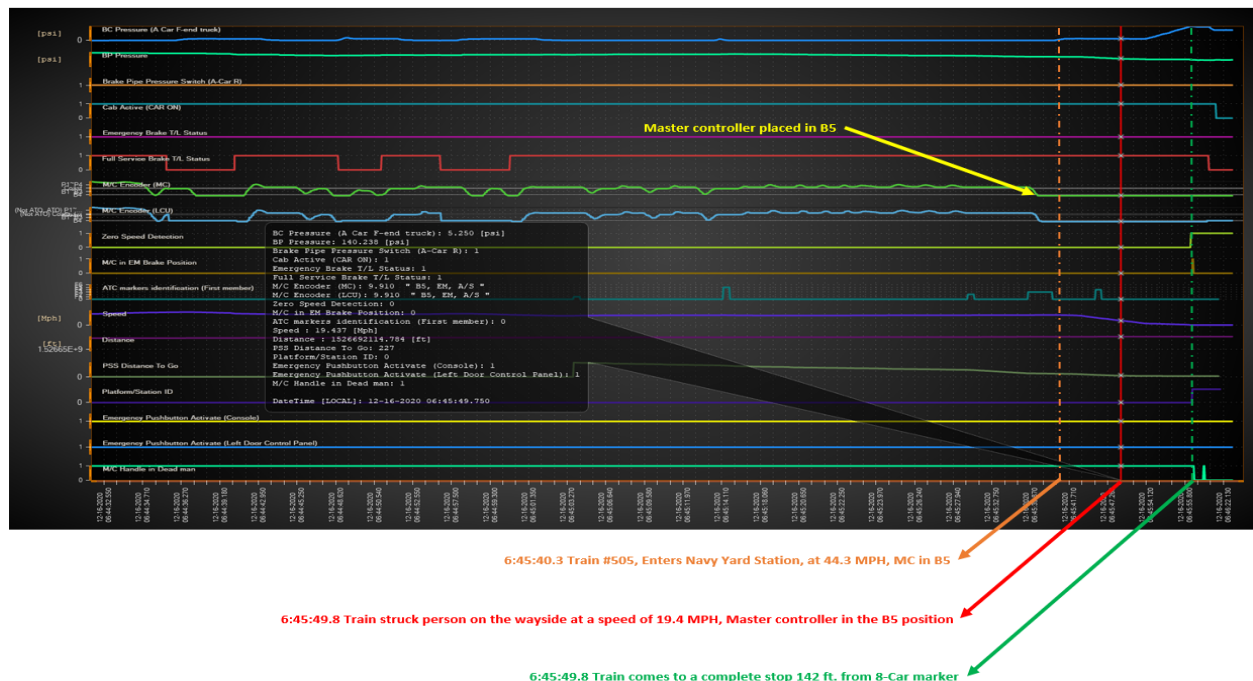
Diagram 1- ER Graphical Analysis

Time	Description
6:45:40:03 hrs.	The Train Operator of Train ID 505, Lead Car 7164, MC, placed in the B5 position, traveled at 44.8 mph, 75.2 feet before entering Navy Yard Station, Track 1.
6:45:41:01 hrs.	The Train Operator of Train ID 505, Lead Car 7164, entered Navy Yard Station, Track 1, at 44.3 mph with the MC in the B5 position.
6:45:57:08 hrs.	The Train Operator of Train ID 505, Lead Car 7164, struck a person on the roadway.
6:45:57.05 hrs.	The Train Operator of Train ID 505 came to a complete stop 142 feet from the 8-car marker, and Zero speed energized.
6:46:17:08 hrs.	The Train Operator of Train ID 505, Lead Car 7164, keyed down.

Based on CMOR IIT data analysis, the Train Operator did not activate the emergency pushbutton.
