WMSC Commissioner Brief: W-0085 – Improper Roadway Worker Protection – Fort Totten Station – December 12, 2020

FINAL REPORT OF INVESTIGATION A&I E20487

Fort Totten Station – Improper Roadway Worker Protection

December 12, 2020

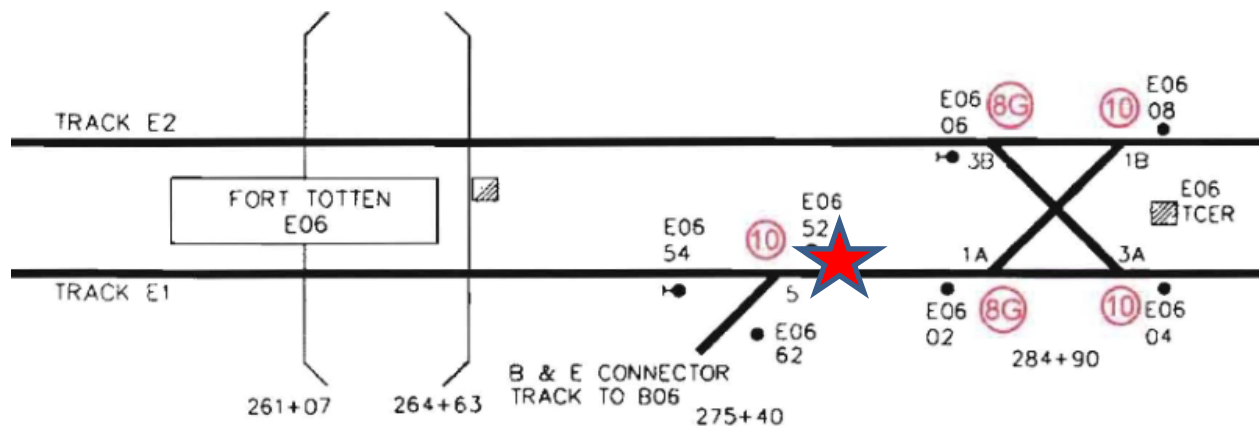
Field Sketch/Schematics

Fort Totten Station, Track 1, CM E1 276+00.

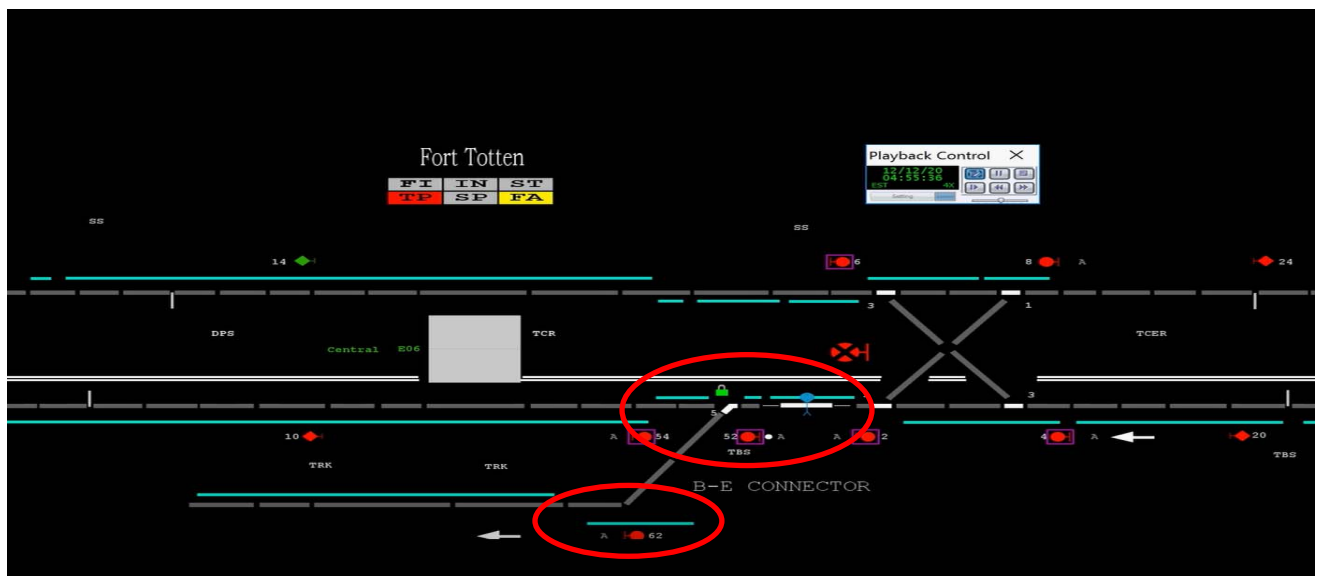
Photo 1: FT protection established at Fort Totten Station displaying E06-62 signal red and E06-52 signal prohibited (red aspect).

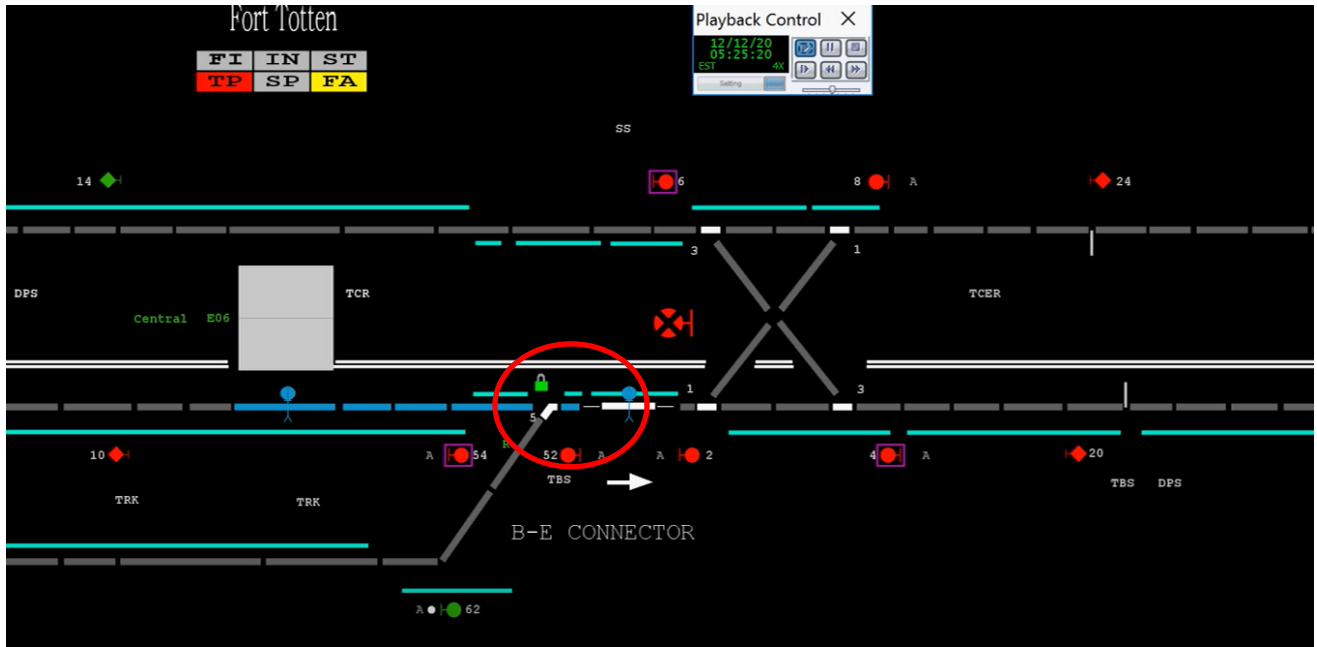
Photo 2: Prohibit exit removed from E06-52 signal to allow entry into the FT area.

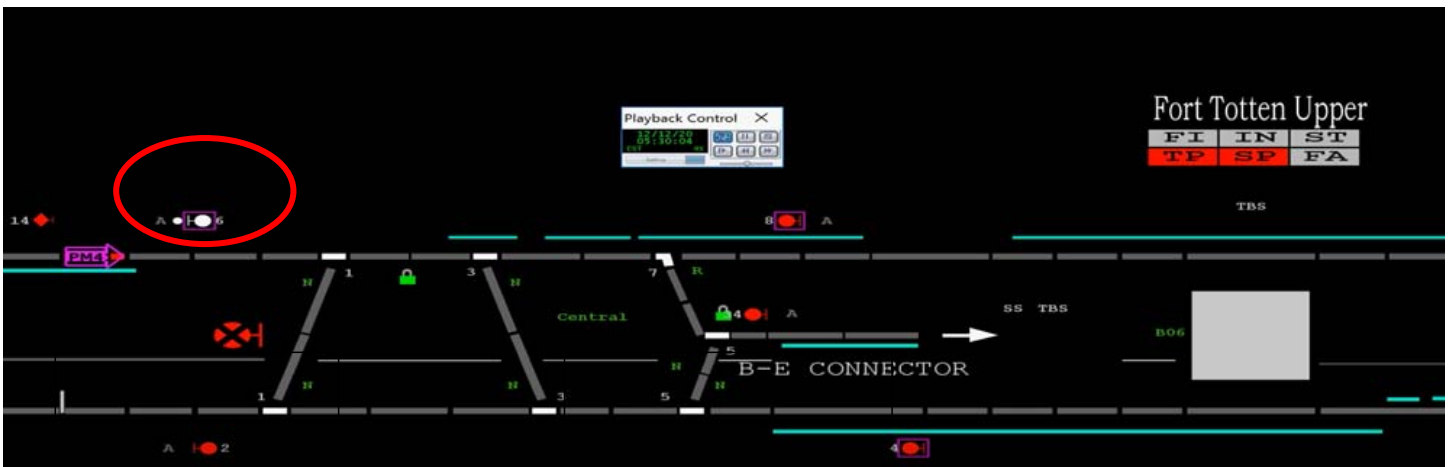
Photo 3: Lunar set at B06-06 signal to allow PM-41 to enter the connector track.
