## **WMSC Commissioner Brief: W-0086 – Improper Vehicle Movement – Red Line – December 30, 2020**

**FINAL REPORT OF INVESTIGATION A&I E20513**

Union Station – Improper Movement of any Rail Vehicle  
on the Mainline or in a Yard, including Over Improperly Aligned Switch(es)

December 30, 2020

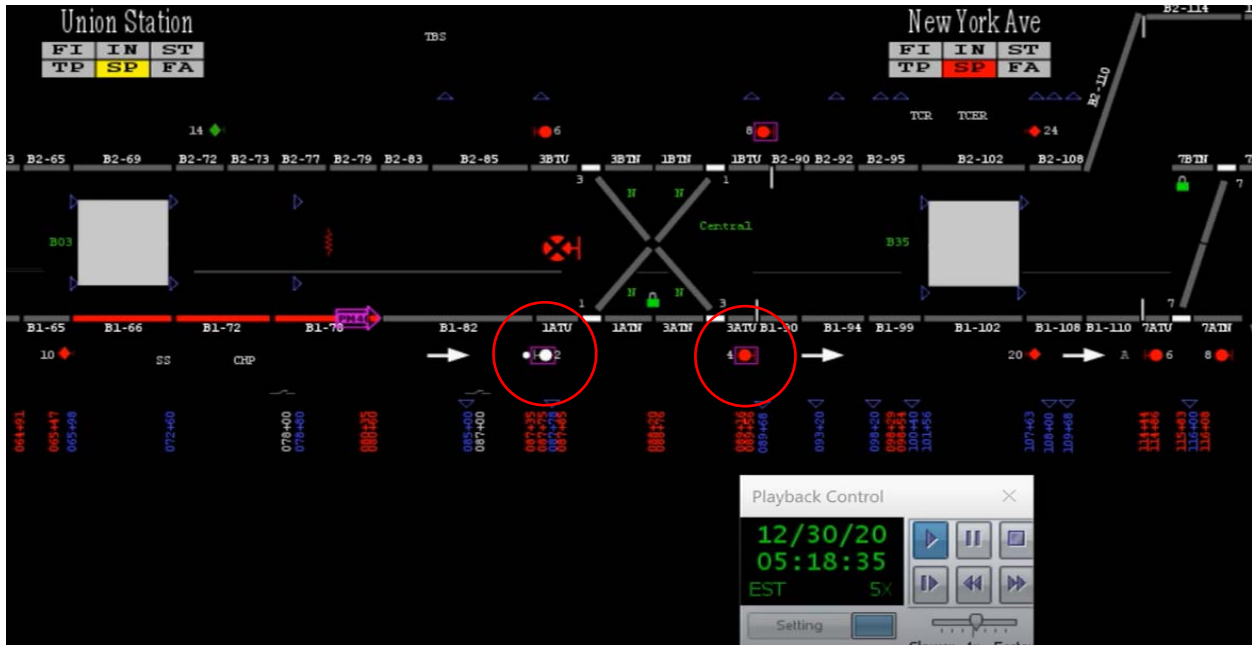
Figure 1: AIMS indication showing PM-46 with a Lunar at B03-02 signal and a prohibit exit at B03-04 signal.

- The AIMS indication showed PM-46 with a Lunar at B03-02 signal, and a prohibit exit at B03-04 signal.
- The AIMS indication showed the Button RTC removed the prohibit exit on the B03-04 signal to allow Train ID 115 access to NoMa-Gallaudet U Station.

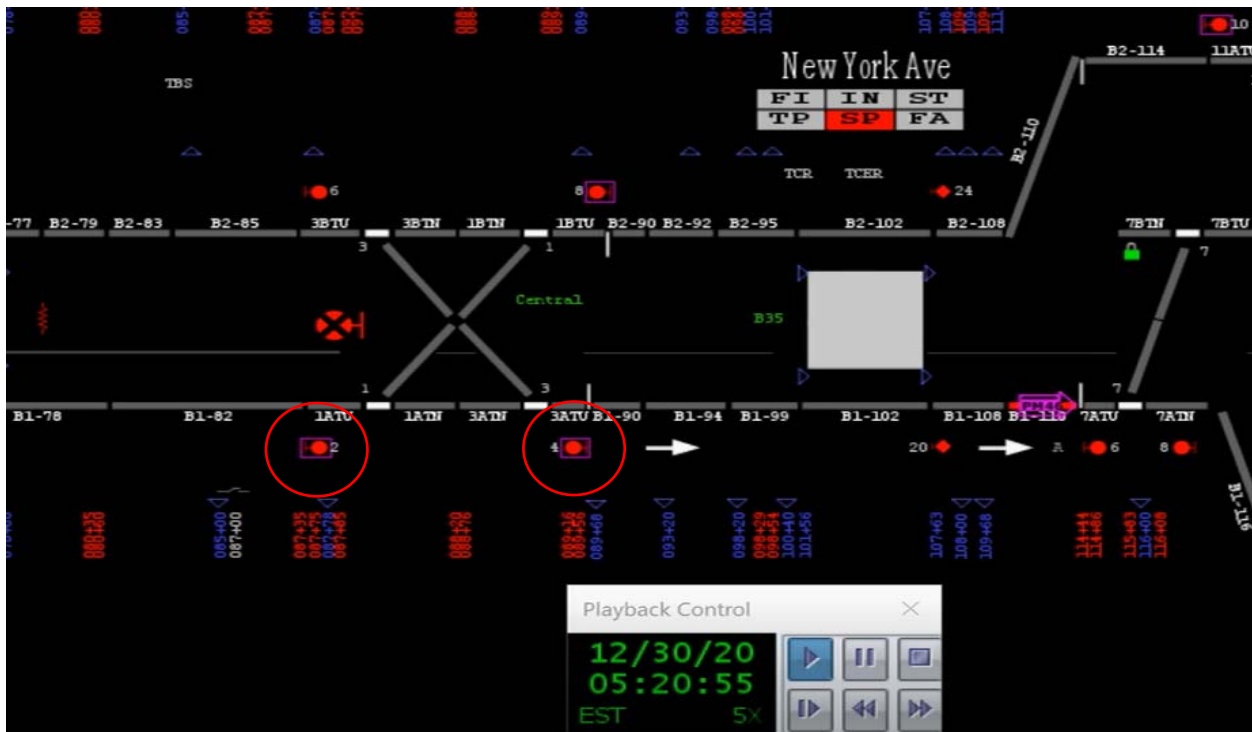
Figure 2: AIMS indication showing PM-46 standing by B99-06 signal waiting to enter the Brentwood Yard. A red aspect is provided at the B03-02 signal and a prohibit exit at the B03-04 signal.

- The AIMS indication showed PM-46 standing by B99-06 signal waiting to enter the Brentwood Yard. A red aspect is provided at the B03-02 signal and a prohibit exit at the B03-04 signal.

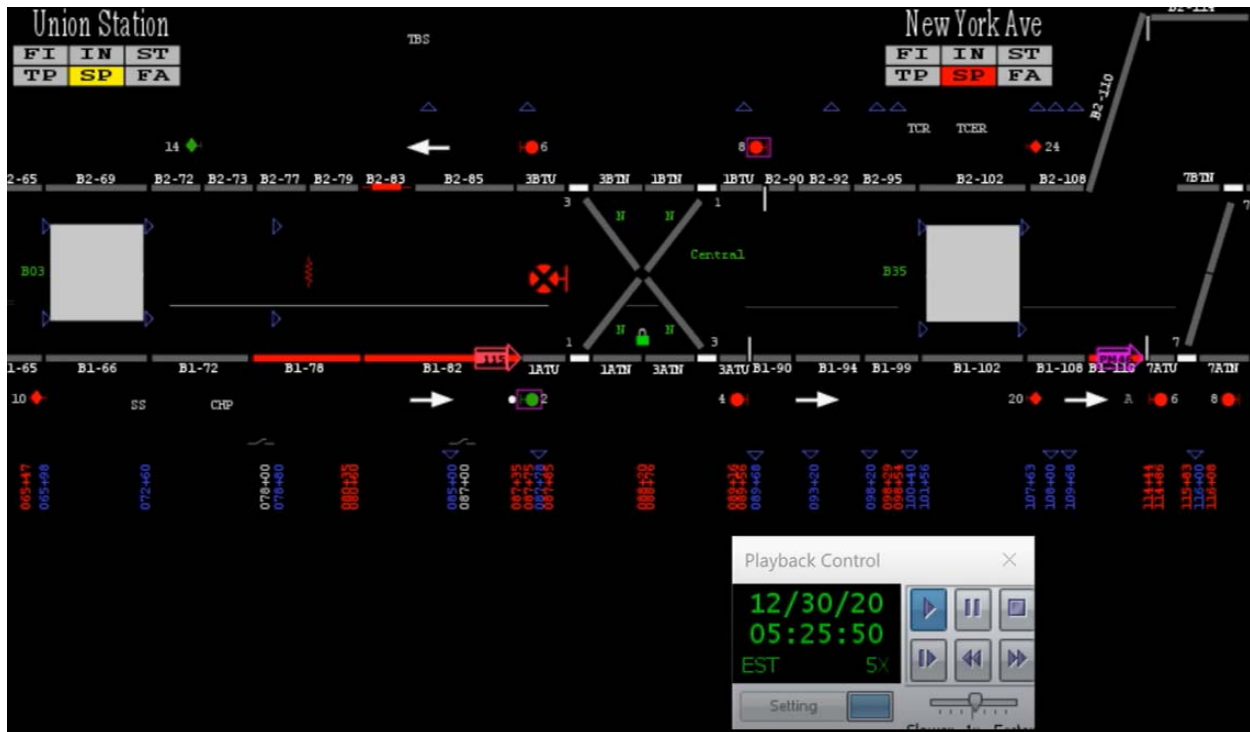
05:25:50 hrs.	<u>Dayshift Button RTC</u> : Removed the prohibit exit at B03-04 signal and set a lunar at B03-02 signal to allow Train ID 115 to enter NoMa-Gallaudet U Station; PM-46 was still waiting to enter the Brentwood Yard. [AIMS]

Figure 3: AIMS indication showing that the Button RTC removed the prohibit exit on B03-04 signal to allow Train ID 115 access to NoMa-Gallaudet U Station.

The probable cause of the Improper Train Movement event at Union Station on December 30, 2020, was lack of adherence to MSRPH written rules and procedures. Further contributors were noted to include on-time performance culture within the ROCC. The Button RTC accepted the turnover from the overnight Buttons RTC and did not utilize their login to access AIMS. The Button RTC removed the prohibit exit and provided a lunar to Train ID 115, subsequently resulting in Train ID 115 entering NoMa-Gallaudet U Station while PM-46 held at B99-06 signal. The Button RTC assumed that PM-46 would have accessed the rail yard by the time Train ID 115 entered the NoMa-Gallaudet U Station platform.

<b>Corrective Action Code</b>	<b>Description</b>
90453_SAFECAPS_ROCC_001	RTC should undergo re-training emphasizing Train/Unit movement procedures.
