WMSC Commissioner Brief: W-0087 – Improper Door Operation – Capitol Heights Station – December 29, 2020

FINAL REPORT OF INVESTIGATION A&I E20511

Capitol Heights Station
Improper Door Operation

December 29, 2020

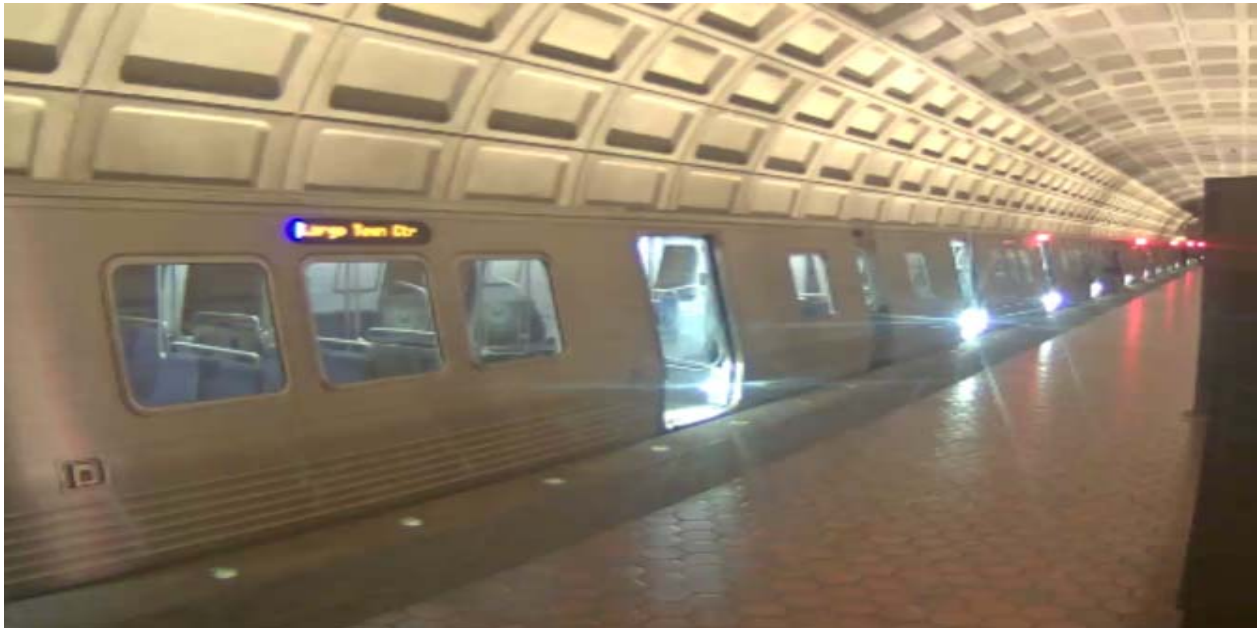
Figure 2 - Based on the CCTV, at 23:28 hours, the consist doors were commanded open on the opposite side of the Capitol Heights Station platform, Track 1.

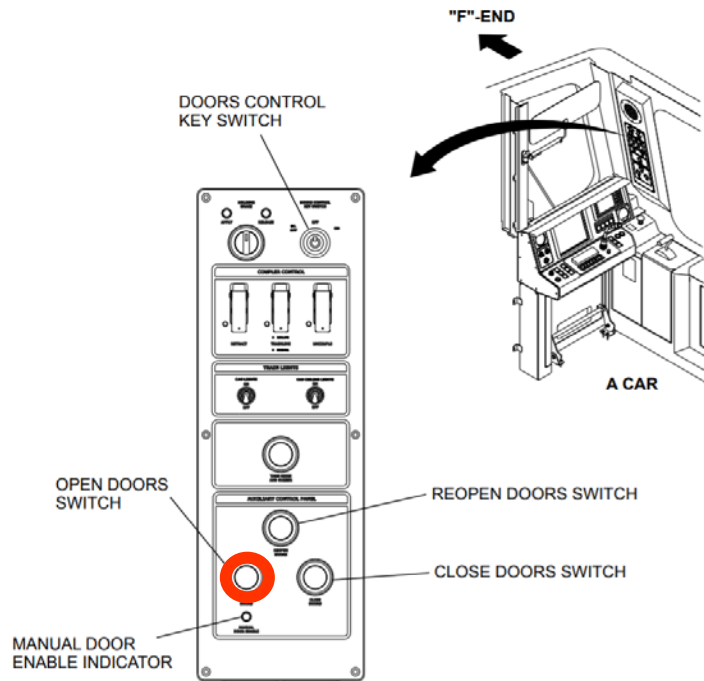
Diagram 6 – This illustration represents the auxiliary control Panel (right doors control). Train ID 491 Operator depressed the right door open push switch (circled in red), which commanded the doors open on the opposite side of the Capitol Heights Station platform, Track 1.

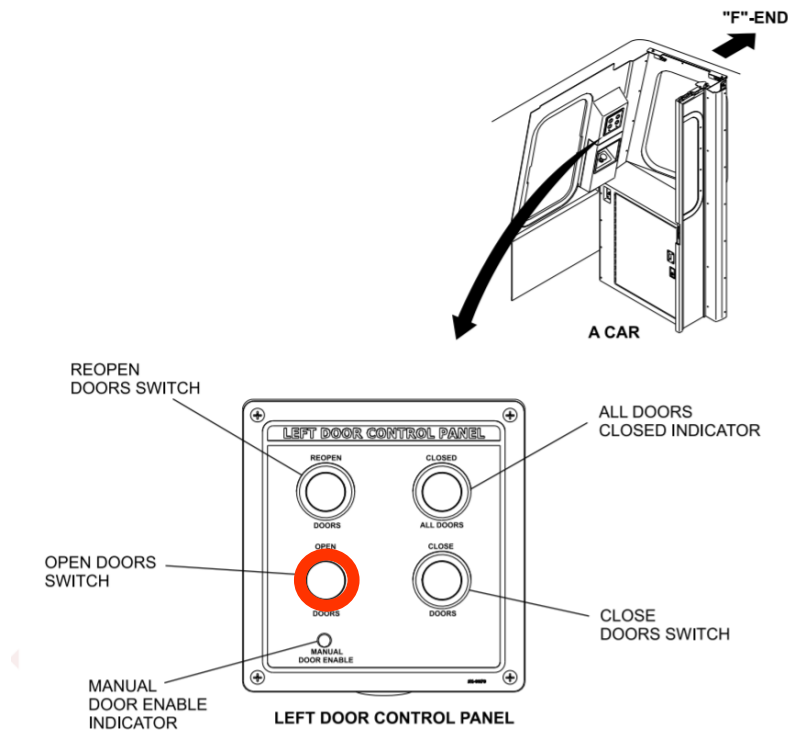
Diagram 7 – This illustration represents the left door control panel. The RTRA Supervisor depressed the left door open push switch (circled in red), which commanded the doors opened on the platform side at Capitol Heights Station platform, Track 1.

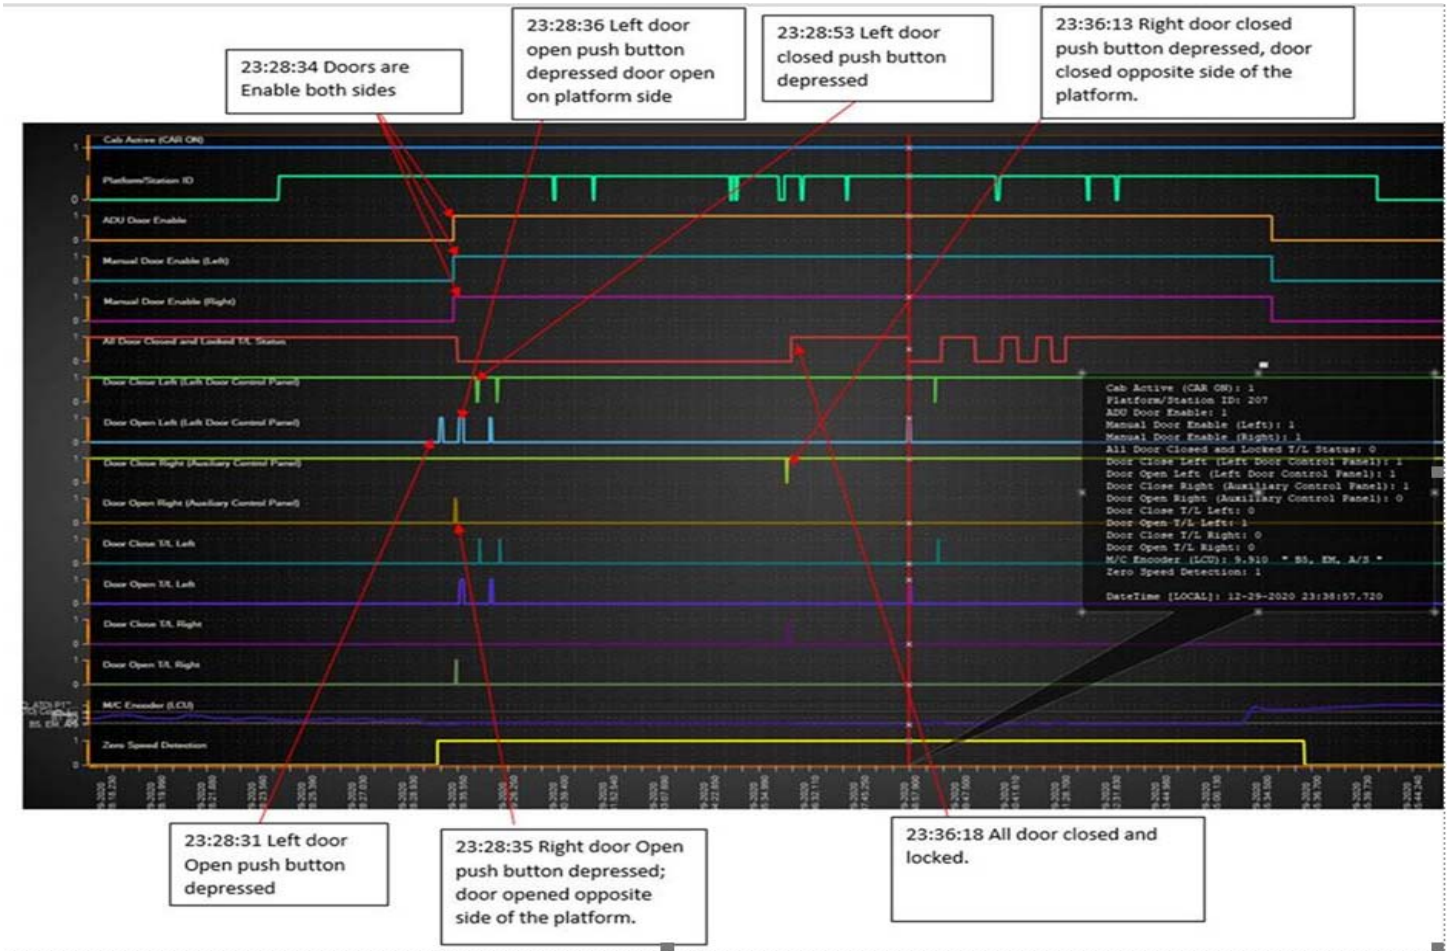
Figure 1: ER Graphical Analysis

TIME	Description
23:28:31 hrs.	The consist left-door open push button was depressed.
23:28:34 hrs.	The consist ADU left and right-side doors were enabled.
23:28:35 hrs.	The consist right-side door open push button was depressed, doors opened on the platform's opposite side.
23:28:36 hrs.	The consist left-door open push button was depressed, doors opened on the platform side.
23:28:53 hrs.	The consist left-door close push button was depressed, doors closed on the platform side.
23:29:08 hrs.	The consist left-door open push button was depressed.
23:29:13 hrs.	The consist left-door close push button was depressed, doors closed platform side.
23:36:13 hrs.	The consist right-door close push button was depressed, doors closed on the opposite side of the platform.
23:36:13 hrs.	All of the consist doors closed and were secure.

The VMDS data verified that the consist doors opened on the opposite side of the platform. All the subsystems' safety components such as ATC, brakes, and propulsion acted as designed, and there were no faults with the train that contributed to this incident.
