**WMSC Commissioner Brief: W-0088 – Improper Door Operation – Franconia-Springfield Station – December 16, 2020**

**FINAL REPORT OF INVESTIGATION A&I E20498**

Franconia Springfield Station – Improper Door Operation

December 16, 2020

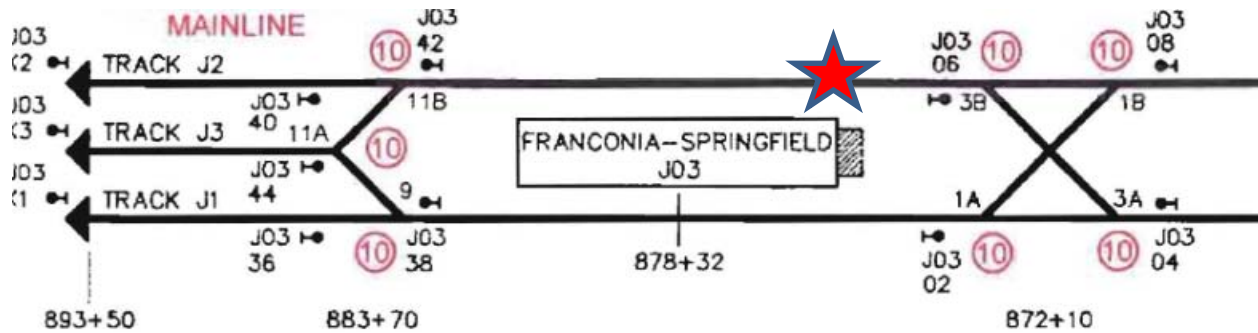
## Field Sketch/Schematics

The Train Operator proceeded to perform a door operation at the 6-car marker allowing the doors on the trailing two cars, 3281 and 3280, to open off the platform. Upon having the door operation, the Train Operator contacted the Terminal Supervisor to ascertain if they were operating a 6-car consist; the Terminal Supervisor confirmed that the Train Operator had an 8-car consist. The Terminal Supervisor notified the Button Rail Traffic Controller (RTC) and instructed the Train Operator to perform a ground walk around the train. At approximately 07:54 hrs., the Terminal Supervisor exited the Terminal Block House to assist the Train Operator with the ground walk around. At 07:59 hrs., the Terminal Supervisor and the Train Operator completed the ground walk around and reported no injuries or damage to any equipment.

The Train Operator did not respond to the Terminal Supervisor's transmission; the Train Operator proceeded to perform a door operation at the 6-car marker allowing the doors on the trailing two cars [Car 3281 and 3280] to open off the platform. Upon executing the door operation, the Train Operator contacted the Terminal Supervisor to ascertain if they were operating a 6-car consist; the Terminal Supervisor confirmed that the Train Operator had a 6-car consist. The Terminal Supervisor notified the Button Rail Traffic Controller (RTC) and instructed the Train Operator to perform a ground walk around the train. At approximately 07:54 hrs., the Terminal Supervisor exited the Terminal Block House to assist the Train Operator with the ground walk around. At 07:59 hrs., the Terminal Supervisor and the Train Operator completed the ground walk around and reported no injuries or damage to any equipment.

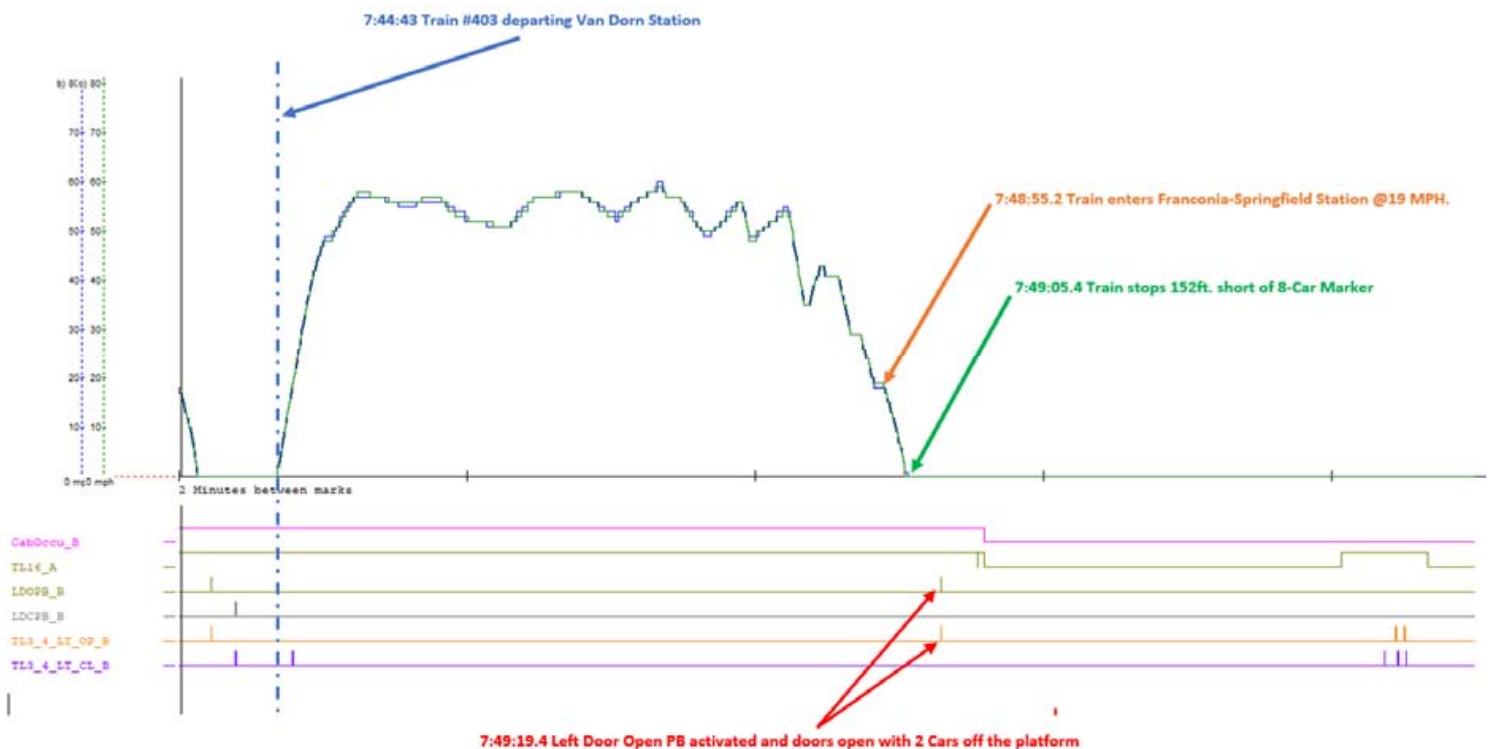
#### Data Analysis

Time	Description
07:44:43 hrs.	Train ID 403, Lead Car 3169 departed Van Dorn Station, Track 2 towards Franconia-Springfield.
07:48:55 hrs.	The Train Operator of Train ID 403 enters Franconia-Springfield Station at 19 MPH, with Master Controller in the B2 position.
07:49:05 hrs.	Train ID 403 Train Operator Stops on Franconia-Springfield platform, 152 ft. short of the 8-car marker.
07:49:19 hrs.	The Train Operator depressed the Left Door Open push button; doors opened with trailing two cars off the platform.
07:49:37 hrs.	The Train Operator keyed down Train ID 403.
