WMSC Commissioner Brief: W-0089 – Red Signal Overrun – Eastern Market Station – December 15, 2020

FINAL REPORT OF INVESTIGATION A&I 20492

**Eastern Market Station – Red Signal Overrun
December 15, 2020**

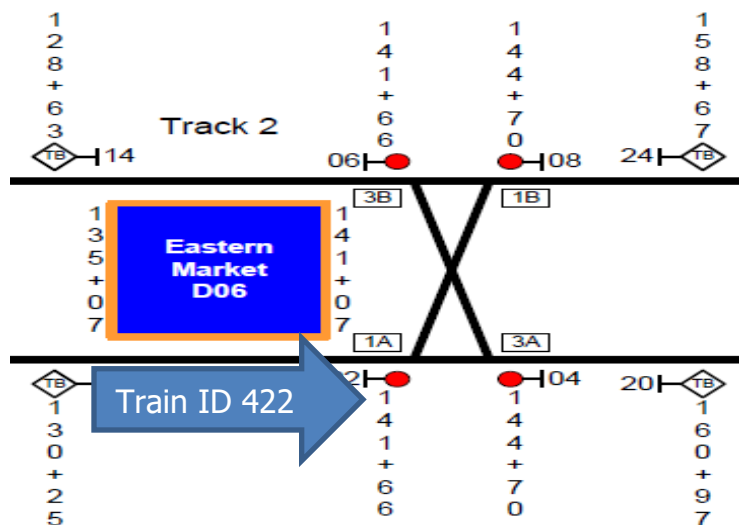
Figure 1: Track Diagram of Eastern Market Station, with impacted signal and switch identified.

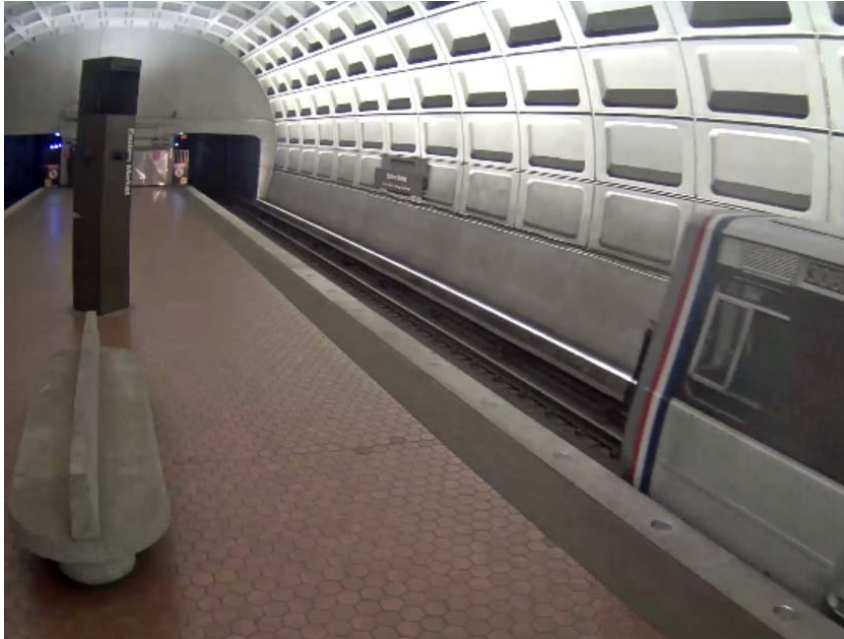
Photo 1: At approximately 04:49:28 hrs., the consist begins to move at Eastern Market Station, Track 1.

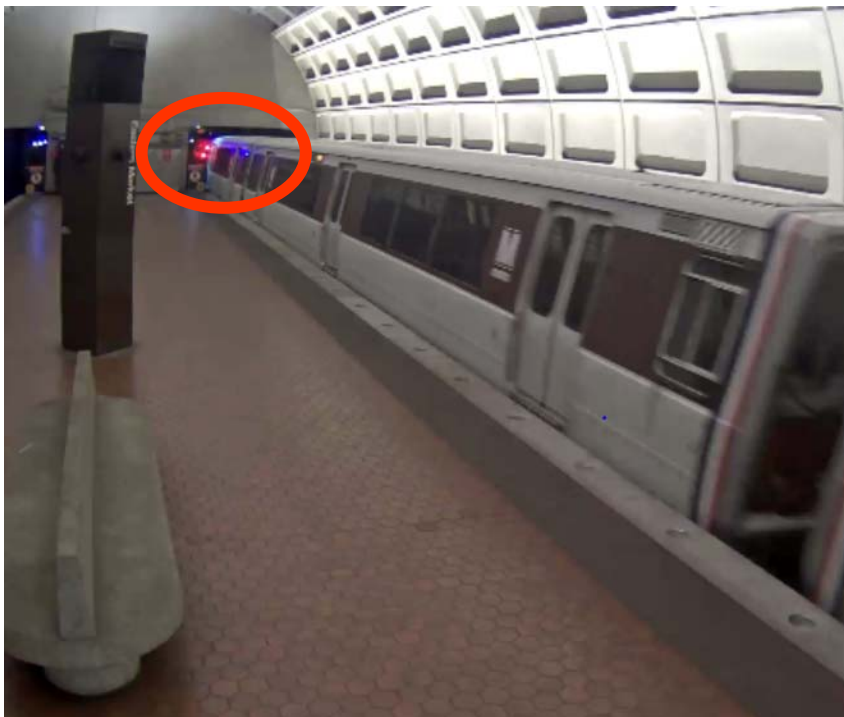
Photo 2: At approximately 04:49:39 hrs., the consist passed Eastern Market Station, Track 1, 8-car marker, and it appeared that the D06-02 signal was displaying a "red" aspect as they proceeded to pass the signal.

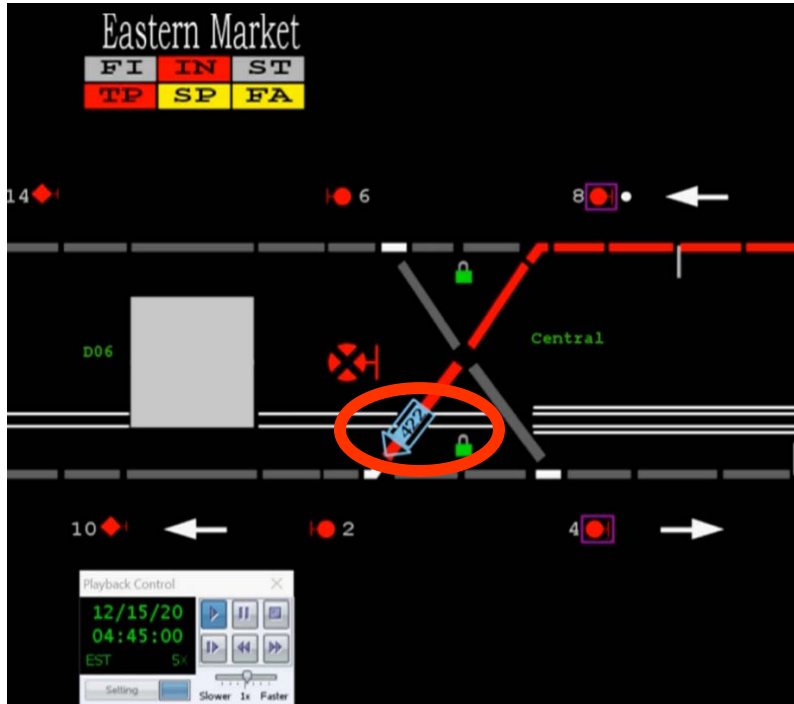
Figure 2: Shows non-revenue Train ID 422 entering Eastern Market Station traversing through the interlocking from Track 2 to Track 1 in the direction of Federal Triangle Station.

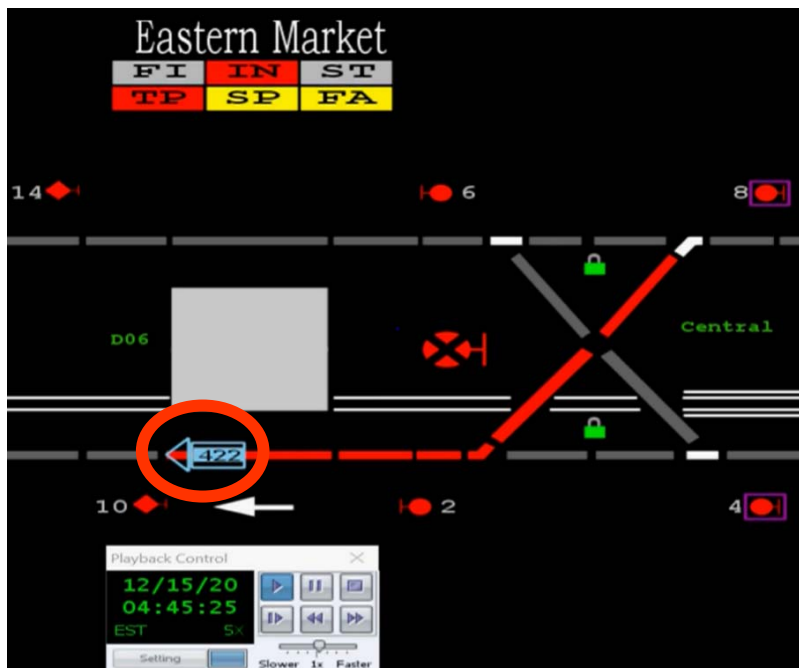
Figure 3: Shows non-revenue Train ID 422 berthed at Eastern Market Station, Track 1 platform.

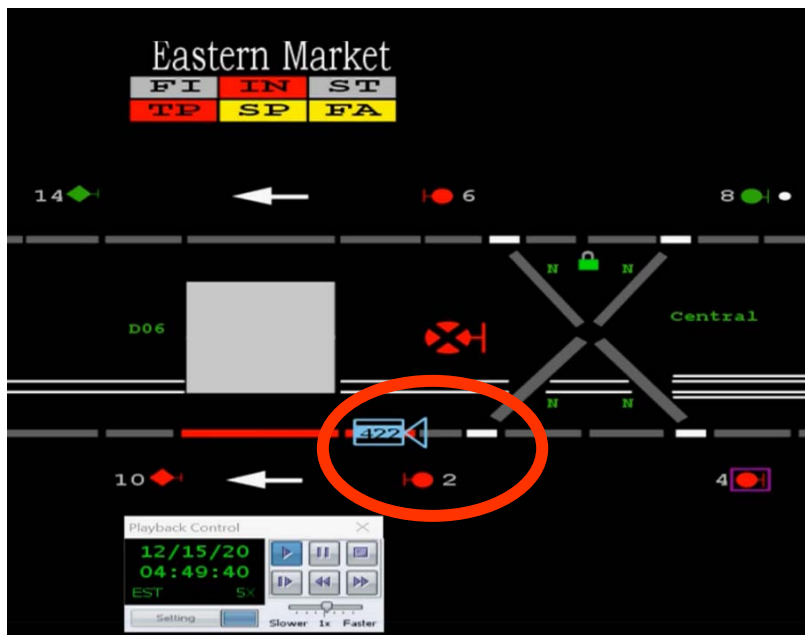
Figure 4: Shows non-revenue Train ID 422 began to move in the direction of Largo Station at Eastern Market Station, Track 1, while D06-02 signal displayed a red aspect.

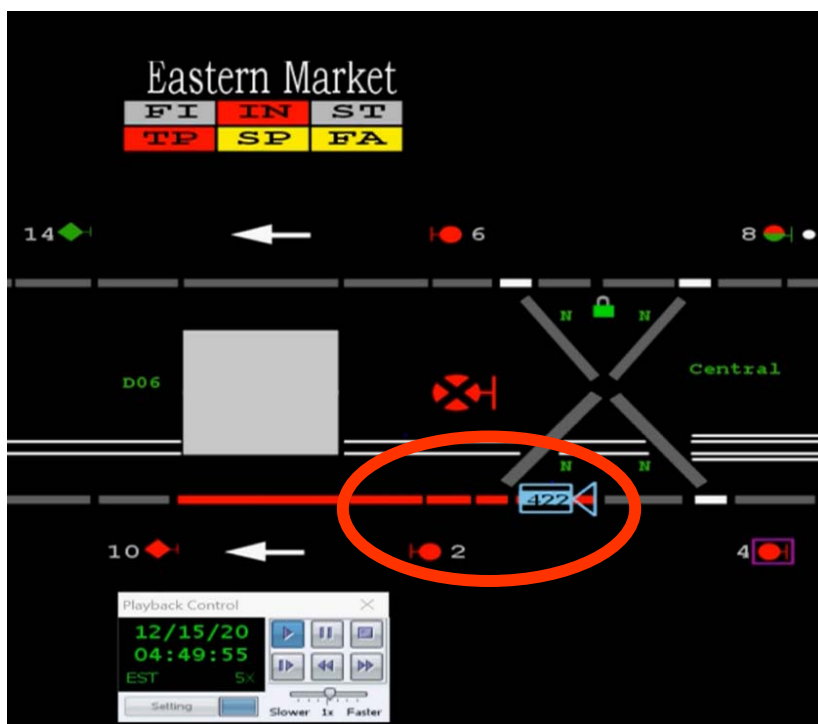
Figure 5: Shows non-revenue Train ID 422 proceeded past signal D06-02 displaying a red aspect.

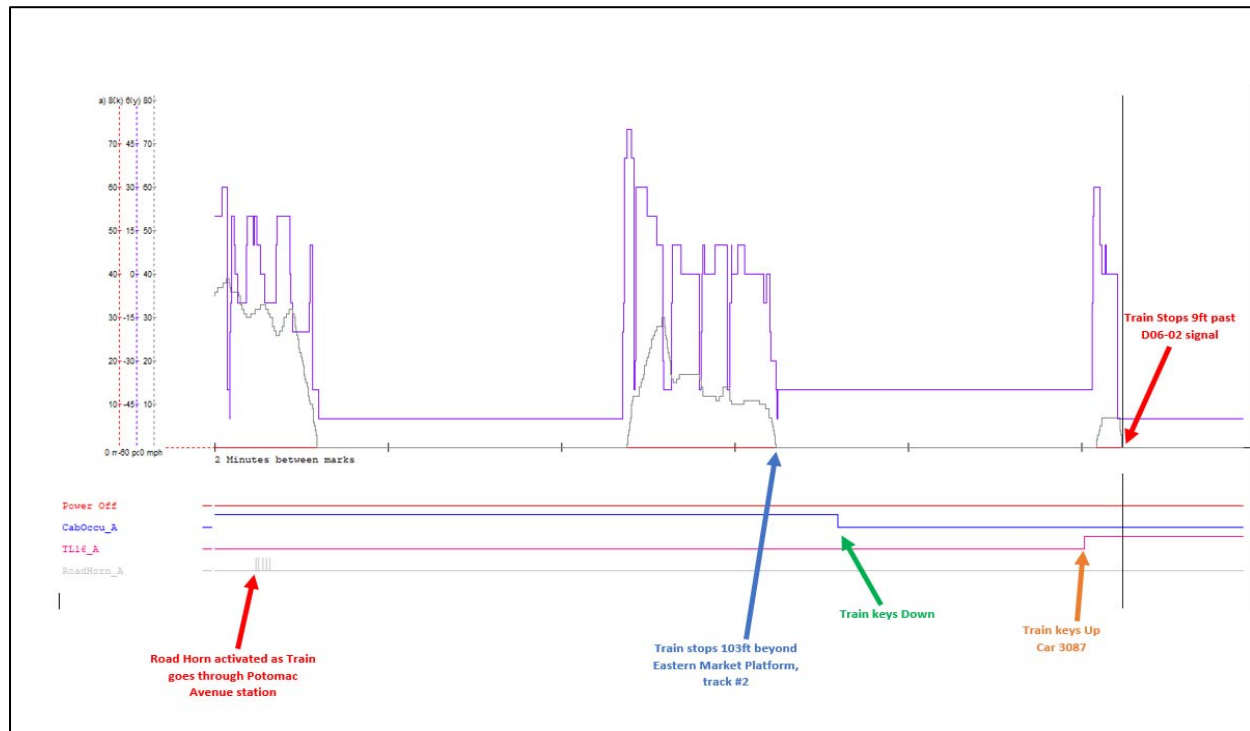
Figure 6: ER Graphical Analysis

TIME	Description
04:39:50 hrs.	The consist enters Potomac Avenue Station, Track 2, towards Eastern Market Station.
04:45:51 hrs.	The consist stopped 103 feet within platform limits at Eastern Market Station after changing over from Track 2 to Track 1 and then keyed down.
04:49:23 hrs.	The consist opposite end, car 3087, was keyed up.
04:49:32 hrs.	The consist train began to move in the direction of Largo Station, operating up to 7 mph.
04:49:50 hrs.	The consist traveled 171 feet and came to a stop 9 feet beyond the D06-02 signal.

Note: The consist data showed no faults observed or any abnormalities with the car's operations contributing to this incident.
