WMSC Commissioner Brief: W-0090 – Red Signal Overrun – New Carrollton Yard – December 16, 2020

Washington Metro Area Transit Authority
Department of Safety and Environmental
Management (SAFE)
FINAL REPORT OF INVESTIGATION A&I E20499

New Carrollton Yard – Red Signal Overrun

December 16, 2020

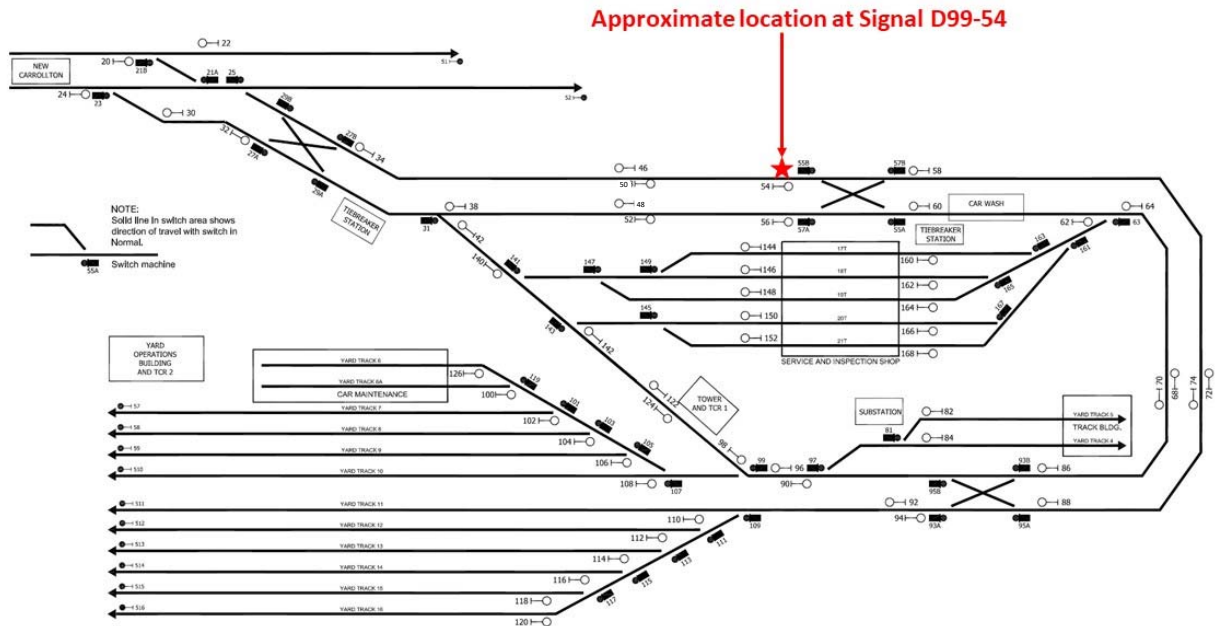
Field Sketch/Diagram

New Carrollton Yard, Signal D99-54

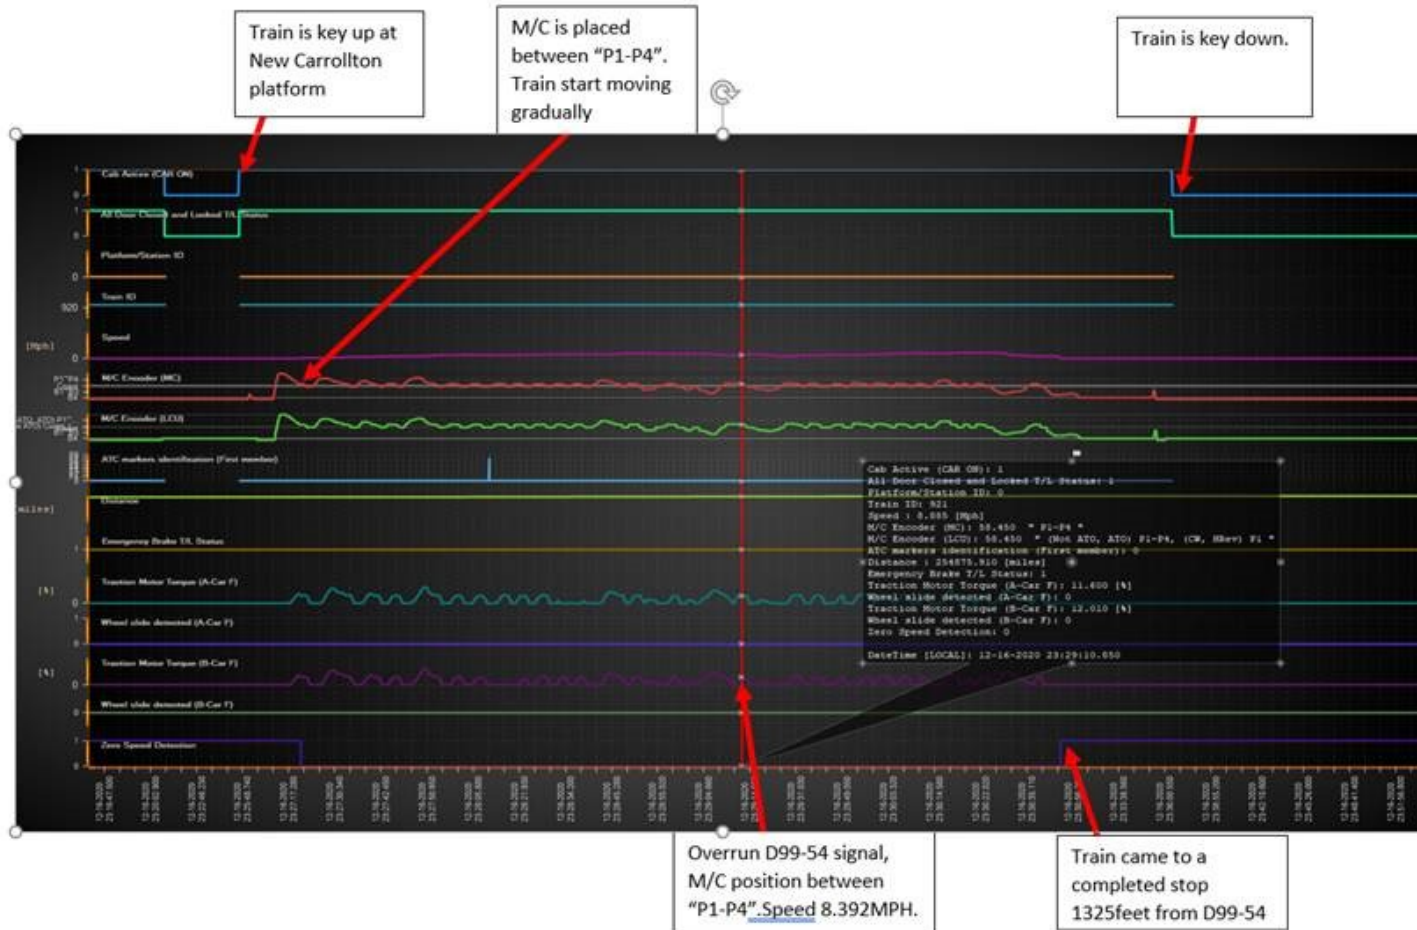
Time	Description
23:25 hrs.	The train is keyed up at New Carrollton Station, Track #1, 8-car marker, Lead Car #7374.
23:27 hrs.	Master Controller (M/C) is placed between “P1-P4”. Train start moving gradually.
23:29 hrs.	Train overrun D99-54 Signal (Red). M/C position between “P1-P4”. Train speed at 8.392 mph. Approximately 1307 ft from the 8-car marker.
23:30 hrs.	The train came to a complete stop. Consist traveled 1,324 ft from D99-54 signal.
23:36 hrs.	The train is keyed down.

Figure 1: VMDS Diagram: CENV reported the train performed as designed. CENV did not observe any brake or propulsion anomalies.

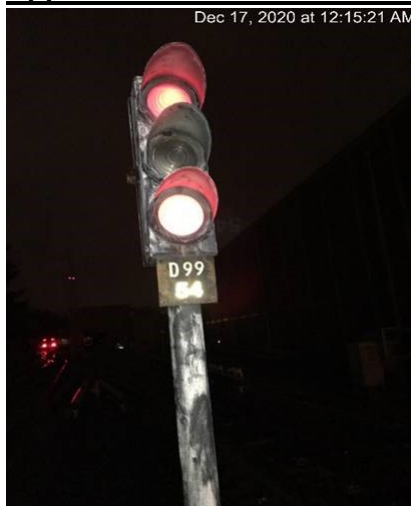
Photo #1: Signal D99-54. Incident consist (left) stationary 1,324 feet past signal.

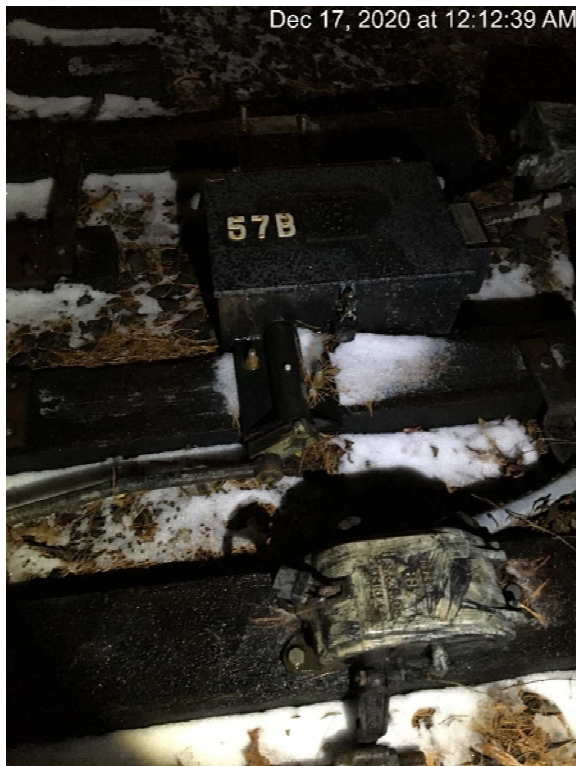
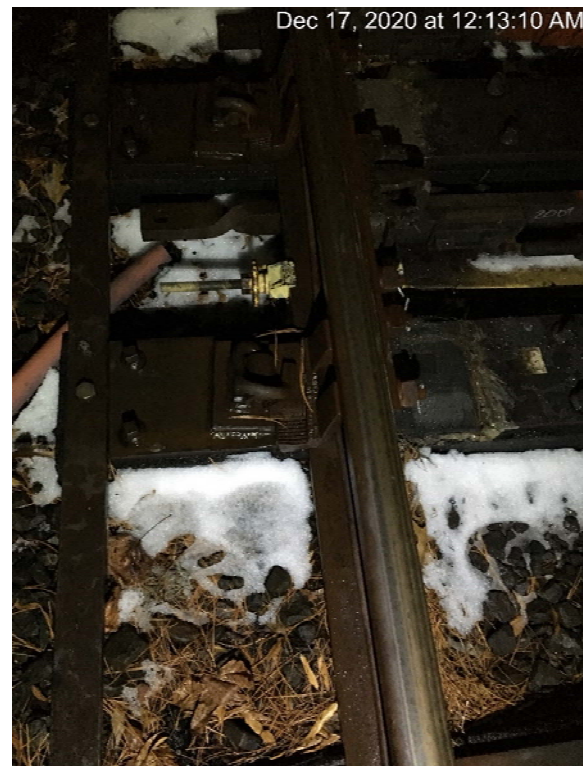
ATCM personnel responded and reported no damages occurred to Switches 55B and 57B that are near Signal D99-54. Switch D99-55B was clamped by ATC before the red signal overrun occurred due to the Tower's inability to establish a lunar. At approximately 01:30 hours, ATC personnel reported no damage to ATC equipment and normal service resumed.

Photos #4 and #5: Incident train traveled through Switch 57B (clamped) after passing Signal D99-54 (Red). ATC found no damage.

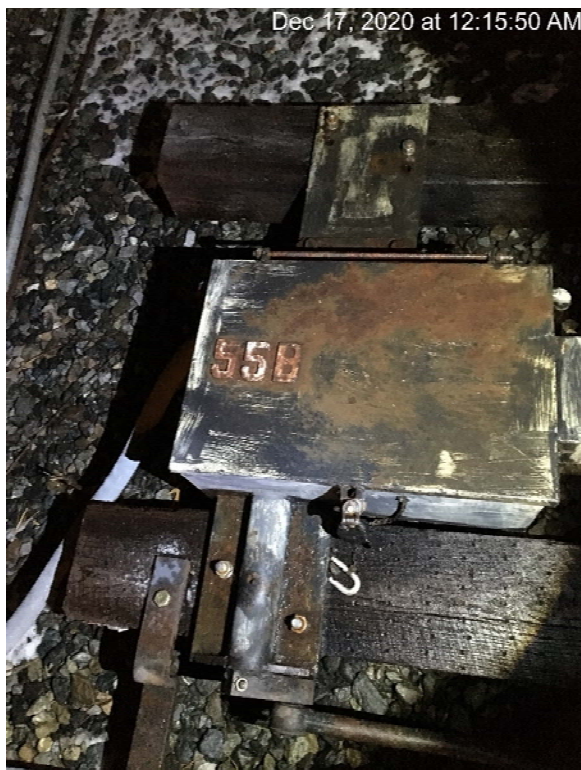
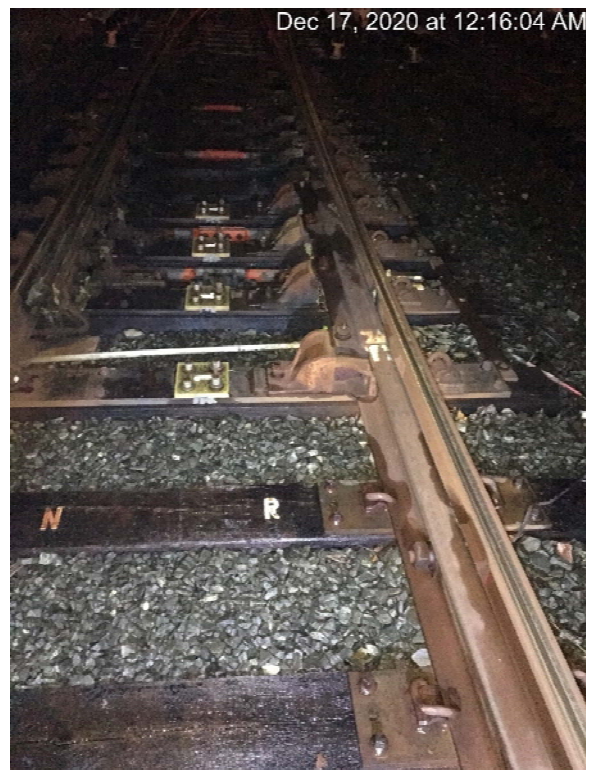
Photos #6 and #7: Incident train traveled through Switch 55B (clamped) after passing Signal D99-54 (Red). ATC found no damage.
