WMSC Commissioner Brief: W-0092 – Improper Roadway Worker Protection – Between Columbia Heights and Georgia Ave.-Petworth stations – January 22, 2021

FINAL REPORT OF INVESTIGATION A&I E21025

Georgia Ave-Petworth
Improper Roadway Worker Protection
January 22, 2021

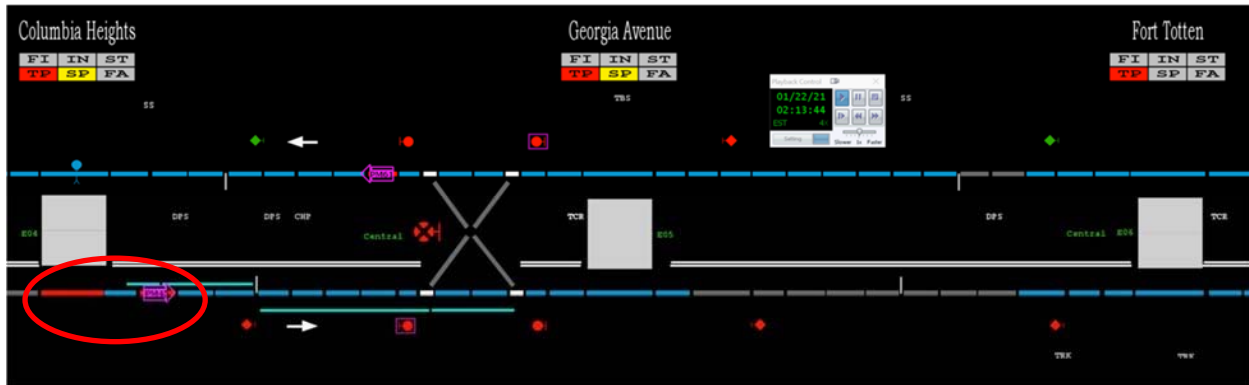
02:13:44 hrs.	<i>AIMS Playback displayed PM45 at Columbia Heights Station with Shunt deployed</i>
02:13:54 hrs.	<u>PM61</u> : PM61 clear at Georgia Ave zero 06. [Radio]

Figure 1: AIMS Playback displayed PM45 at Columbia Heights Station with shunt deployed.

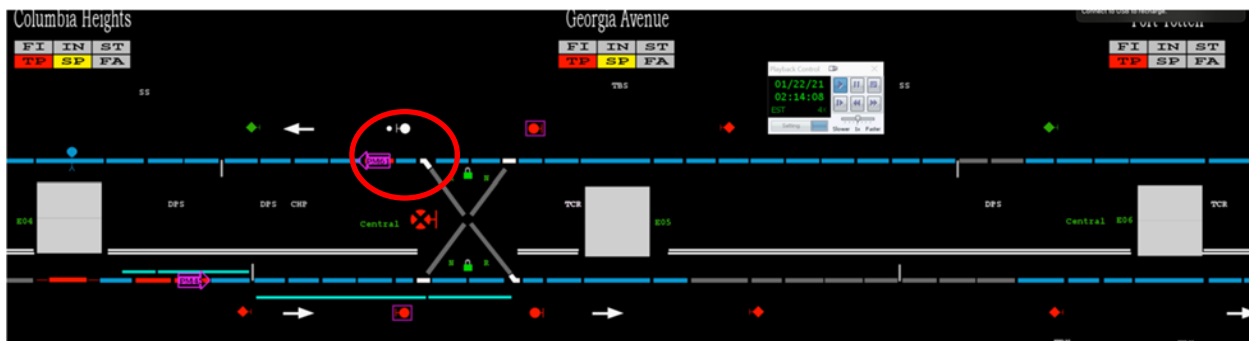
02:14:08 hrs.	<i>AIMS playback displayed a flashing lunar at E05-06 Signal after Buttons RTC set a reverse move from Track #2 to Track #1.</i>
02:17:39 hrs.	<u>Radio RTC</u> : PM61 verify personnel and equipment are clear to move, verify lunar Echo zero five crossing over from Track #2 to Track #1 absolute block Fort Totten Station, Track #1. <u>PM61</u> : PM61 copy that lunar crossing over two to one absolute block work location Fort Totten Station, Track #1 verifying all PM 61. <u>Radio RTC</u> : That's a good Copy 61 central out. <u>Flag Person on PM 61</u> : Proceed 61, got flashing lunar turnout Fort Totten. [Radio]

Figure 2: Buttons RTC sent a reverse move from Track #2 to Track #1; flashing lunar displayed on the AIMS Screen.

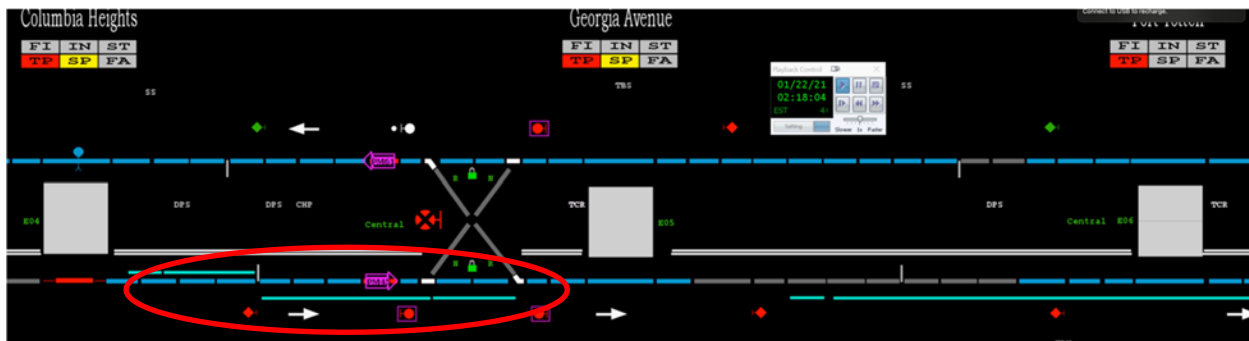
02:18:04 hrs.	<i>AIMS playback displayed third rail power de-energized on Track #1 Columbia Heights Station to Georgia Ave-Petworth Interlocking. Note: Third rail power was de-energized at this work location at approximately 01:54 hrs.</i>

Figure 3: AIMS playback displayed third rail power de-energized on Track #1 Columbia Heights station up to the end of Georgia Ave-Petworth Interlocking Note: Third Rail Power was de-energized at approximately 01:54 hours.

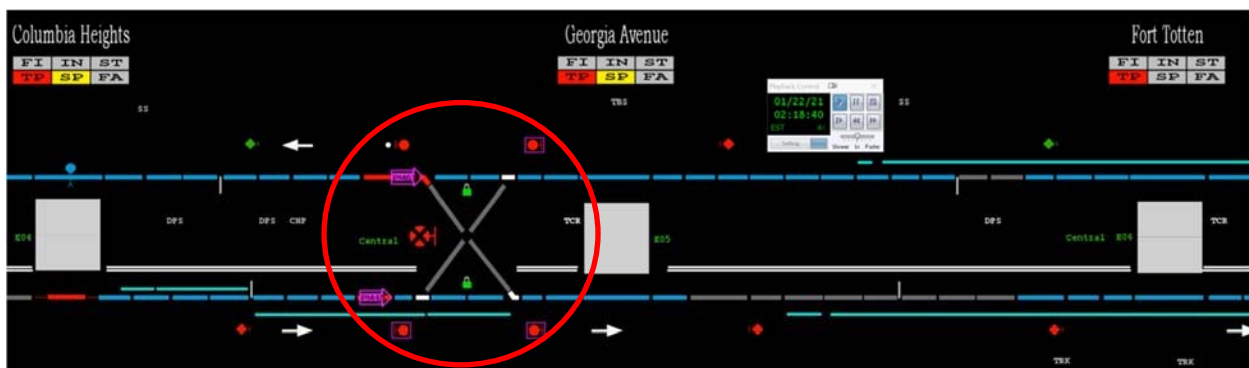
02:18:40 hrs.	<i>AIMS playback displayed PM61 occupied E05 interlocking crossing over from Track #2 to Track #1.</i>
02:19:04 hrs.	<i>AIMS playback displayed PM61 occupied Track #1.</i>

Figure 4: AIMS playback displayed PM61 occupied E05 interlocking crossing over from Track #2 to Track #1 with PM 45 holding at Red Signal.

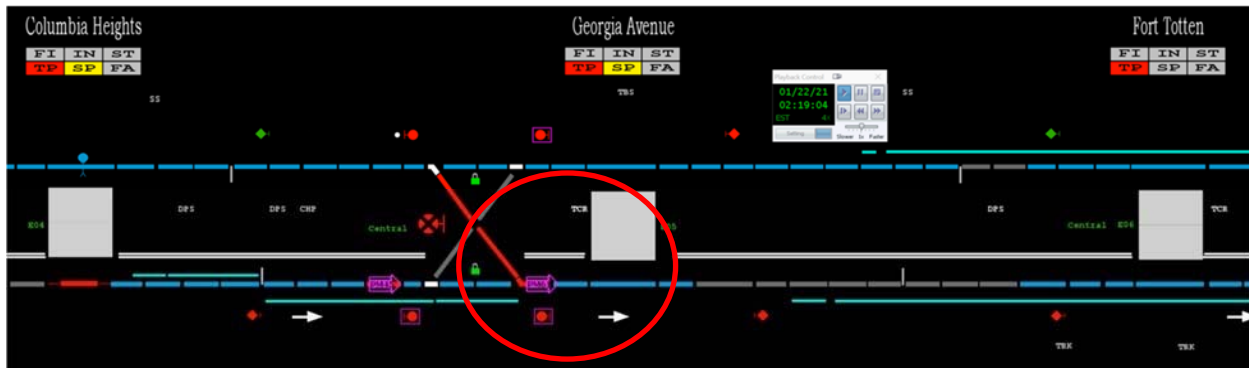
Figure 5: AIMS playback displayed PM61 occupied Track #1 in front of PM45, utilizing the unit to set up their work location.

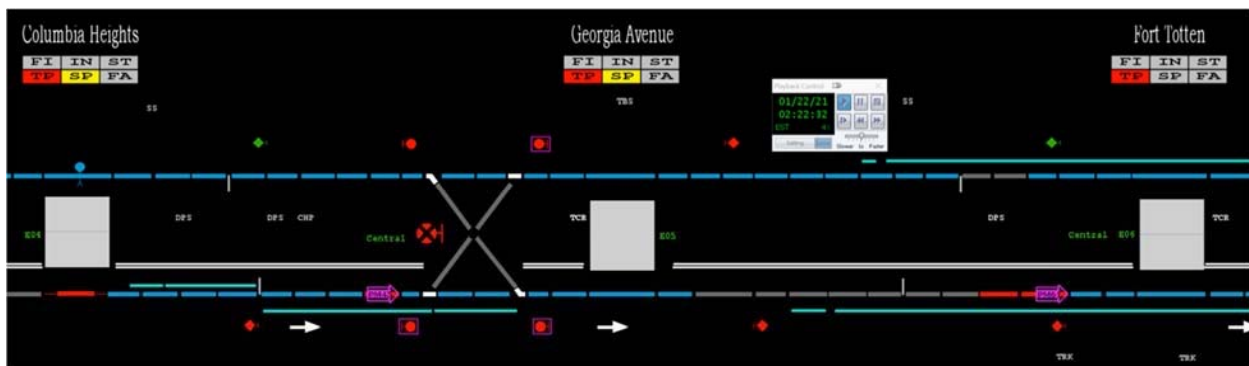
02:22:32 hrs.	<i>AIMS playback displayed PM61 approaching a blue block location.</i>
02:23:32 hrs.	<i>AIMS playback displayed PM61 arrived at Fort Totten Station platform.</i>

Figure 6: AIMS playback displayed PM61 approaching a blue block location.

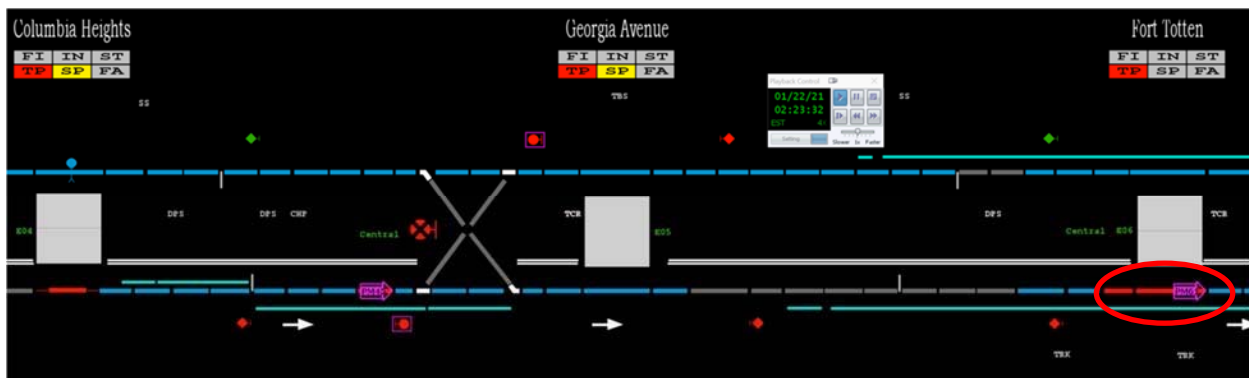
Figure 7: AIMS playback displayed PM61 arrived at Fort Totten Station platform.
