**WMSC Commissioner Brief: W-0093 – Unintended Movement – U Street Station – December 9, 2020**

Washington Metro Area Transit Authority
Department of Safety and Environmental
Management (SAFE)
FINAL REPORT OF INVESTIGATION A&I E20483

Columbia Heights Station – Unintended Movement

December 9, 2020

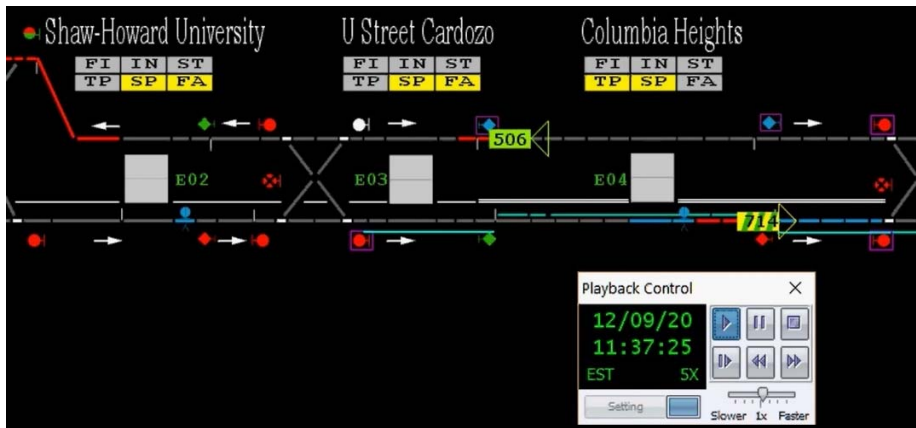
Based on Audio Recording System (ARS) playback [radio and ambient], the Train Operator was instructed to depart Shaw-Howard U Station, cross over to Track #2 at U Street Station and reverse ends to be back in service towards Branch Avenue Station. The Train Operator affirmed the directions but did not complete them. After the ROCC transmitted instructions, the Train Operator moved the consist past the permissive block authorized by ROCC without speed commands.

Illustration #4 - Train ID #506 continues on Track #2 with zero speed commands in the direction of Columbia Heights Station.

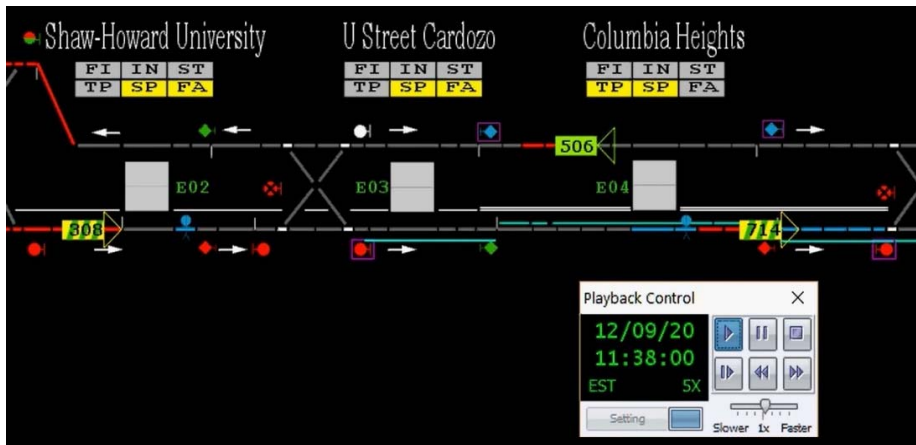
Illustration #5 - Train ID #506 comes to a complete stop on Track #2 in between U Street Station and Columbia Heights Station.

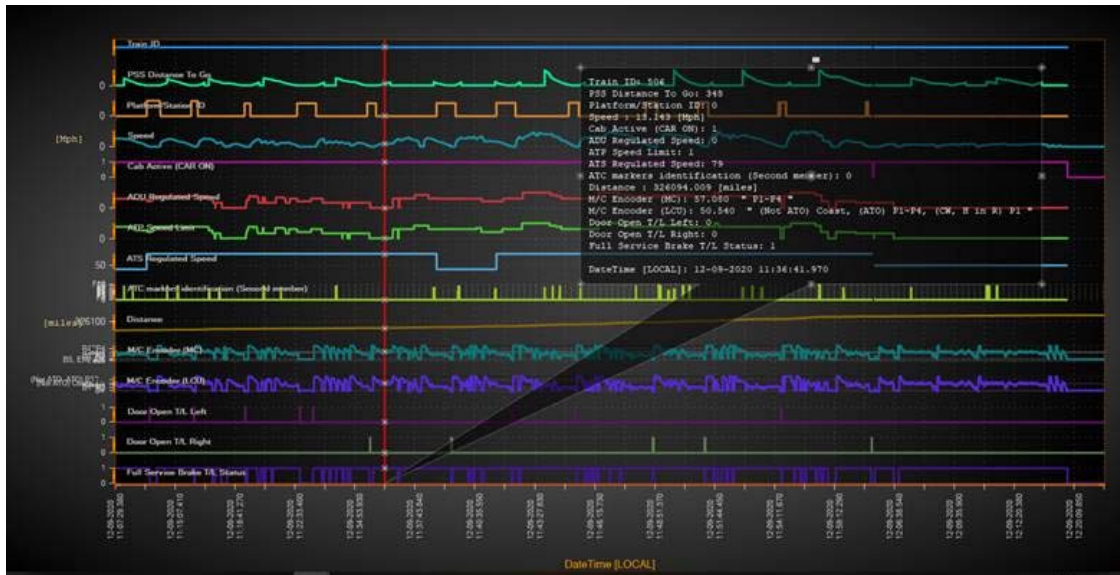
VMDS analysis verified, Train ID #506 began to proceed from U Street Station, Track #2, using Stop and Proceed (Loss Of Speed Command-ATP Speed Limit 1) at approximately 11:36 hrs. This indicates the Train Operator did not verify they had speed commands before they moved the train towards Columbia Heights Station. ROCC subsequently contacted the Train Operator to verify their location and if they had speed commands.

Photo #2 - Train ID #506 departed from U Street Station using Stop and Proceed (Loss Of Speed Command).

- The Train Operator did not verify if they had speed commands before departing U Street Station. This is not in compliance with SOP #40.5.3.1 – *“Prior to initiating the Close Door button, the train operator shall check the operating console for speed commands and check Roadway ahead of the train to ensure it is clear.”*

Corrective Action Code	Description
90683_SAFECAPS_RTRA_001	Schedule and ensure Train Operator completes refresher training on Operating Rule 3.79
90683_SAFECAPS_SAFE_002	SAFE will develop a radio transmission performance monitoring evaluation process where ROCC radio transmissions will be audited, and resulting findings/corrective actions will be shared with ROCC leadership. Focus will be on similar conditions as this event (i.e., single tracking events).
90683_SAFECAPS_ROCC_003	ROCC management will partner with SAFE to correct any systemic issues noted as a result of 90683_SAFECAPS_SAFE_002.

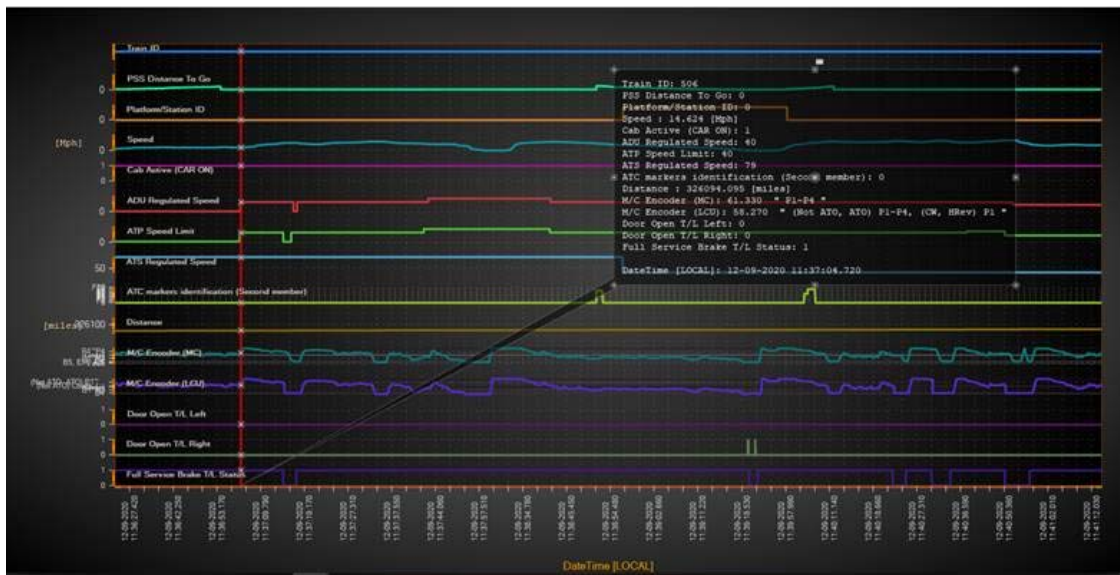
Photo #3 - Train ID #506 regains ATP Speed Readout limit 40 mph.

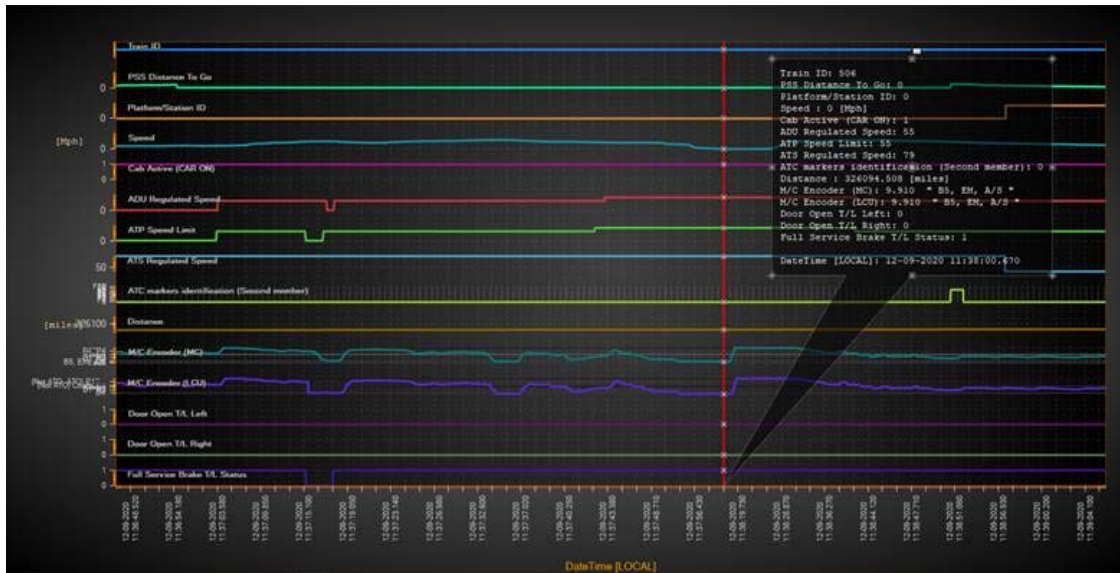
Photo #4 - Train ID #506 has stopped between U Street and Columbia Heights Station, Track #2. ATP Speed Command 55mph.
