WMSC Commissioner Brief: W-0094 – Improper Vehicle Movement – King St. Station – February 18, 2021

FINAL REPORT OF INVESTIGATION A&I E21071

King Street Station
Improper Movement of any Rail Vehicle
on the Mainline or in a Yard, Including Over Improperly Aligned Switch(es)

February 18, 2021

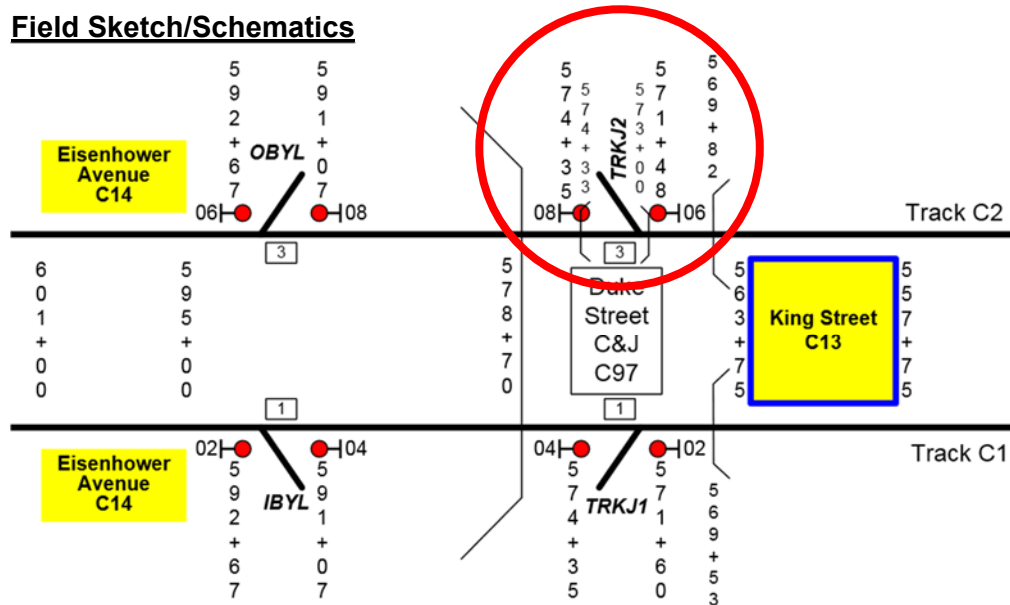
Field Sketch/Schematics

King Street, Track 2

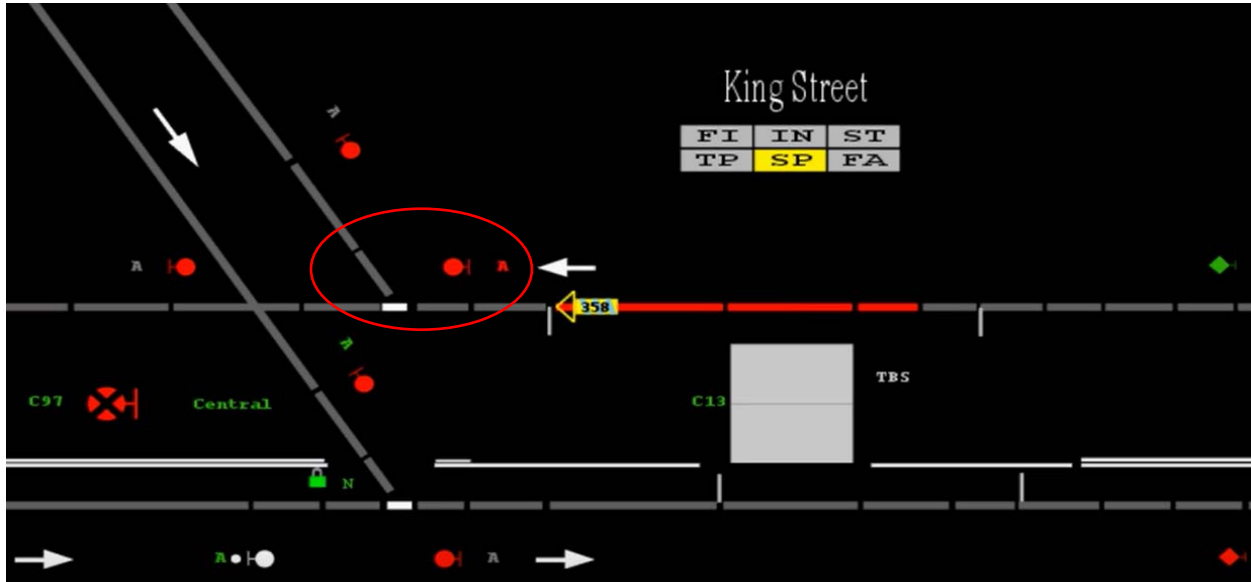
Diagram 1: Train ID 358 holding at the C97-06 signal.

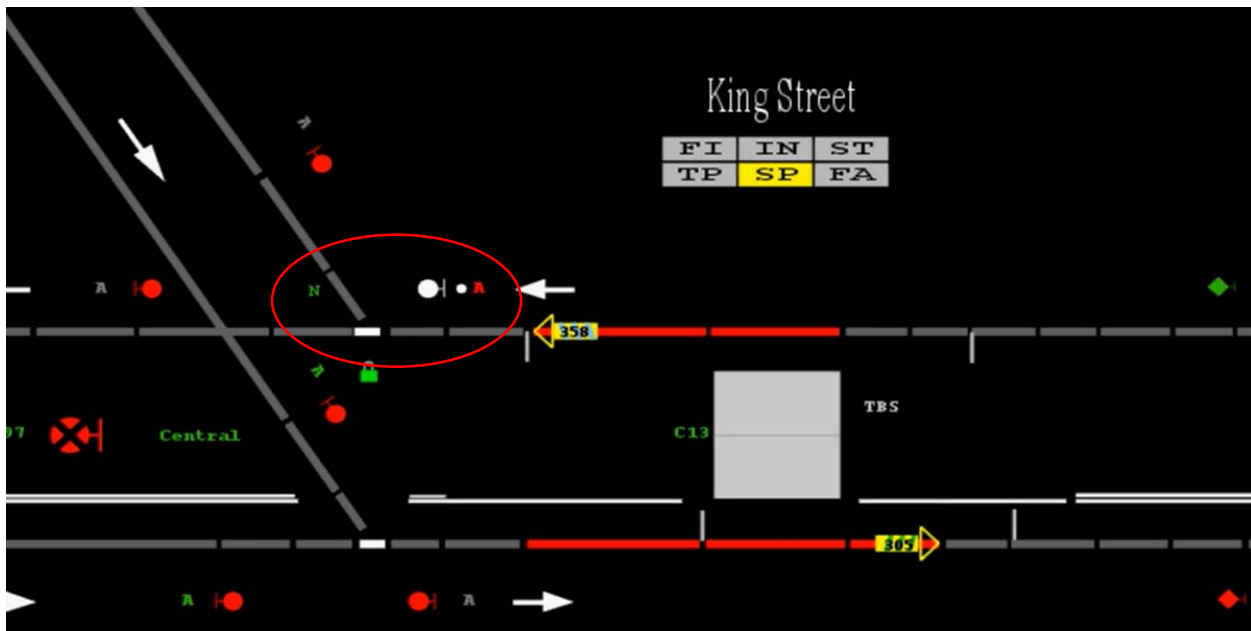
Diagram 2: Lunar set by the Radio RTC at the C97-06 signal for a straight-through move.

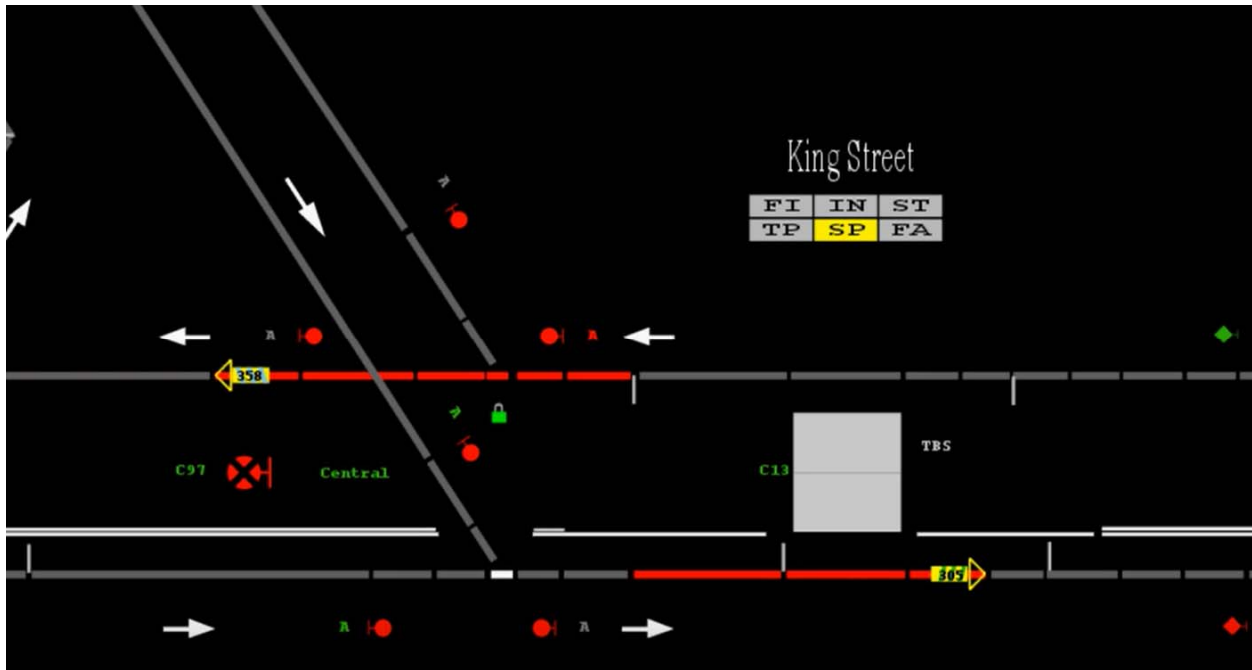
Diagram 3: Train ID 358 accepted the lead at the C97-06.

The probable cause of this Improper Movement of any Rail Vehicle on the Mainline or in a Yard, including Over Improperly Aligned Switch(es) event was due to human error on the part of the Train Operator and the Radio RTC. The Radio RTC and Train Operator failed to follow MSRPH General Rule 1.79. The Radio RTC thought the Train Operator stated their destination was Huntington Station and not Franconia Springfield but never gave the Train Operator a 100 percent word for word repeat back to verify the radio transmission. The Train Operator should not have taken any action since there was not a 100 percent repeat back from the Radio RTC. Also, the Train Operator failed to follow MSRPH Section 3 Operating Rule 3.76. The Train Operator failed to identify that the switch was properly aligned in the direction that they requested and verify the flashing lunar.

Corrective Action Code	Description
91959_SAFECAPS_ RTRA_001	Train Operator should undergo remedial training emphasizing procedures during the verification process after receiving a lunar alignment.
91959_SAFECAPS_ ROCC_002	Radio RTC should undergo remedial training emphasizing radio communication procedures.
91959_SAFECAPS_ SAFE_003	SAFE should work with ATC to explore alternative options for line junction signals to clearly indicate the intended route for the train operators.
91959_SAFECAPS_ ROCC_004	ROCC should provide for contingencies if one RTC becomes overburdened and cannot maintain their responsibilities, while maintaining the separate RTC roles.
