WMSC Commissioner Brief: W-0095 – Derailment – Arlington Cemetery Station – March 26, 2021

FINAL REPORT OF INVESTIGATION A&I E21122

Arlington Cemetery Station – Derailment

March 26, 2021

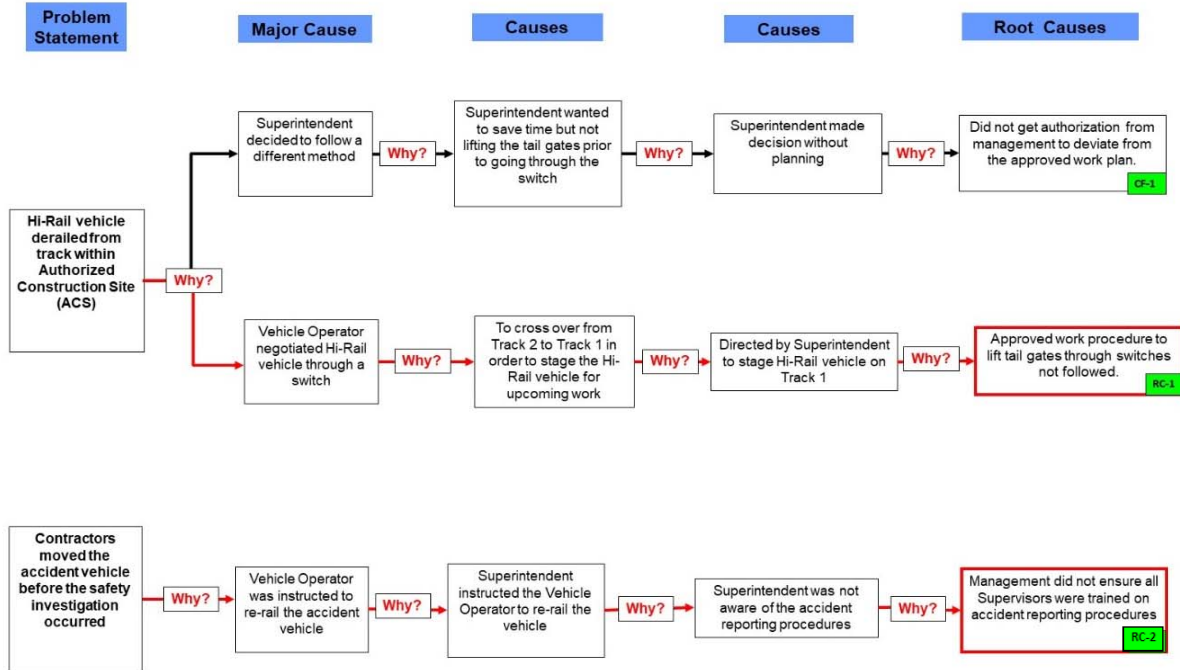
Appendix A - Root Cause Analysis

The derailment's primary probable cause was the failure to follow the approved work procedure by not lifting the carts' tailgates before the Vehicle Operator moved the Hi-Rail Vehicle. Contributing to the derailment was improper decision-making caused by the Superintendent not consulting with management before changing the work procedure. An additional finding was discovered upon investigating this accident which revealed that appropriate accident reporting procedures were not followed. The incident vehicle was re-railed prior to a safety investigation being conducted.

Corrective Action Code	Description	Responsible Party	Due Date
92529_SAFE CAPS_PICO_ 001	(RC-1, CF-1) Office of Capital Delivery - Project Implementation and Construction (PICO) will ensure Kiewit Management conducts a safety stand-down/ lessons learned sessions for equipment operators focusing on proper procedures for Hi-Rail Vehicle movements.	CAPD SRC	5/1/2021
92529_SAFE CAPS_PICO_ 002	(RC-2) PICO will ensure Kiewit Management removes contractor/subcontractor personnel from service for safety incident-related post-incident testing and holds them off until testing results are received.	CAPD SRC	7/1/2021

92529_SAFE CAPS_PICO_ 003	(RC-2) PICO will ensure Kiewit Management informs all contractor/subcontractor personnel of the investigation content provided in SB#20-12 : Safety Investigation Roles and Responsibilities.	CAPD SRC	7/1/2021
---------------------------------	---	----------	----------

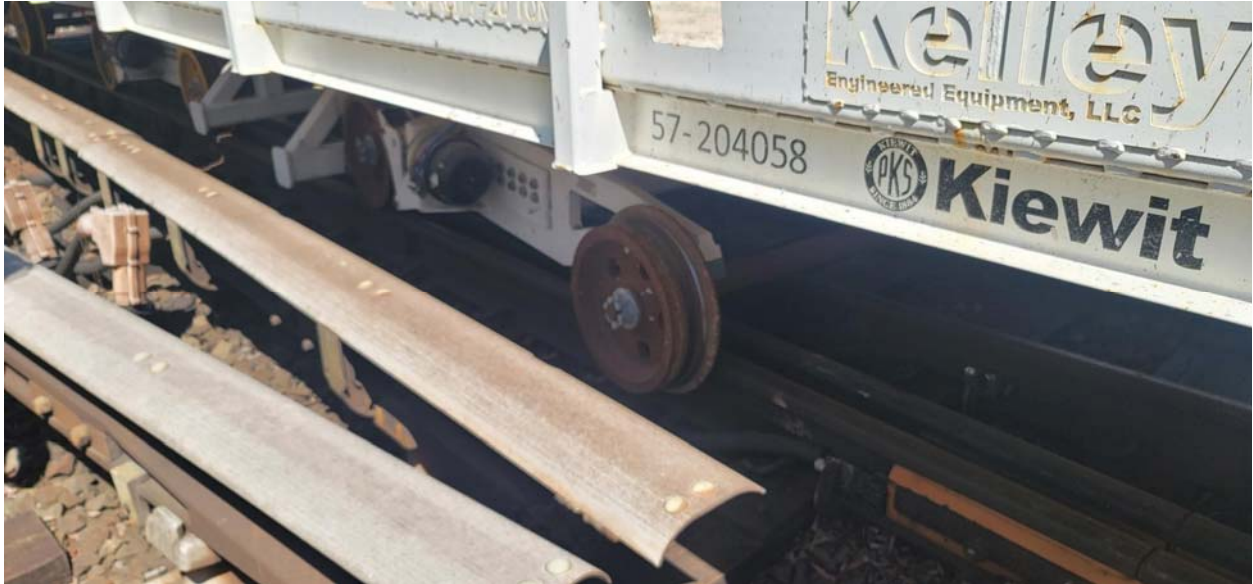
Photo 1: Wheel of flatcar derailed from the track.

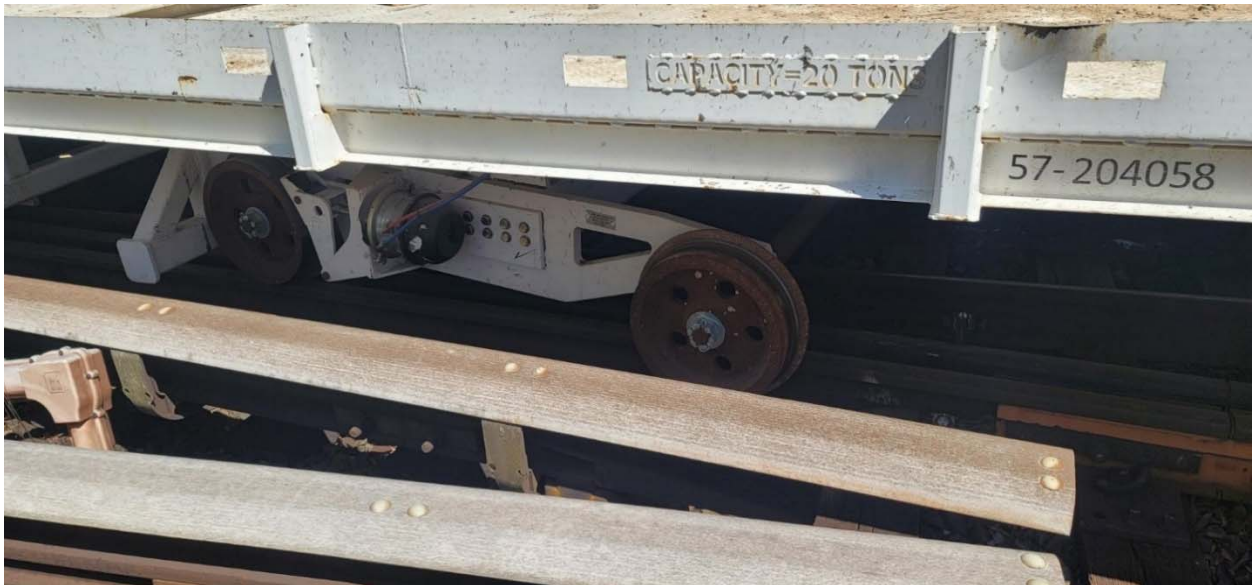
Photo 2: Wheel of flatcar derailed from the track.

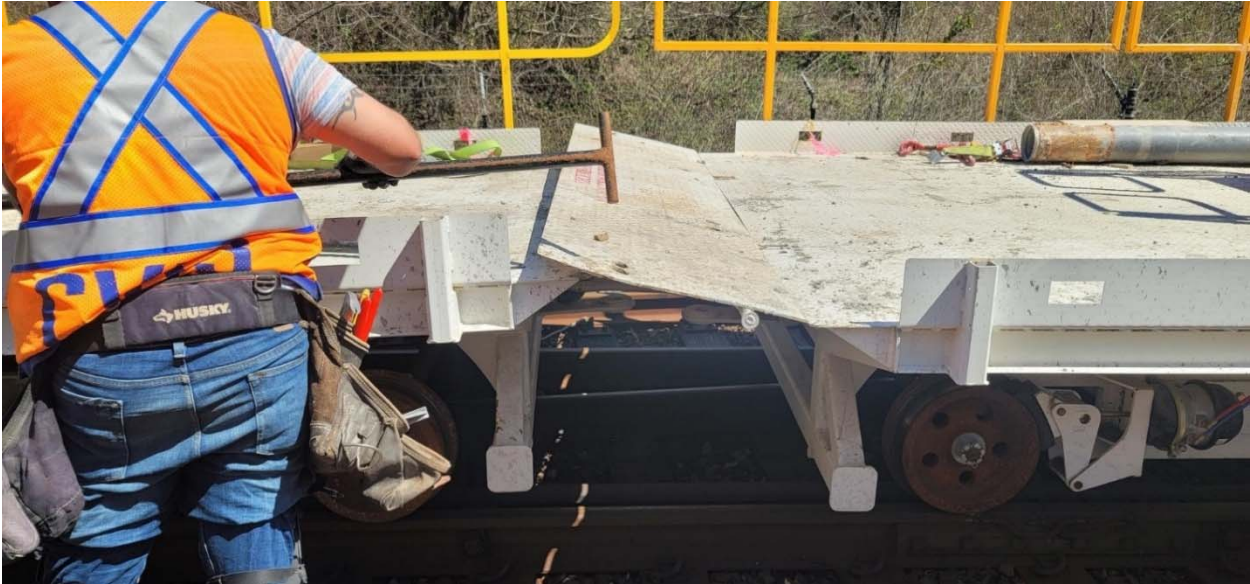
Photo 3: Flatcars with the tailgate down. Flatcar tailgates were in this position while traversing the switch from Track 2 to Track 1.

- Kiewit immediately halted work operations.
- Kiewit lifted Tailgates on all carts.

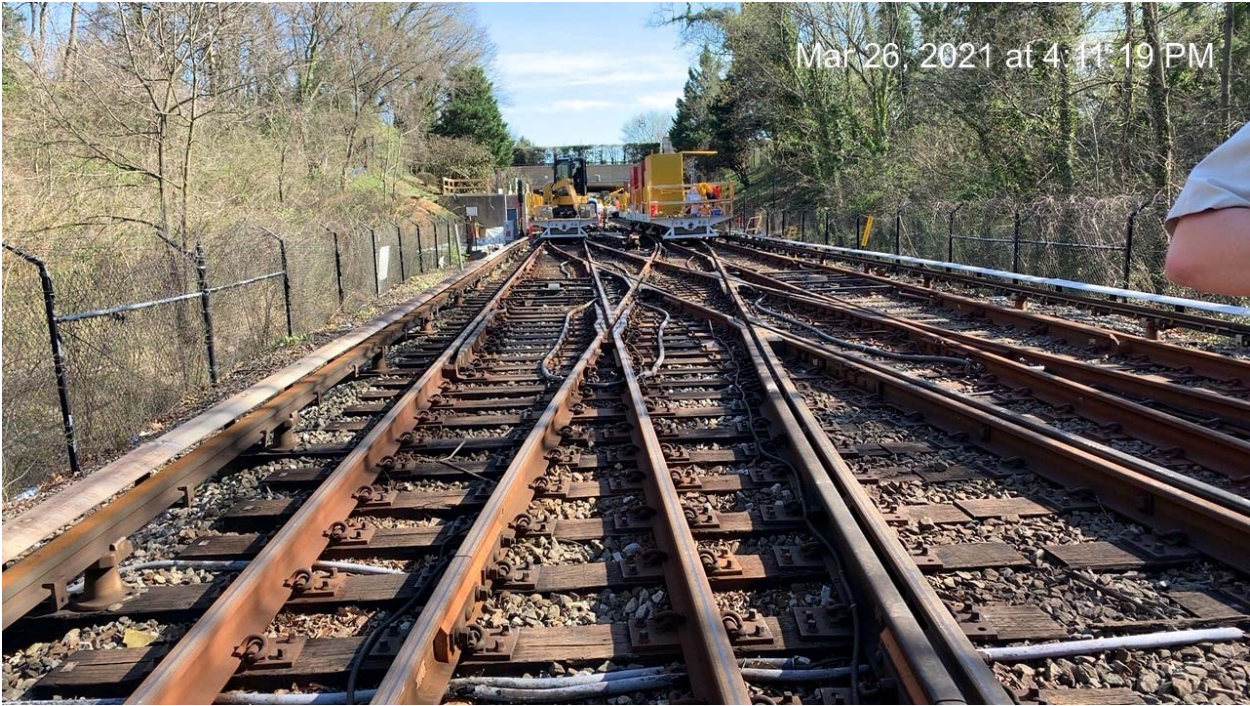
Photo 4: Switch located near Arlington Cemetery Station.

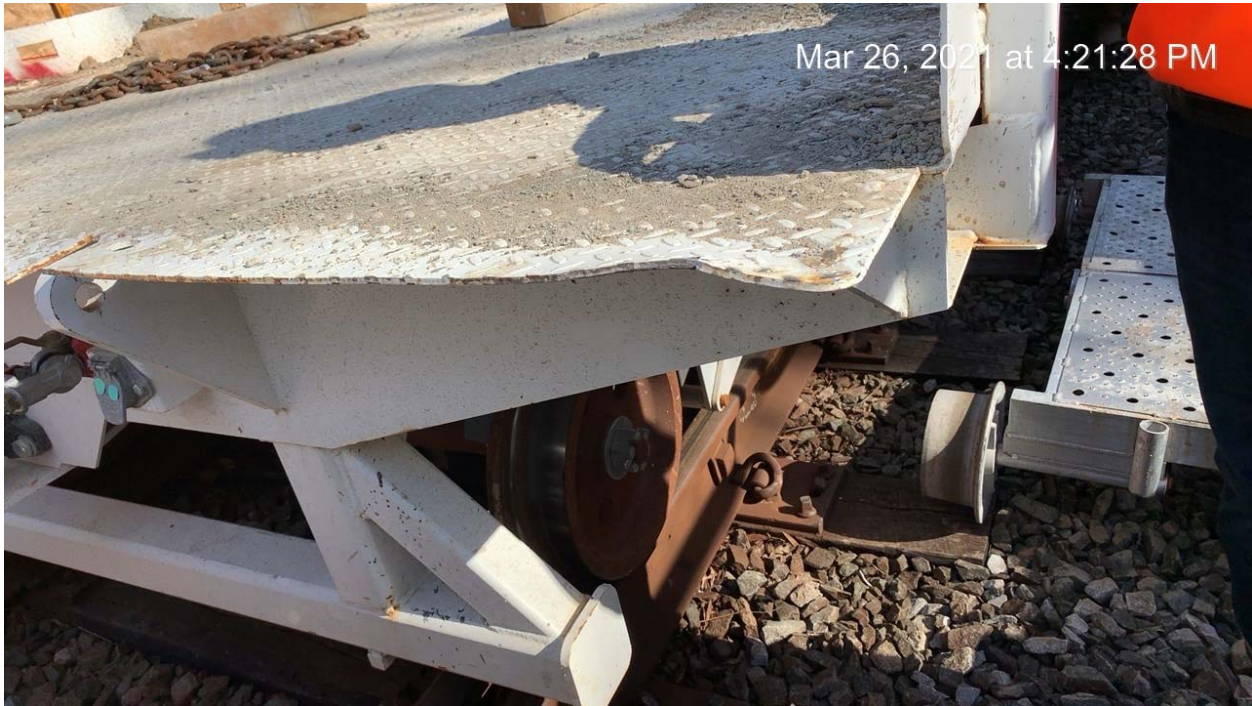
Photo 5: Damage to the tailgate as the result of the flatcar derailing. Total damages are currently pending.

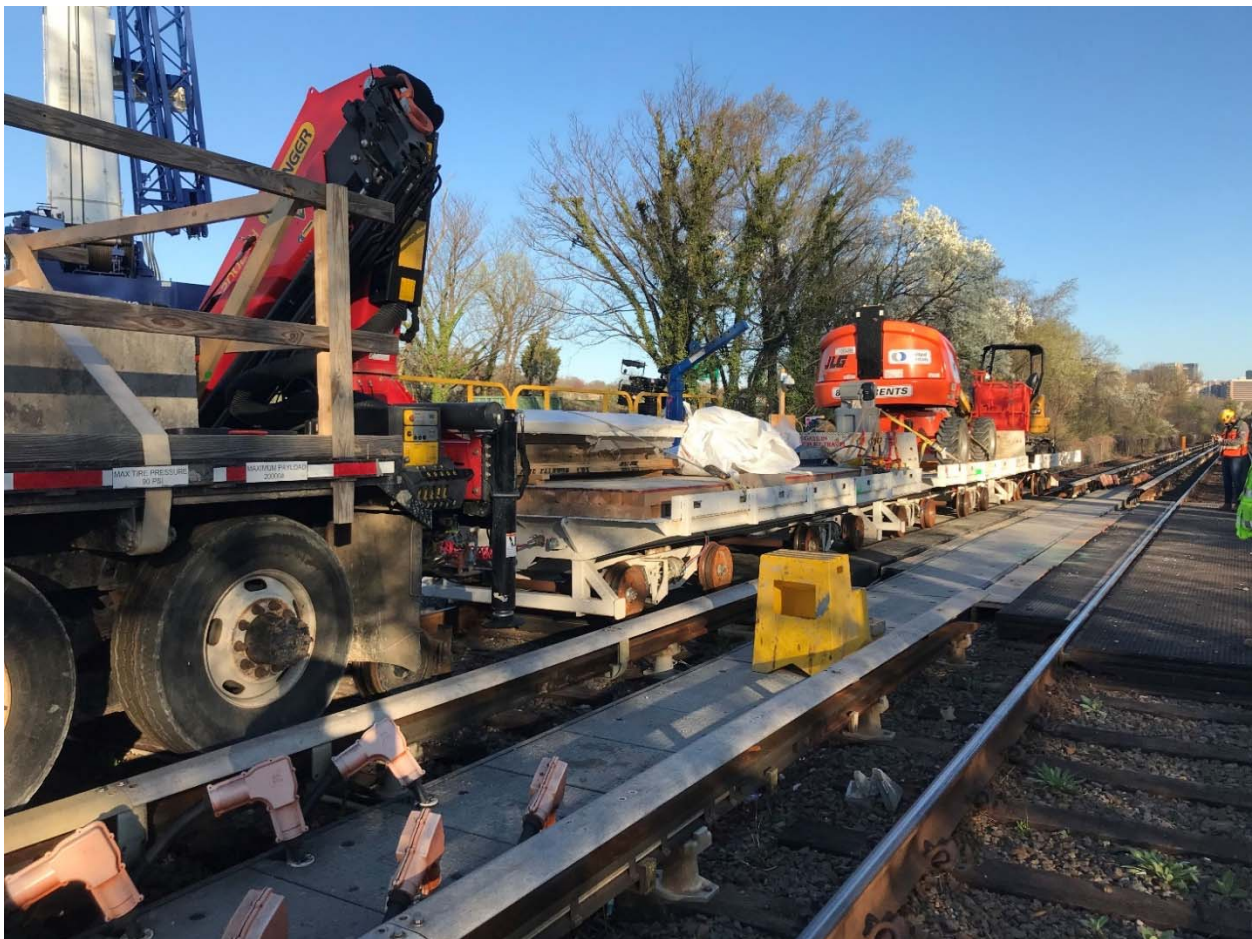
Photo 6: View of the consist.
