WMSC Commissioner Brief: W-0097 – Serious Injury – Potomac Yard Station construction site – February 14, 2021

FINAL REPORT OF INVESTIGATION A&I E21068

Date of Event:	2/14/2021
Type of Event:	Serious Injury
Incident Time:	15:34 hours.
Location:	Potomac Yard Station Construction Site, Chain Marker (CM) C1-479+40
Time and How received by SAFE:	16:00 hours SAFE On-call Phone
WMSC Notification Time:	17:38 hours
Rail Vehicle:	None
Injuries:	Fractured left femur and left hip
Damage:	None
SMS I/A Incident Number:	20210214#91841

Potomac Yard Station
Serious Injury
February 14, 2021

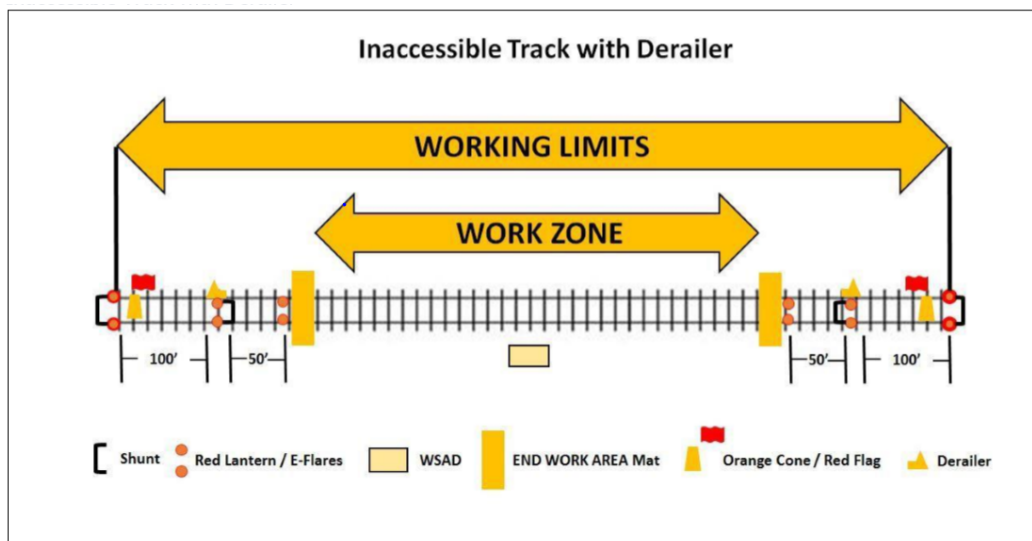
Diagram 1 – IT setup with derailleurs.

The RWIC had a Red Tag Power Outage scheduled in GOTRS under IT, RWP. The assigned RWIC utilized detailers in their specific working limits as their physical barrier to render the track inaccessible to rail vehicle movement into the working limits. The RWIC followed procedures to establish IT with detailers per the Metrorail Safety Rules and Procedures Handbook (MSRPH) RWP, 5.13.8. Inaccessible Track (IT).

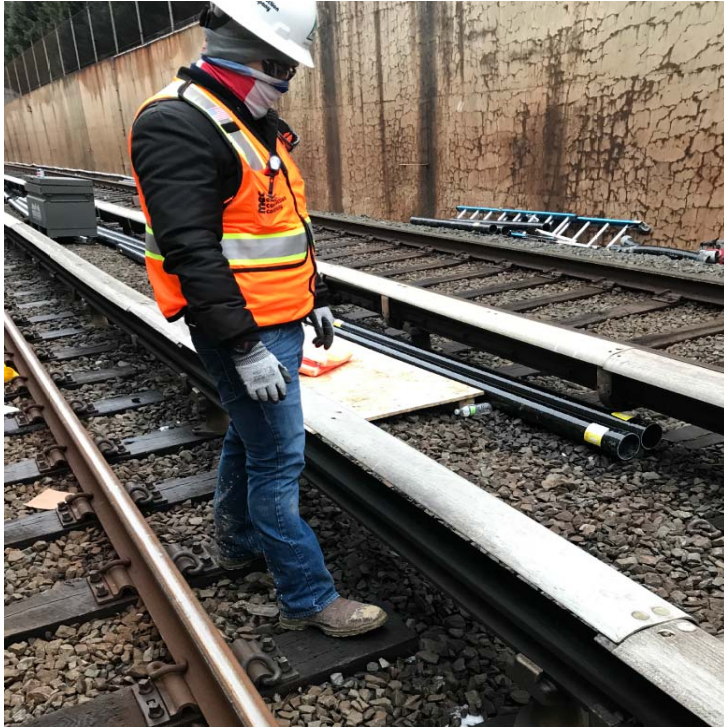
Figure 1 – Reportedly, the Injured Contractor was located at CM 479+40 and was in the process of stepping over the third rail and the adjacent running rail when crossing over from Track 1 to Track 2.

The Mass Electric Construction contractor reported to the RWIC and the Emergency Medical Services personnel of the Alexandria Fire Department that while at CM 479+40 on Track 1, they stepped over the third rail to enter Track 2 and subsequently fell in pain. The Injured Contractor did not lose consciousness and was fully alert. The RWIC indicated the Injured Contractor's supervisor stated this type of incident happened to the Injured Contractor approximately three times before. Once the responding Emergency Medical Services personnel of the Alexandria Fire Department arrived, they were briefed before entering the roadway. The Emergency Medical Services personnel boarded a Prime Mover and were transported to the scene using the Prime Mover and performed their assessment. The Injured Contractor complained of severe pain, and the Emergency Medical Services personnel administered pain medication to the Injured Contractor. Emergency Medical Services personnel secured the Injured Contractor on a Backboard Stretcher and safely placed them on the Prime Mover. The Emergency Medical Services personnel and the Injured Contractor were transported back to Potomac Yard Station Construction Site using the Prime Mover and safely exited the unit. Emergency Medical Services personnel of the Alexandria Fire Department then transported the Injured Contractor to Inova Alexandria Hospital for further medical evaluation.

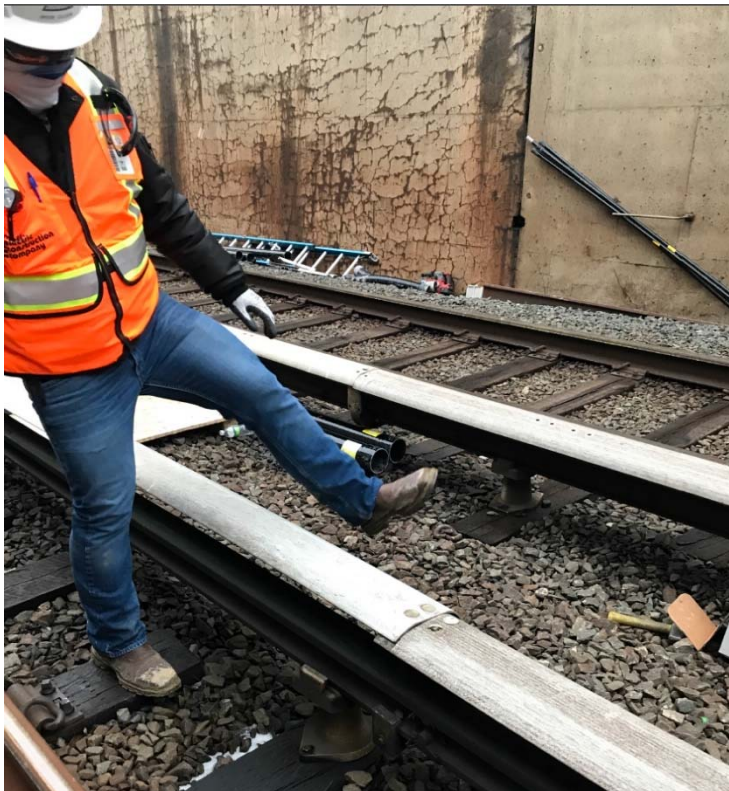
Figure 2 – The Injured Contractor stepped over the third rail leading with their left leg.

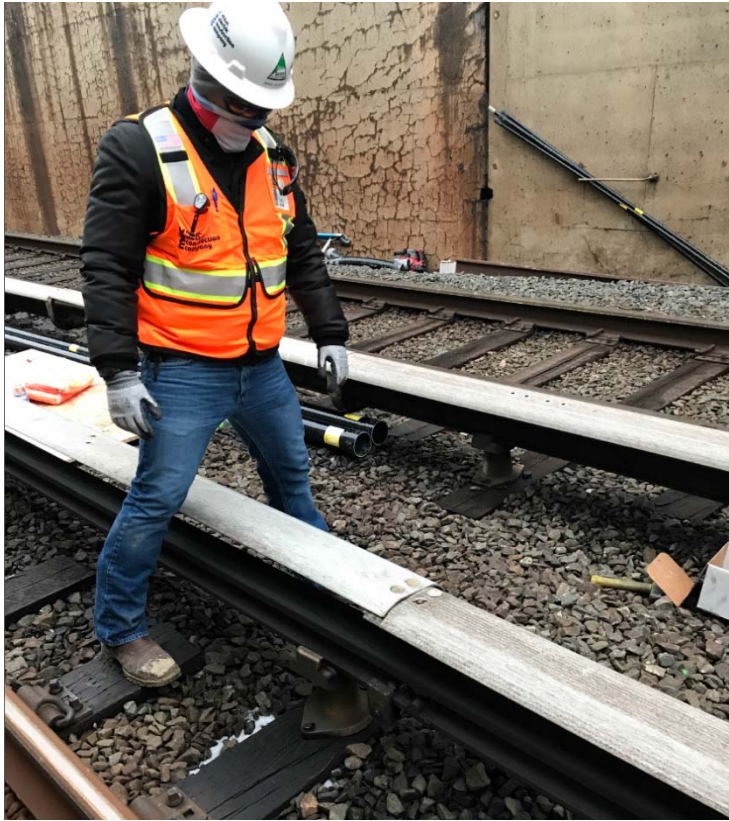
Figure 3 – The Injured Contractor assumed a braced position with firm footing, straddling the third rail.

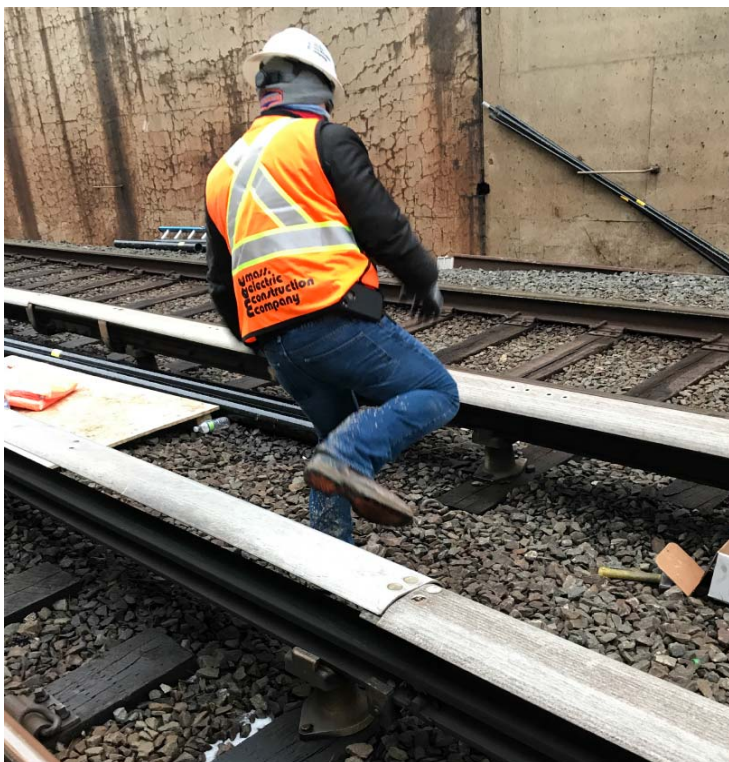
Figure 4 – The Injured Contractor then stepped over the third rail and pivoted on their planted left leg, and subsequently fell between both of the third rails.

The probable cause of this serious injury incident, based by the treating medical staff's assessment, was a pathological condition. The Contractor suffered femur and hip fracture due to a preexisting medical condition. Additionally, Mass Electric Construction reported that fatigue and overexertion might have contributed to the Contractor's serious injury. However, SAFE was unable to determine whether work environment, fatigue and overexertion contributed to the Contractor's injury.

Corrective Action Code	Description
91841_SAFECAPS_TRST_001	Review the option of requiring confirmation that contractors have completed appropriate medical assessments related to the job's essential physical requirements before allowing work to be done on the Authority's property. This certification is meant to help determine whether an employee can safely perform the job's requirements and help eliminate or mitigate any risks associated with allowing a contractor, who may not meet the physical requirements for duty, fulfilling their job requirements.
91841_SAFECAPS_SAFE_002	Conduct site visits and perform safety observations to identify any safety hazards of employees not safely completing the job's requirements and developing strategies to reduce their risk.

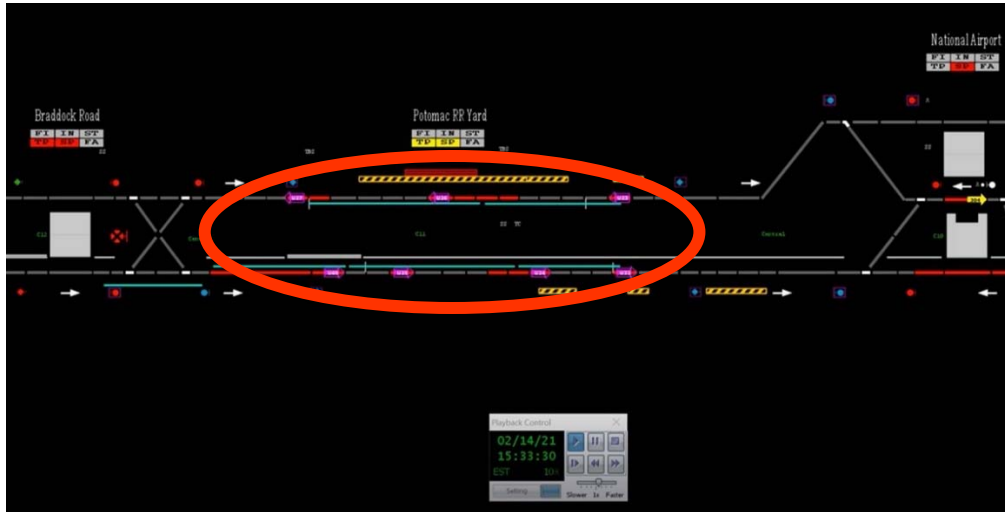
Diagram 2 - At 15:33 hours, the AIMS playback revealed the power display shows the third rail power was de-energized at Potomac Yard Station, Track 1, and Track 2 before the reported incident.

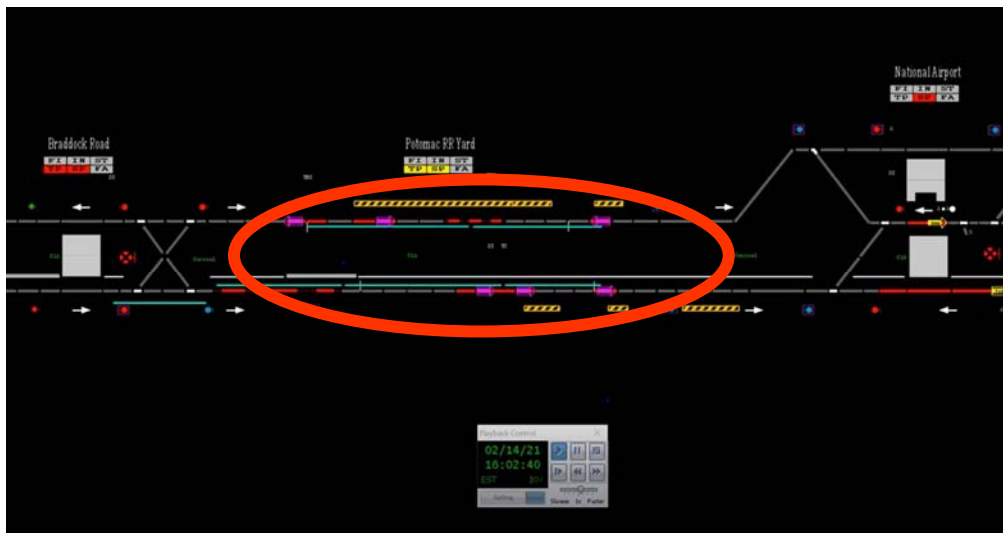
Diagram 3 - At 16:02 hours, the AIMS playback revealed, the power display indicated third rail power was de-energized at Potomac Yard Station, Track 1, and Track 2 before the fire department arriving on the scene and entering the roadway.

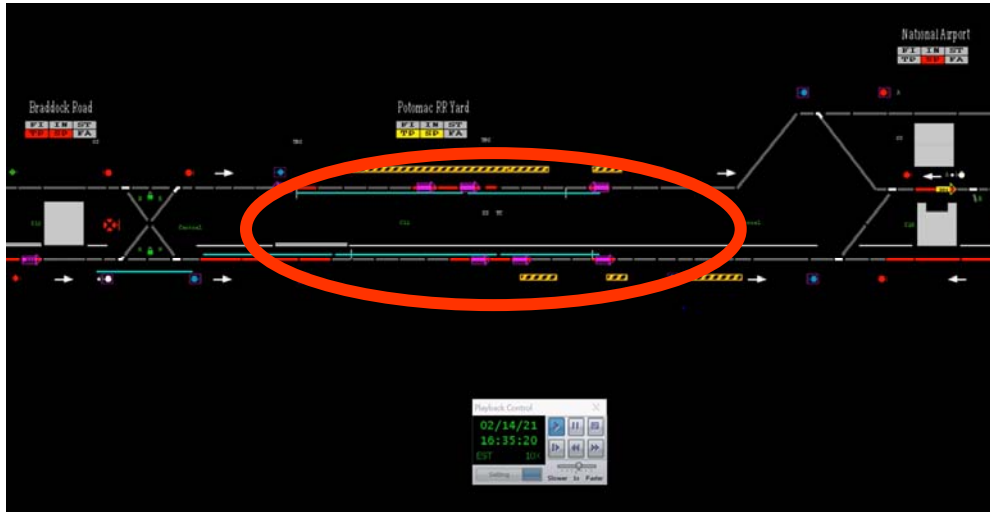
Diagram 4 - At 16:35 hours, the AIMS playback revealed that the power display indicated third rail power being de-energized at Potomac Yard Station, Track 1, and Track 2. AFD departed the scene and transported the Injured Contractor to Inova Alexandria Hospital for further medical evaluation.
