**WMSC Commissioner Brief: W-0098 – Improper Roadway Worker Protection – L’Enfant Plaza Station – January 25, 2021**

FINAL REPORT OF INVESTIGATION A&I E21029

Date of Event:	1/25/2021
Type of Event:	Improper Roadway Worker Protection
Incident Time:	02:35 hours
Location:	L'Enfant Plaza Station, Track 2
Time and How received by SAFE:	03:36 hours SAFE On-call Phone
WMSC Notification Time:	04:28 hours
Rail Vehicle:	None
Injuries:	None
Damage:	None
SMS I/A Incident Number:	20210125#91529

L'Enfant Plaza Station
Improper Roadway Worker Protection
January 25, 2021

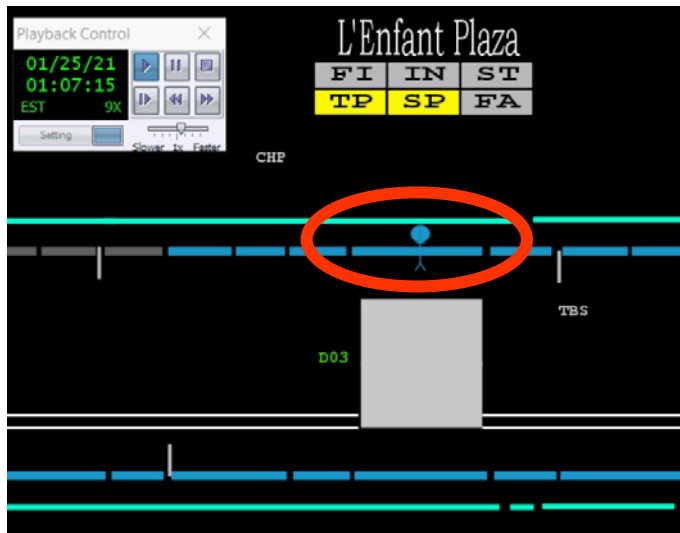
Diagram 1 - At 01:07 hours, the AIMS playback reflected third rail power was de-energized, blue block, and human form status were in place before the RWIC entered the roadway to hot stick and confirm third rail power was de-energized at L'Enfant Plaza, Tracks 2.

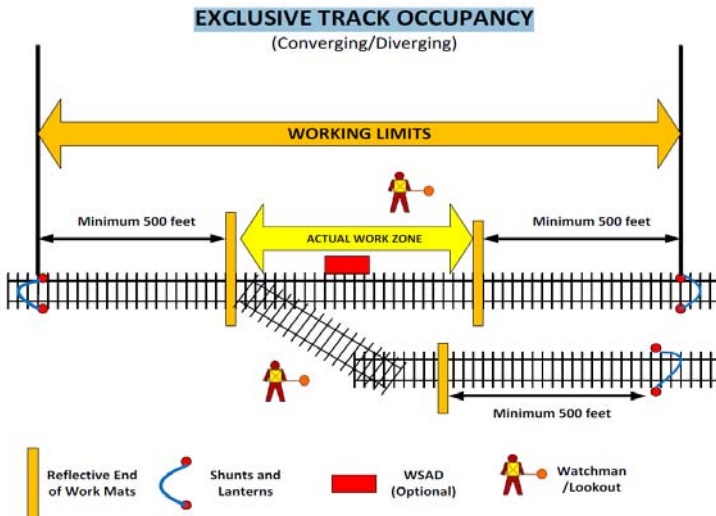
The RWIC only installed shunts and e-flares, which is not in compliance with the Metrorail Safety Rules and Procedures Handbook (MSRPH) RWP, as detailed in section 5.13.7. An ETO RWP setup requires shunts to be located at 500 feet outside of each end of the working zone, red lanterns or e-flares, "END Work AREA" mats, and WSADS.

Diagram 2 – Correct ETO protection diagram.

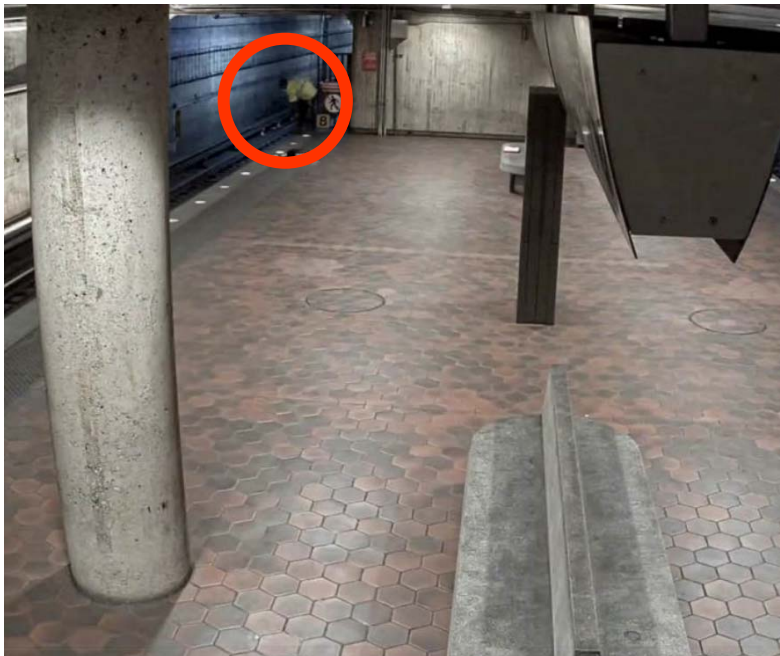
Figure 1 - Based on the CCTV, at 01:22 hours, the RWIC jumped from the station platform without using an appropriate means of descent.

- Based on CCTV footage, the RWIC jumped from the station platforms without using an appropriate means of descent. This action was not in compliance with MSRPH, 4.186.

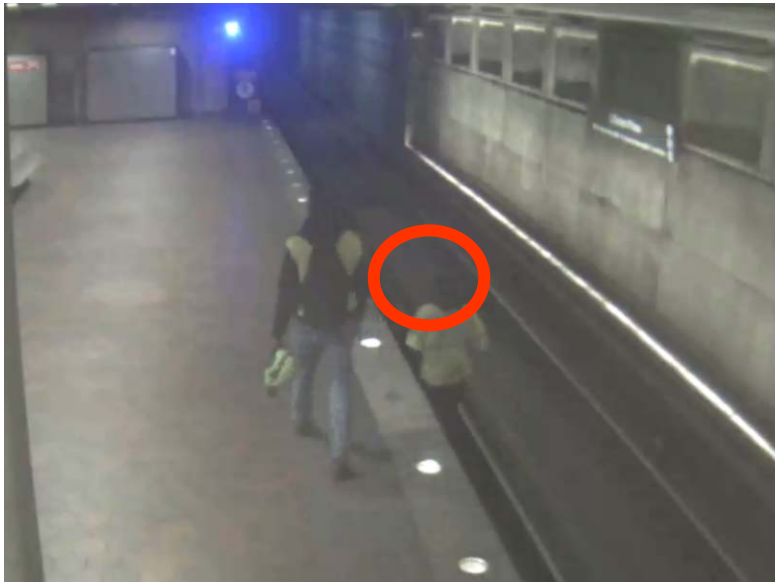
Figure 2 - Based on the CCTV, at 01:33 hours, the RWIC was not wearing a hardhat while installing safety equipment on WMATA's roadway.

- Laboratory results revealed that the RWIC was not in compliance with WMATA's Drug and Alcohol policy.
- The RWIC was identified on CCTV as not wearing a hardhat while installing safety equipment on WMATA's roadway. This action was not in compliance with MSRPH 5.11.

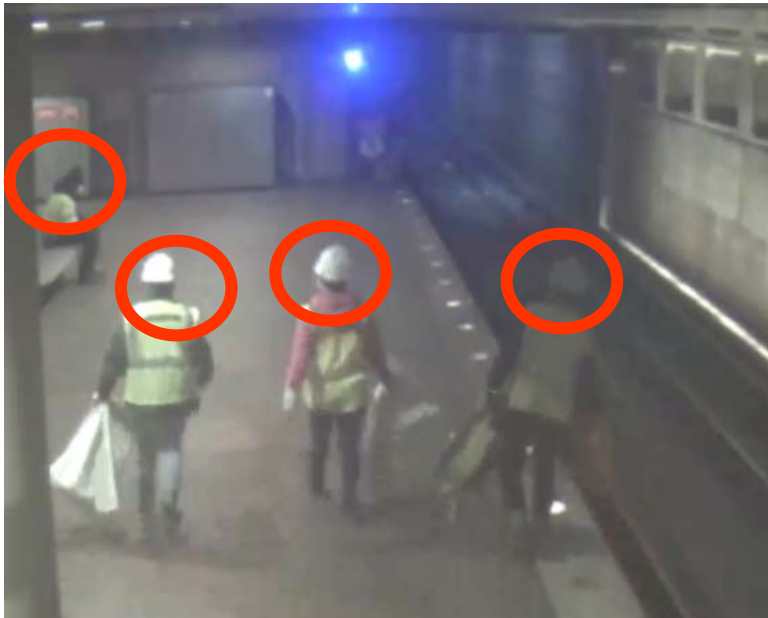
Figure 3 - Based on the CCTV, at 02:34 hours, the RWIC is sitting on the bench while the three contractors are walking over to be escorted by the RWIC to enter the roadway wearing yellow vests without an X-stripe pattern on the back.

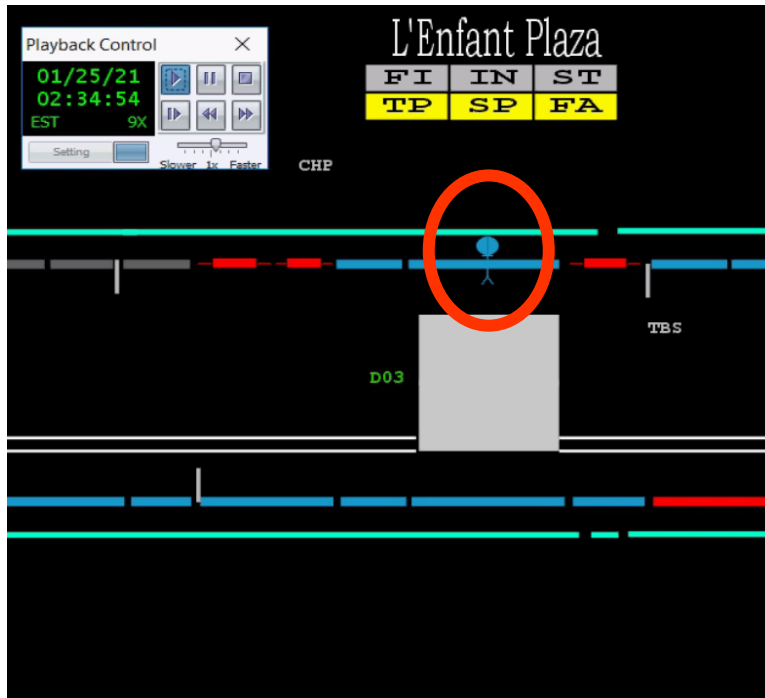
Diagram 3 - At 02:34 hours, the AIMS playback shows prohibit exits, block calls, cancellation of automatic signals, blue block, and human form status are in place while the before the RWIC and contractors entered the roadway to clean up the debris.

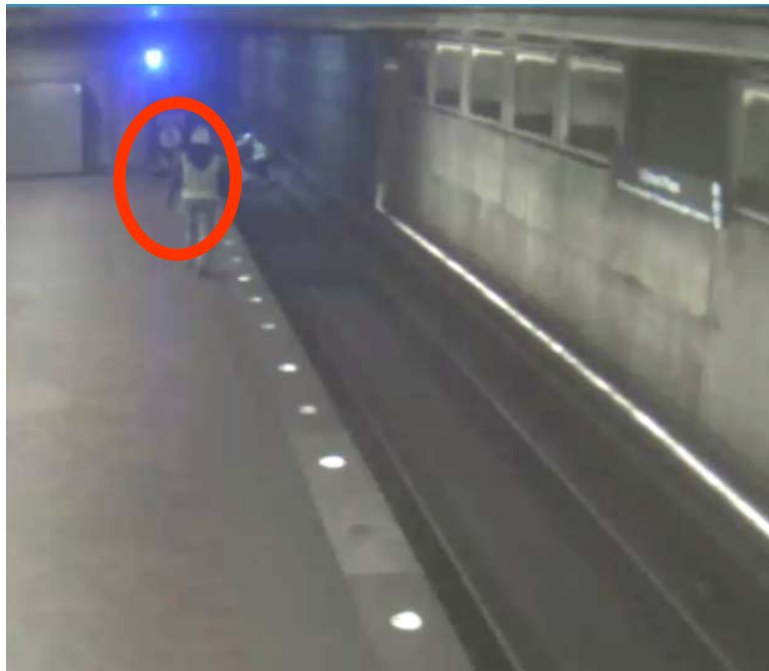
Figure 4 - Based on the CCTV, at 02:35 hours, the RWIC and three contractors entered the roadway to engage in work activities without being RWP trained and qualified. Additionally, the PLNT Craft Supervisor arrived on the scene and walked beyond the station's end-gate while the three contractors were retrieving debris from the roadway.

- The RWIC allowed three contractors to enter the roadway to engage in work activities without being RWP trained and qualified. This action was not in compliance with MSRPH 5.2.1 RWP Cardinal Rules, *"All personnel, regardless of rank or title, shall be RWP trained and qualified before entering the Authority's roadway."*

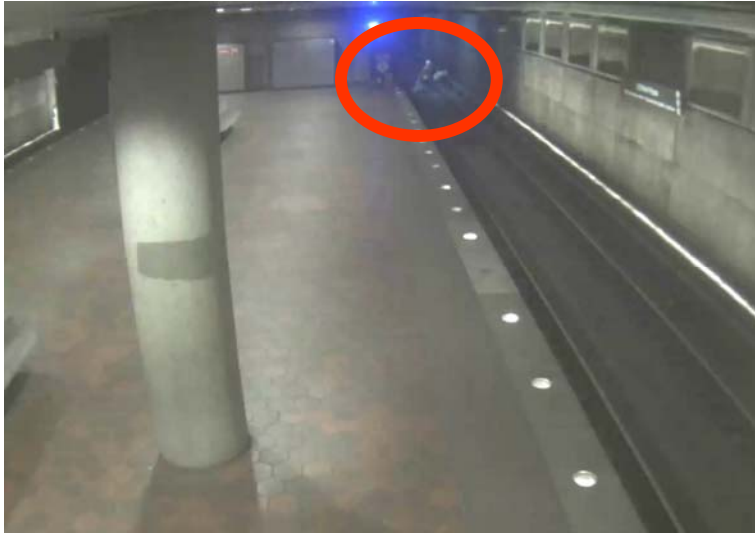
Figure 5 - Based on the CCTV, at 02:40 hours, the RWIC and three contractors were still retrieving the roadway's debris working close to the third rail.

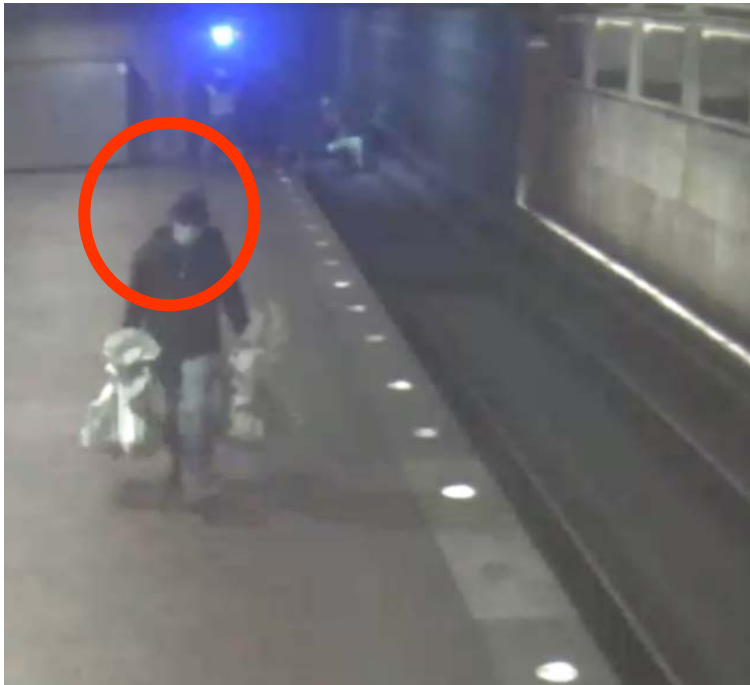
Figure 6 - Based on the CCTV, at 02:41 hours, the fourth contractor never entered the roadway but removed the bags filled with the debris handed to them by the other contractors. CCTV shows that the fourth contractor was not adequately outfitted for work.

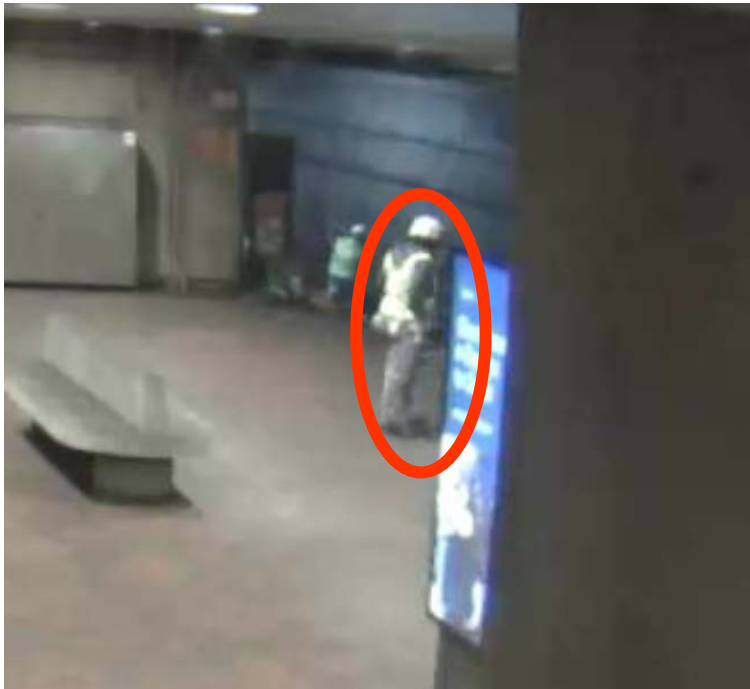
Figure 7 - Based on the CCTV, at 02:45 hours, the PLNT Craft Supervisor observed RWIC and three contractors cleaning up the roadway's debris.

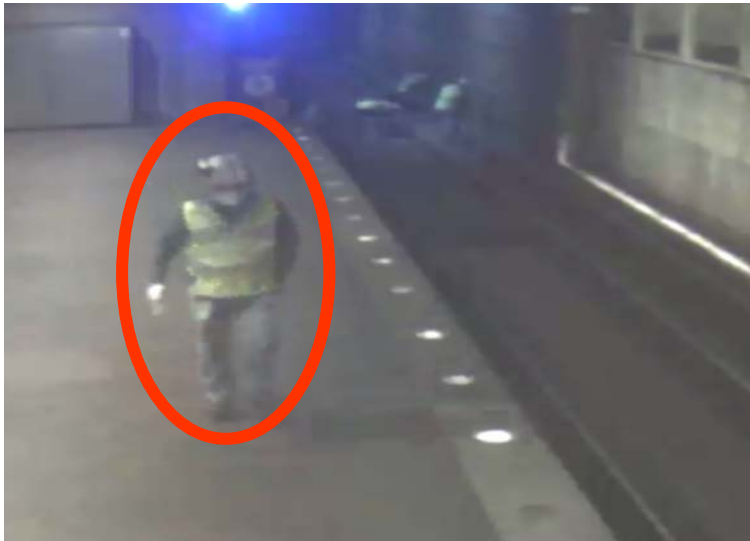
Figure 8 - Based on the CCTV, at 02:47 hours, the PLNT Craft Supervisor departed the work area.

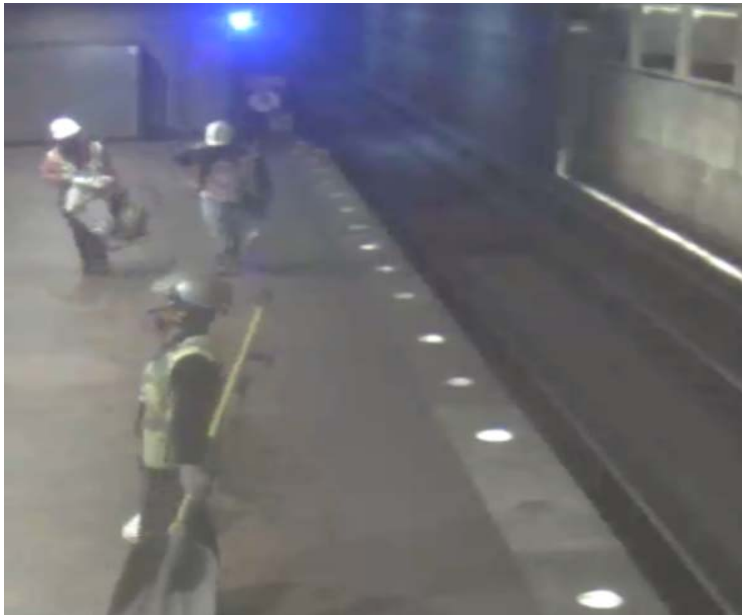
Figure 9 - Based on the CCTV, at 02:54 hours, the RWIC and the three contractors cleared the roadway.

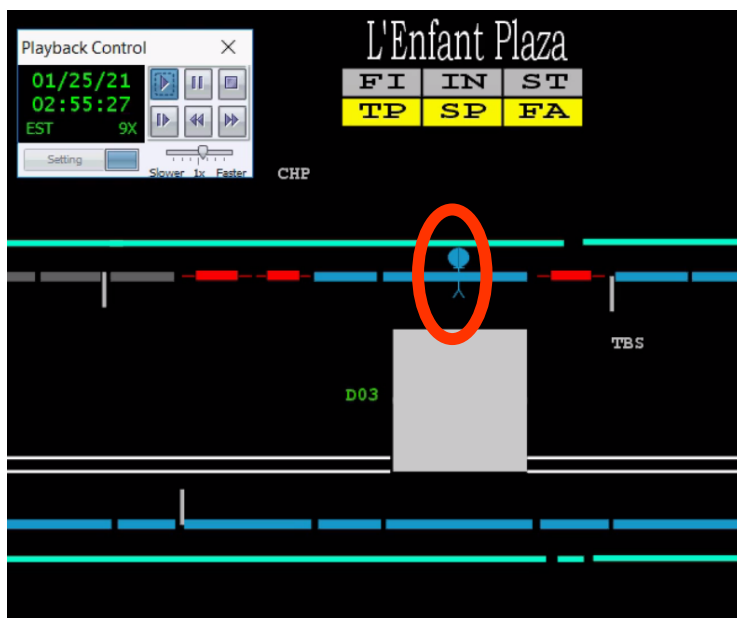
Diagram 3 - At 02:55 hours, the AIMS shows prohibit exits, block calls, cancellation of automatic signals, blue block, and human form status still in place after the RWIC and contractors cleared the roadway.
