**WMSC Commissioner Brief: W-0101 – Collision With Customer – Suitland Station – March 13, 2021**

Prepared for Washington Metrorail Safety Commission meeting on August 3, 2021

FINAL REPORT OF INVESTIGATION A&I E21108

Suitland Station
Collision
March 13, 2021

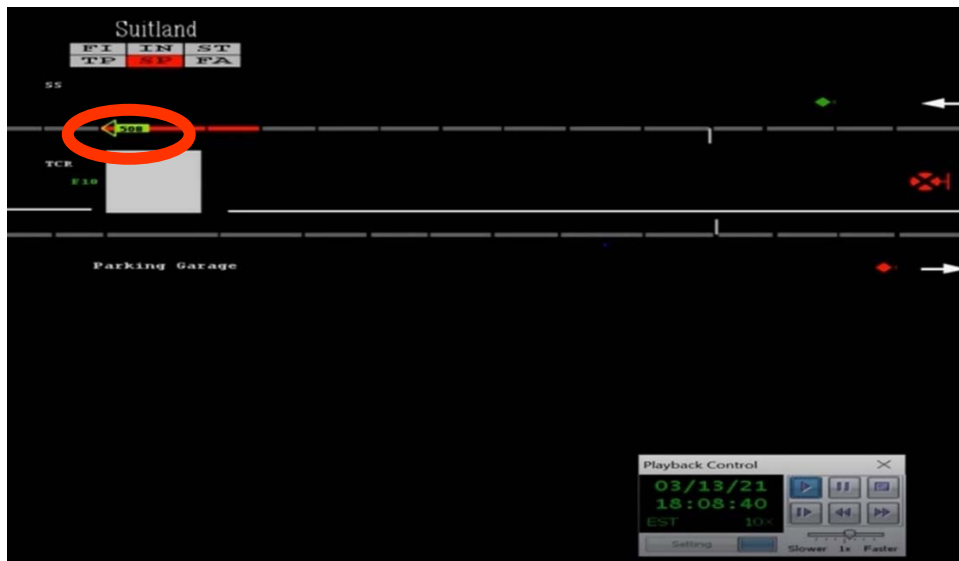
Diagram 1 - Based on the AIMS playback, Train ID 508 entered Suitland Station, Track 2, at 18:08:40 hours, and appears to be when they reported the person on the roadway per ARS.

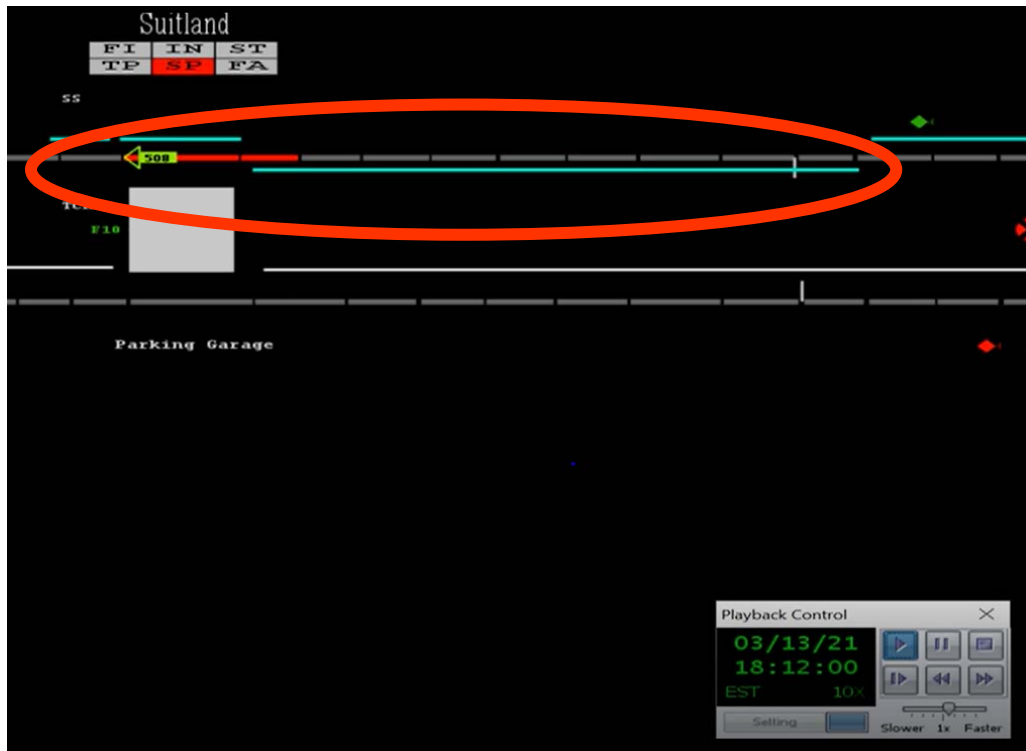
Diagram 2 - Based on the AIMS, the green symbol on the AIMS power display shows that the third rail power was subsequently de-energized at Suitland Station, Track 2, at 18:12:00 hours.

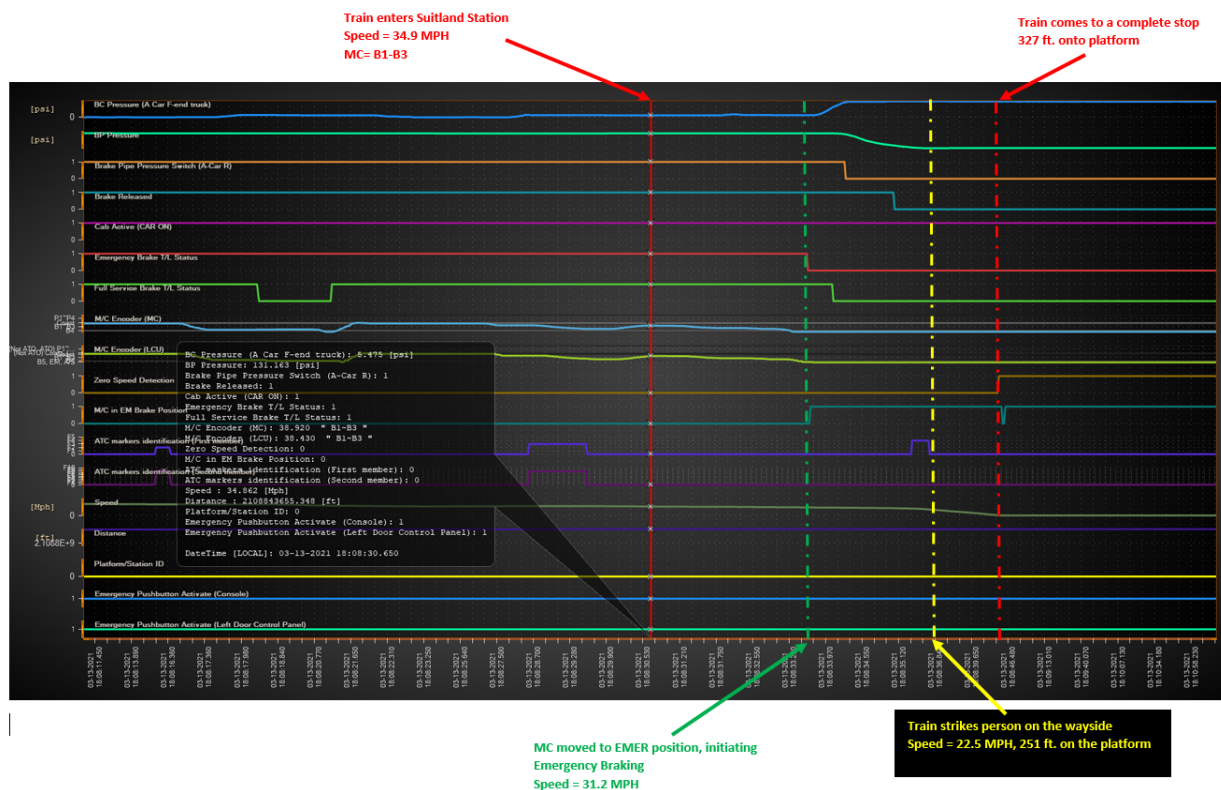
Diagram 3 - ER Graphical Analysis

TIME	Description
18:08:34.8 hrs.	The consist entered the Suitland Station, Track 2, traveling at 34.9 mph, with the master controller in a B1-B3 braking position.
18:08:37.3 hrs.	The consist master controller was moved to the B4 braking position, and the consist speed was 32 mph.
18:08:37.4 hrs.	The consist master controller was moved to the B5 braking position, and the consist speed was 31.7 mph.

18:08:37.7 hrs.	The consist master controller was moved to the EMERGENCY position, initiating emergency braking application; train speed was 31.2 mph and 140 feet onto the platform limits.
18:08:40.7 hrs.	The consist made contact with the person on the roadway; the consist speed was approximately 22.5 mph with the master controller in the EMERGENCY position and 251 feet onto Suitland Station platform limits.
18:08:47.1 hr.	The consist came to a complete stop 327 feet onto the Suitland Station platform limits.

The VMDS data does not show any anomalies with the railcar's operations contributing to this incident. All the subsystems' safety components such as Automatic Train Control (ATC), brakes, and propulsion acted as designed to bring the train to a complete stop.
