**WMSC Commissioner Brief: W-0102 – Collision With Customer – Shaw-Howard U Station – March 24, 2021**

**FINAL REPORT OF INVESTIGATION A&I E21117**

<b>Date of Event:</b>	3/24/2021
<b>Type of Event:</b>	Collision
<b>Incident Time:</b>	19:53 hours.
<b>Location:</b>	Shaw-Howard U Station, Track 2.
<b>Time and How received by SAFE:</b>	19:59 hours. SAFE On-call Phone
<b>WMSC Notification Time:</b>	21:21 hours.
<b>Rail Vehicle:</b>	Train ID 509, [L7630-7631.7635-7634.7712-7713.7619-7618T]
<b>Injuries:</b>	Fatality
<b>Damage:</b>	Damaged Front Cowling on Lead Car 7630
<b>SMS I/A Incident Number:</b>	20210324#92450MX

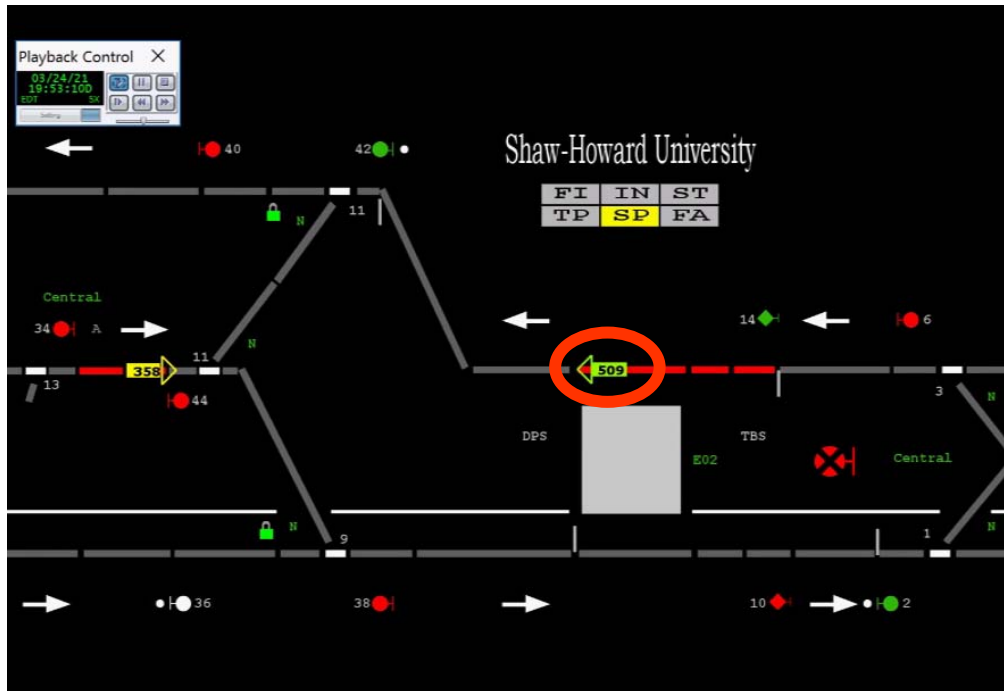
Diagram 1 - Based on the AIMS playback, Train ID 509 entered Shaw-Howard U Station, Track 2, at 19:53:10 hours, and appears to be when they reported the person on the roadway per ARS.

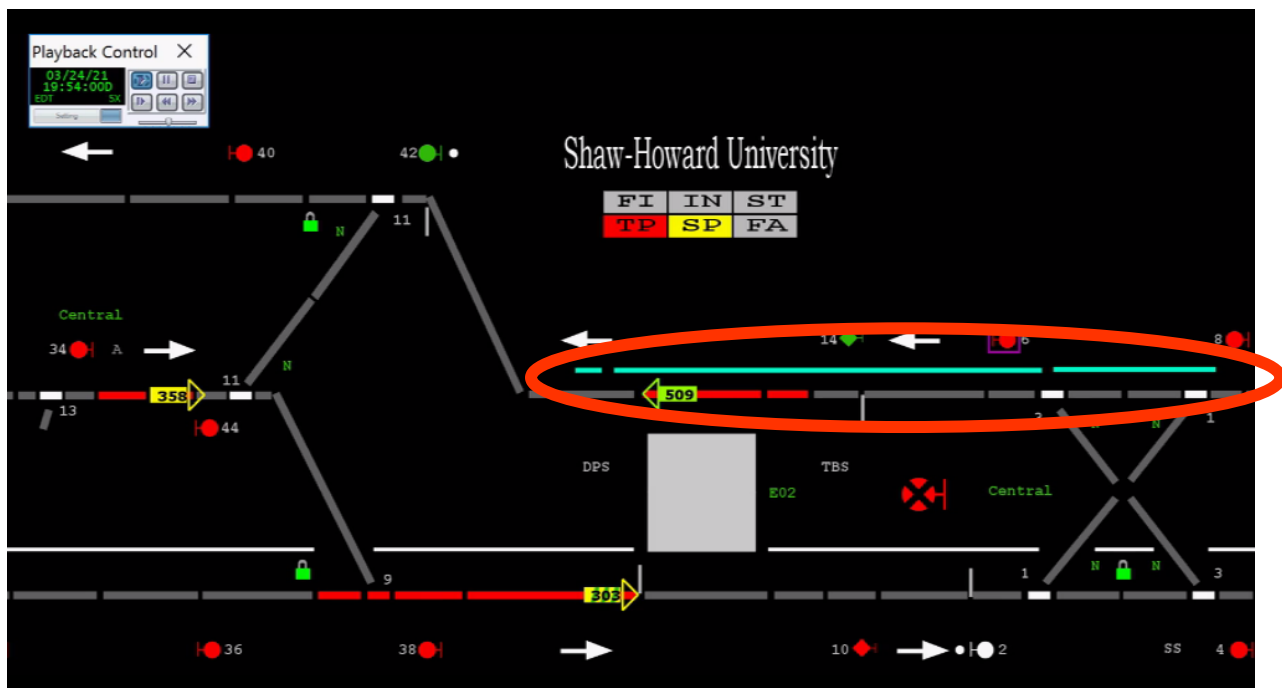
Diagram 2 - Based on the AIMS, the green symbol on the AIMS power display shows ROCC subsequently de-energized third rail power at Shaw-Howard U Station, Track 2 19:54:00 hours.

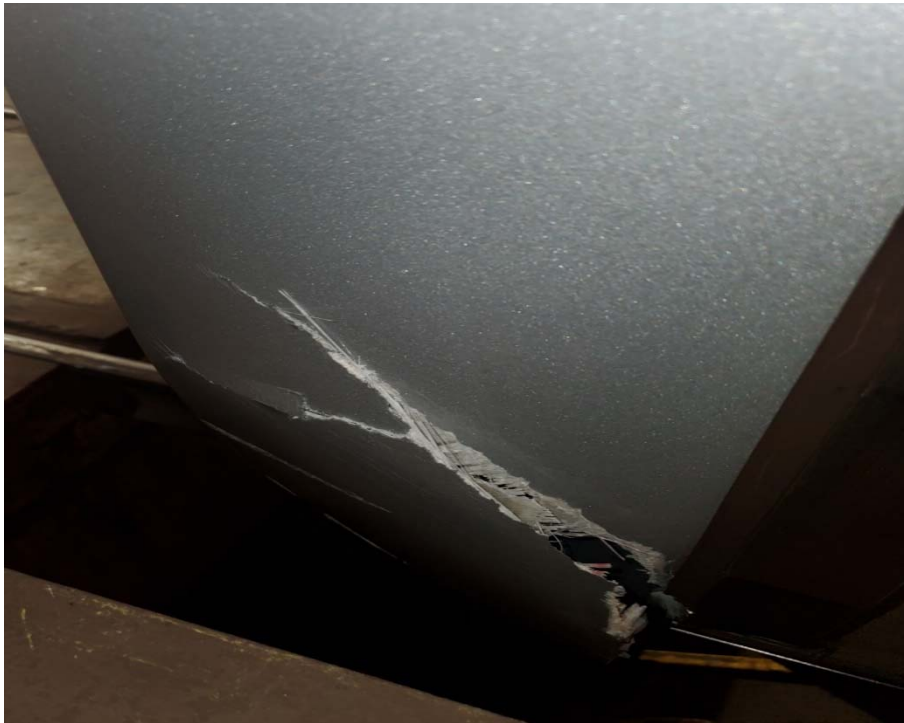
*Photo 1 – Damaged sustained to the front cowling on lead car 7630.*

Upon arrival at the scene, CMNT performed an on-site exterior and interior inspection of the affected consist and deemed the consist safe for rail vehicle movement in travel to Greenbelt Yard. CMNT personnel identified damage sustained to the front cowling on lead car 7630, which CMNT repaired. Additionally, CMNT performed an under-car cleaning and a post-incident inspection on the brake system, propulsion system, and master controller operational checks. CMNT found these subsystems worked as designed. CMNT did not identify any abnormal conditions that contributed to the collision event. See Appendix B.

Task IDs	
Task ID	
10	INSPECTED FOR BODY AND UNDER CAR DAMAGE. LEFT FRONT LOWER BONNET DAMAGED. NO OTHER DAMAGE FOUND.

- CMNT personnel identified damage sustained to the front cowling on lead car 7630, which CMNT repaired and painted car 7630. Additionally, CMNT performed an under-car cleaning and a post-incident inspection on the brake system, propulsion system, and master controller operational checks. CMNT found these subsystems worked as designed.

30 REPAIR FRONT END FIBERGLASS AND PREPARE; PAINT TO MATCH

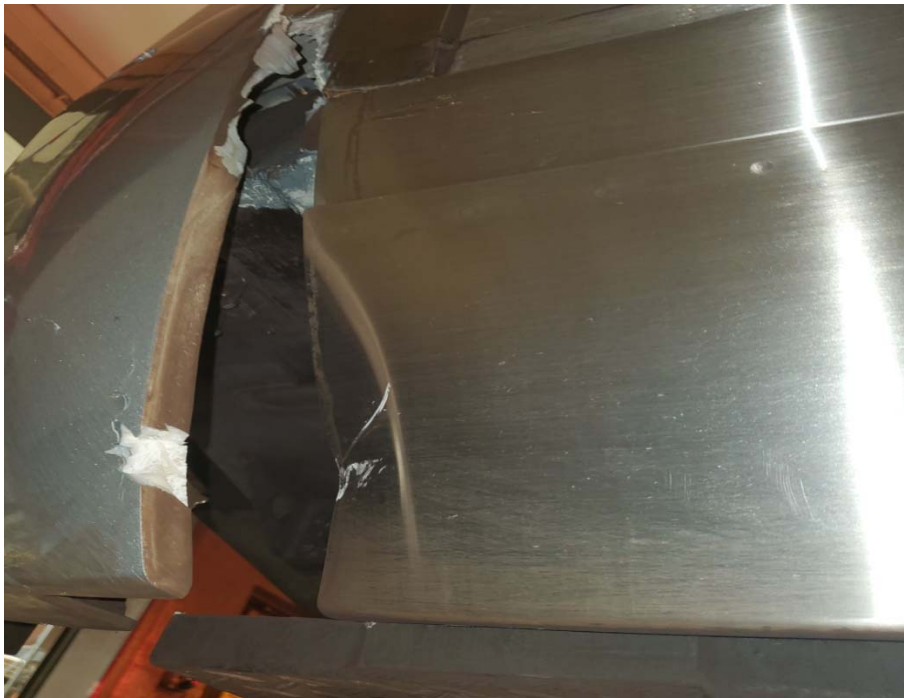
*Photo 2 – Damaged sustained to the front cowling on lead car 7630.*

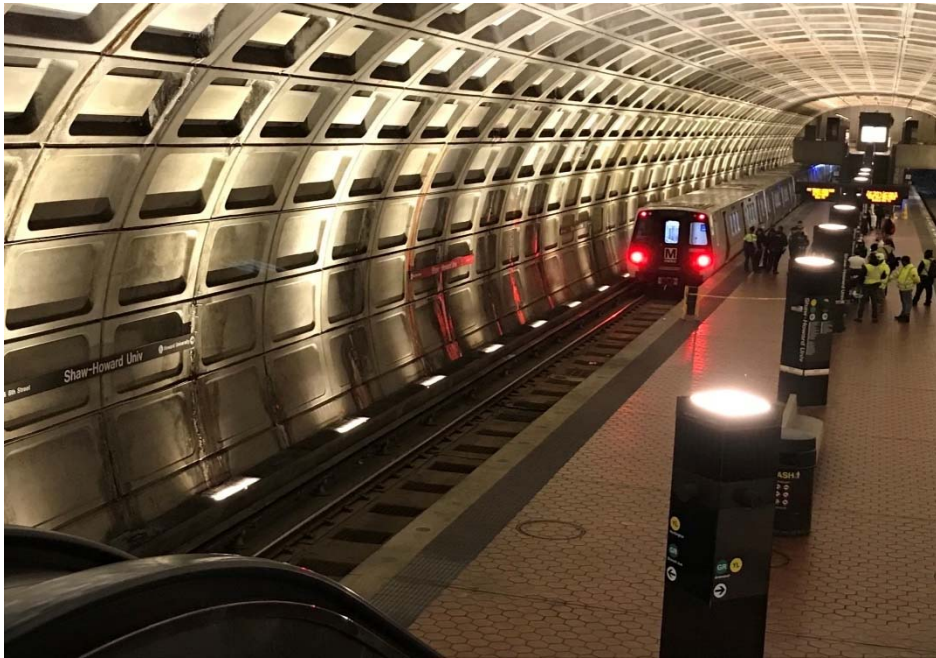
Photo 3 – Shaw-Howard U Station, Track 2 incident scene.

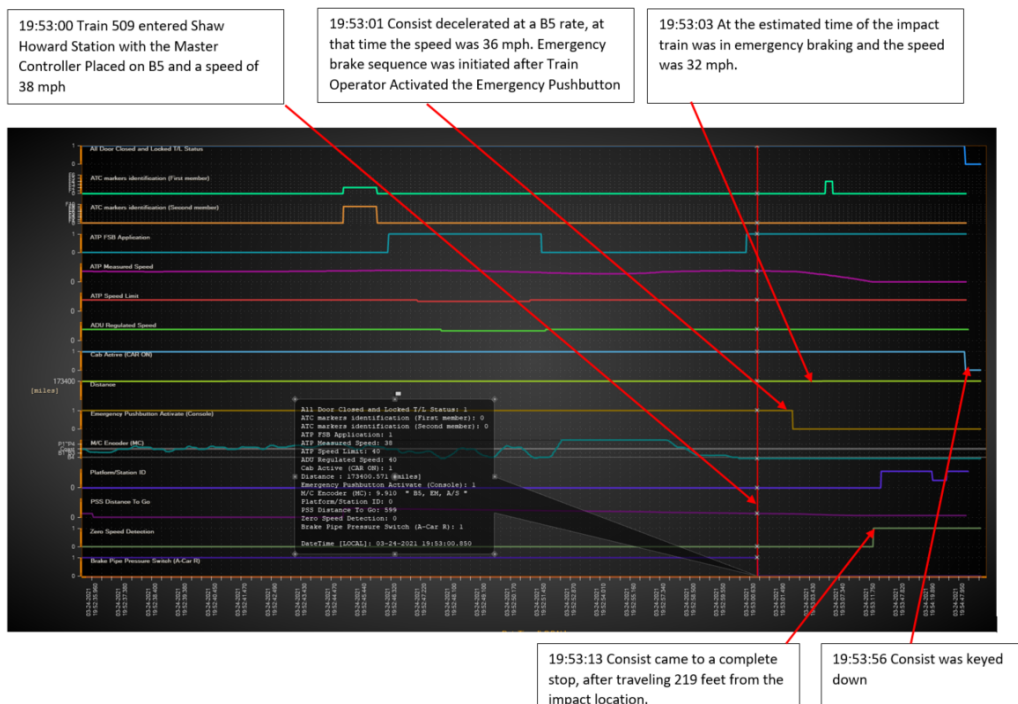
Diagram 3 - ER Graphical Analysis

TIME	Description
19:53:00 hrs.	The consist entered Shaw-Howard U Station with the master controller placed in B5 mode, and the speed was 38 MPH.
19:53:01 hrs.	The Consist decelerated at a B5 rate, at that time the speed was 36 mph. Emergency brake sequence was initiated after Train Operator activated the emergency brake function "mushroom."
19:53:03 hrs.	At the estimated time of impact the consist was in emergency braking, and the speed was 32 mph.
19:53:13 hrs.	The consist came to a complete stop after traveling 219 feet from the impact location.
19:53:56 hrs.	The consist was keyed down.

**Note:** The VMDS data does not show any abnormalities with the railcar's operations contributing to this incident. All of the associated subsystems' such as Automatic Train Control (ATC), brakes, and propulsion, acted as designed to bring the train to a complete stop.
