**WMSC Commissioner Brief: W-0103 – Improper Door Operation – Court House Station – March 14, 2021**

Washington Metro Area Transit Authority  
Department of Safety and Environmental  
Management (SAFE)  
**FINAL REPORT OF INVESTIGATION A&I E21109**

# Court House Station – Improper Door Operation

March 14, 2021

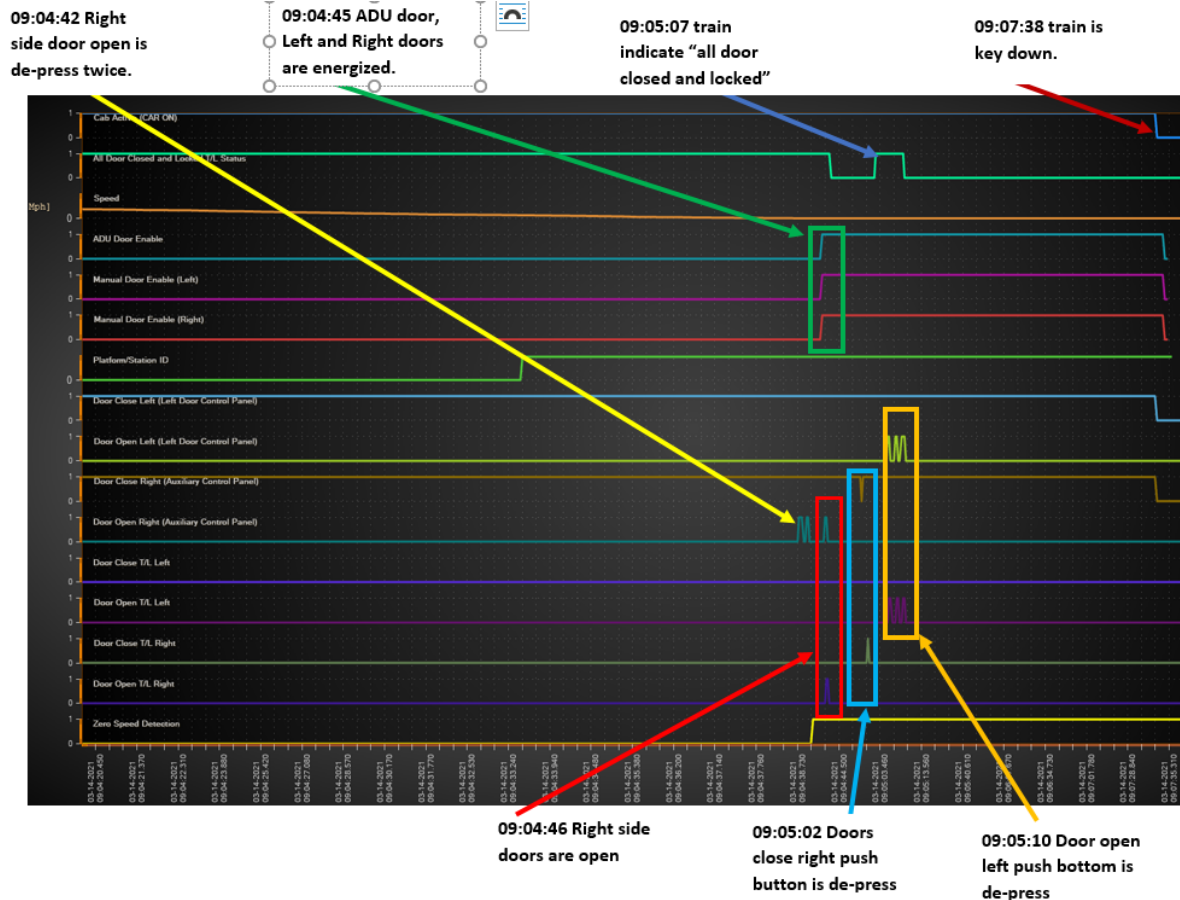
IIT CMOR analysis of the VMS data from Car 7006 verified the Train Operator of Train ID 608 depressed the door open right side button two times at 09:04:42 hours. The right-side doors were opened at 09:04:46 hours, and the door open right-side button was depressed again at 09:05:02 hours to close doors. The door open left side button was depressed at 09:05:10, and the Train Operator keyed down the train at 09:07:38 hours. IIT found no failure with the train.

Graph #1 – IIT CMOR VMS analysis showing Train Operator's door actions.

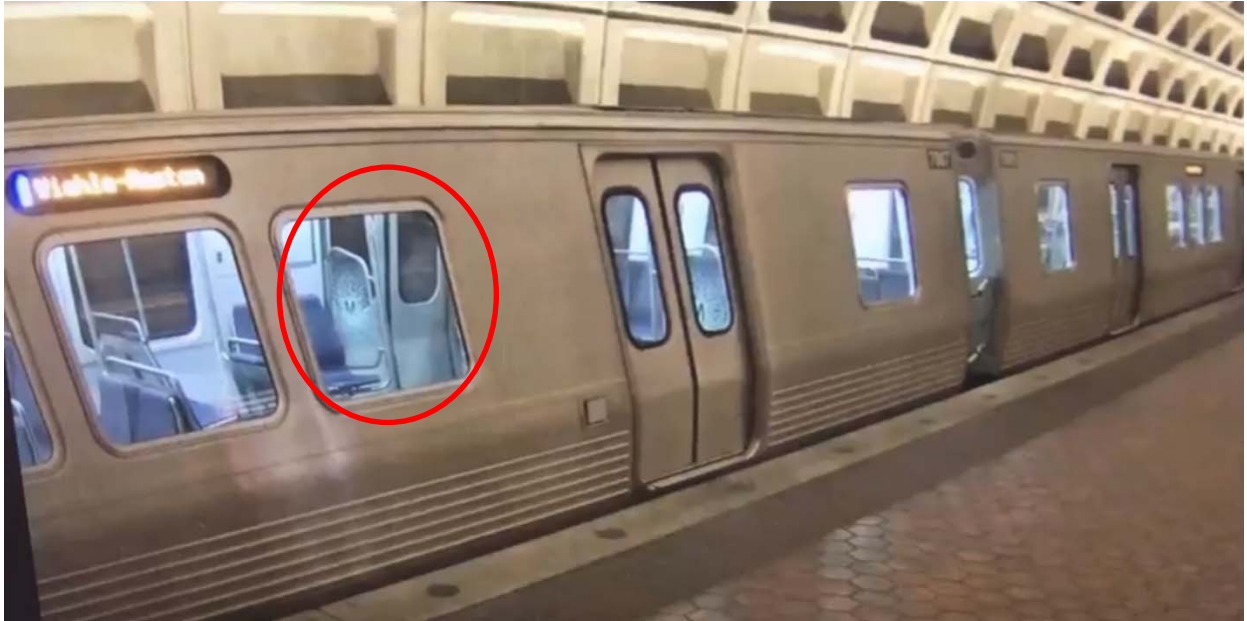
*Photo #1 – Train ID 608 properly berthed at Court House Station, Track 2 at 09:04:39 hours.*

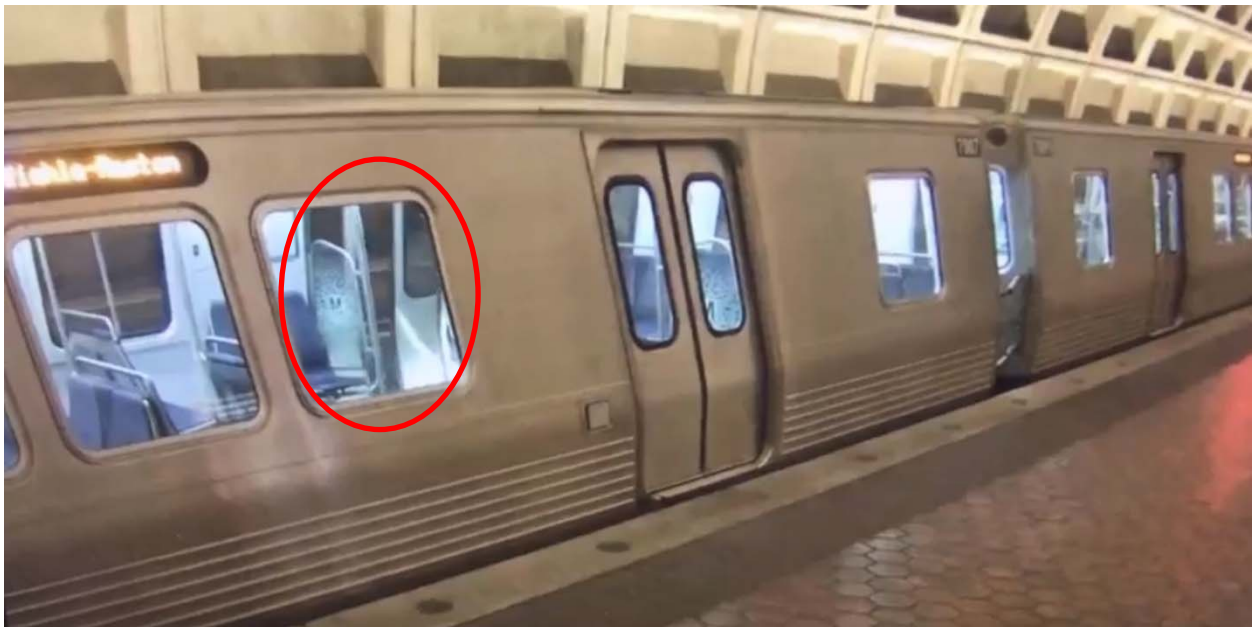
*Photo #2 – Train ID 608 right side doors begin to open on the non-platform side at Court House Station, Track 2 at 09:04:46 hours.*

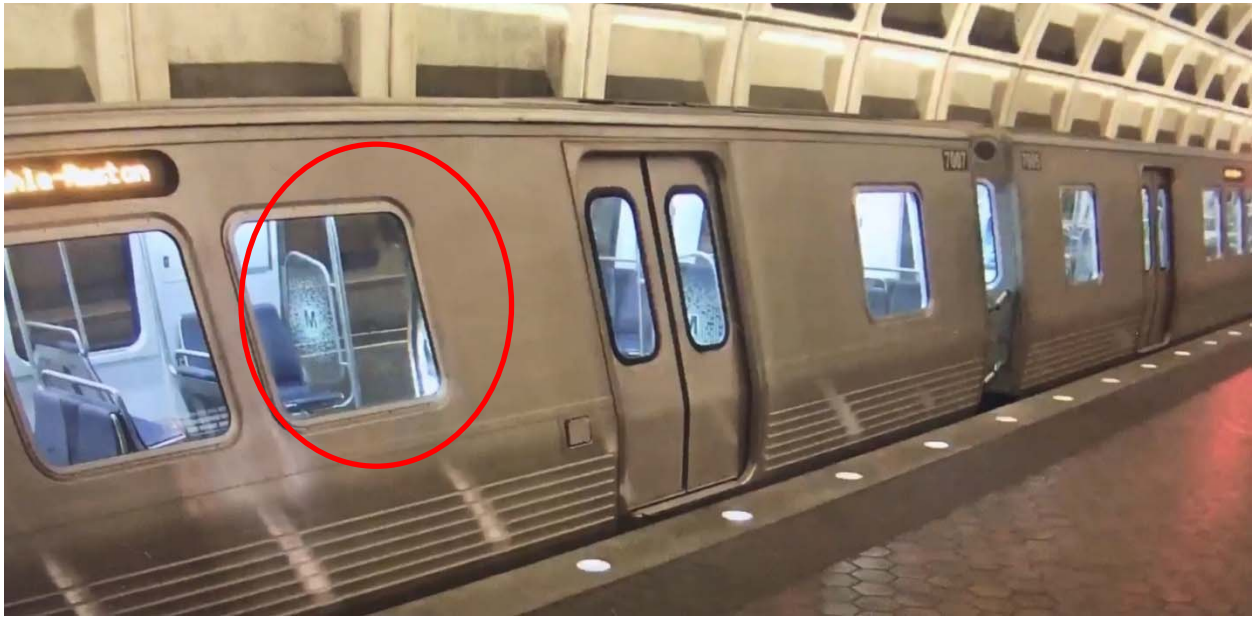
Photo #3 – Train ID 608 right side doors on the non-platform side completely opened.

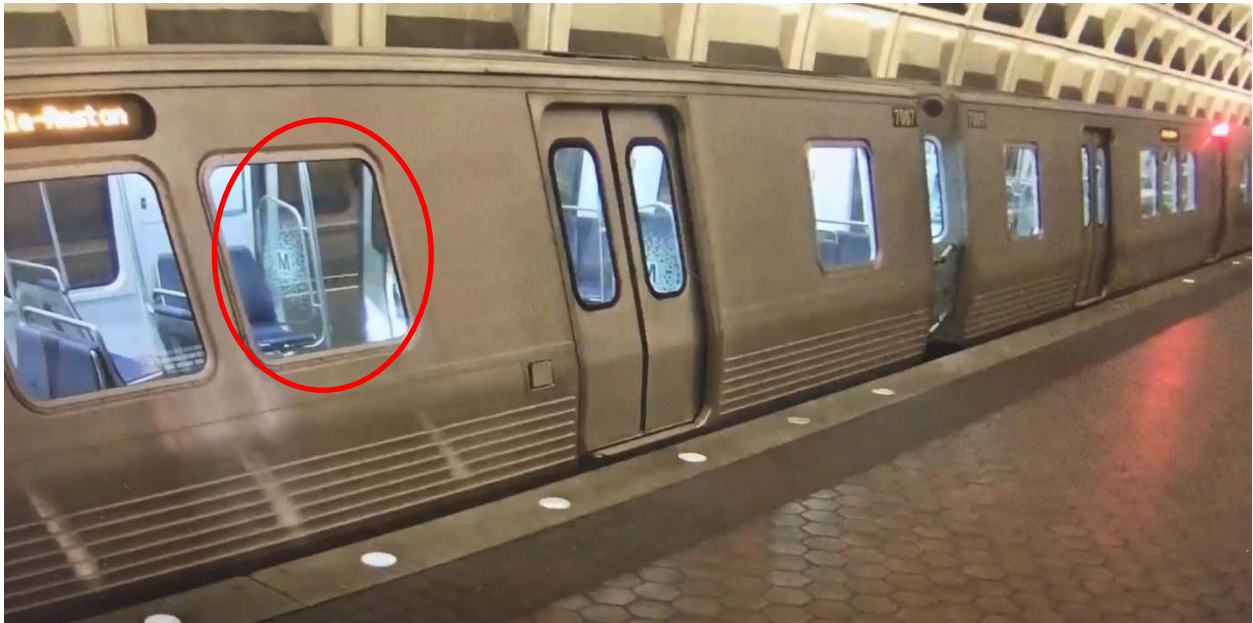
Photo #4 – Train ID 608 right side doors on the non-platform side begin to close at Court House Station, Track 2 at 09:05:02 hours.

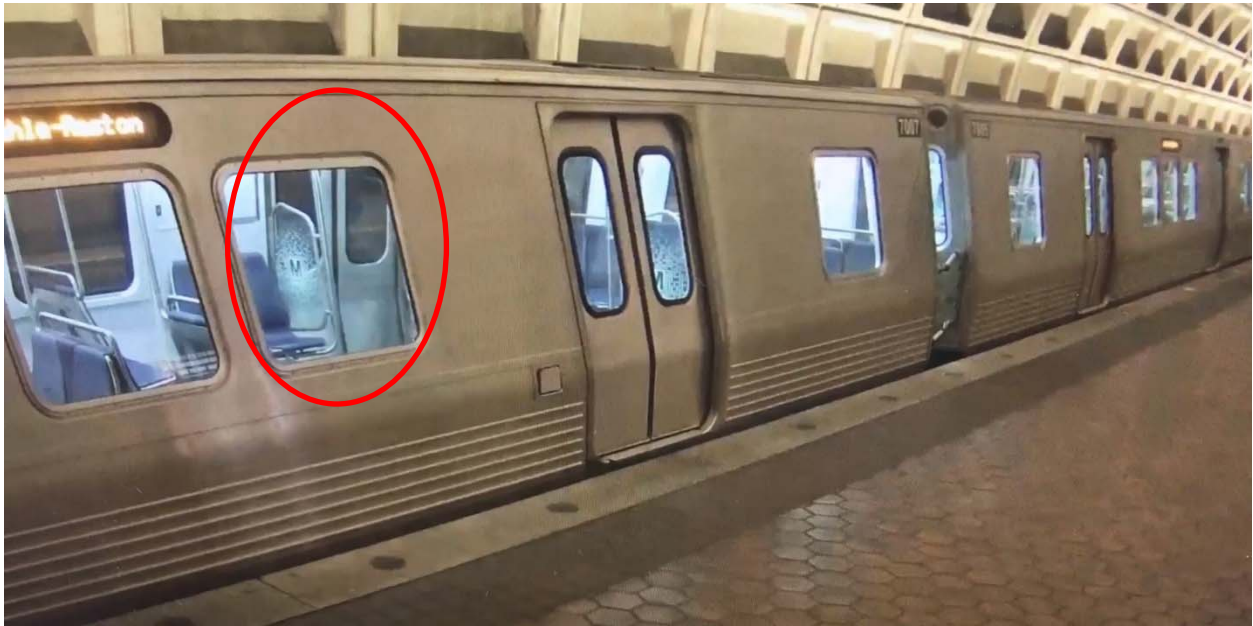
Photo #5 – Train ID 608 right side doors on the non-platform side completely closed at Court House Station, Track 2 at 09:05:07 hours.

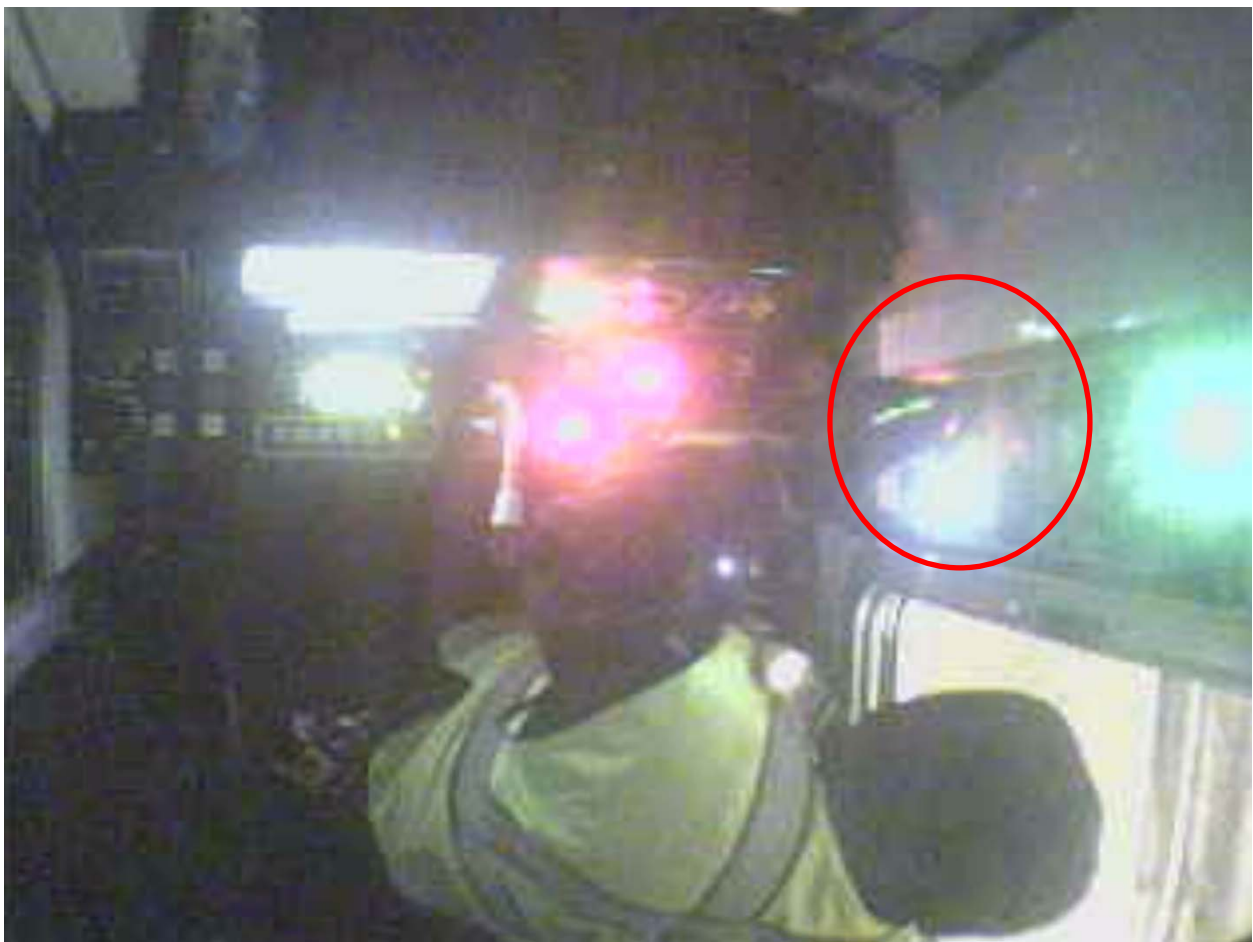
Photo #6 – Train Operator depressing Doors Open Button while observing the non-platform side of the train.

- The Train Operator depressed the Open Doors button on the non-platform side of the train. This action was not in compliance with SOP #40 – Door Operations / Station Servicing Procedures – 40.5.1.5.3 – “Depress Open Doors button on the platform side of the train.”

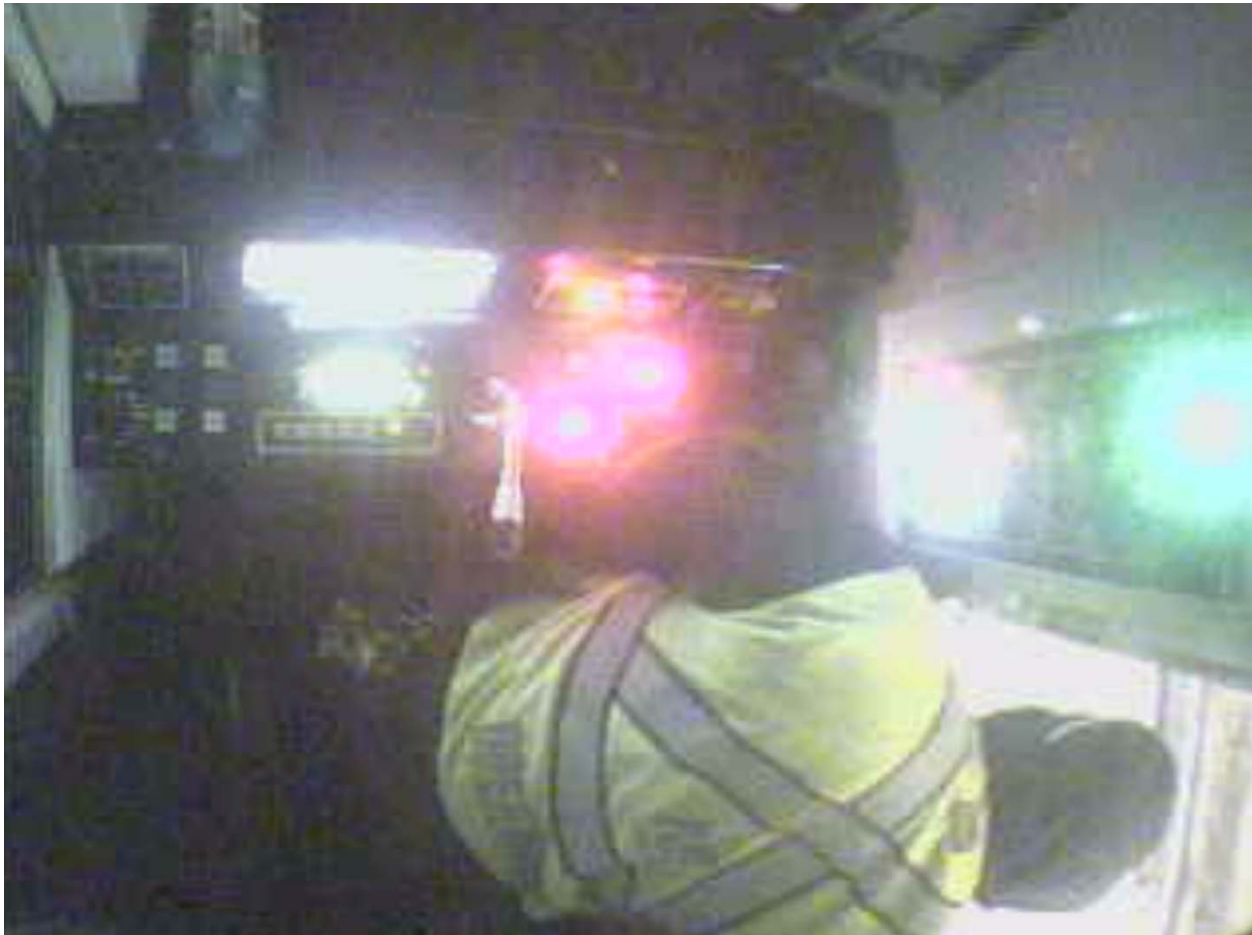
Photo #7 – Train Operator looking out of the window on the non-platform side of the train.

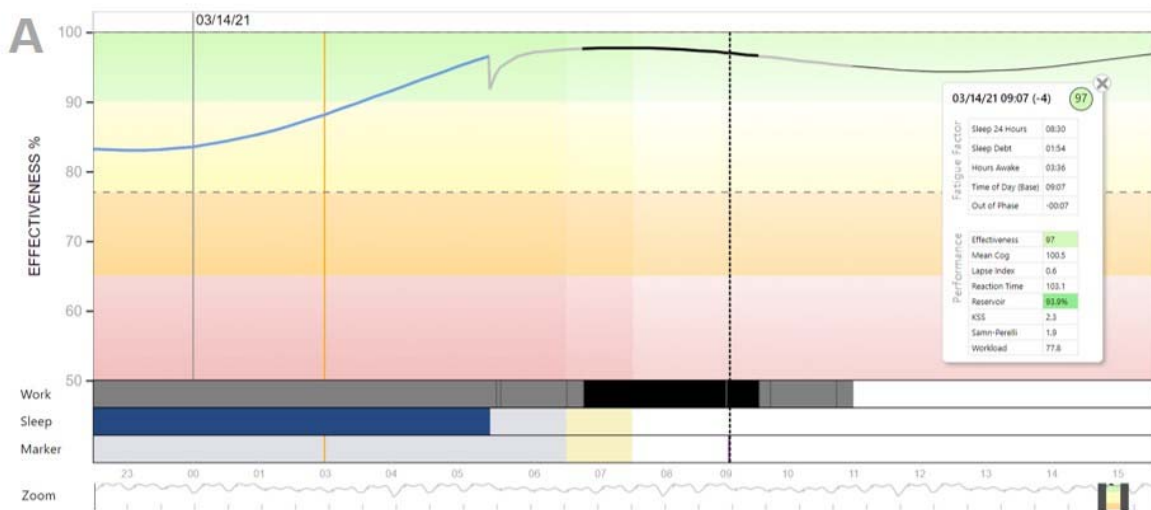
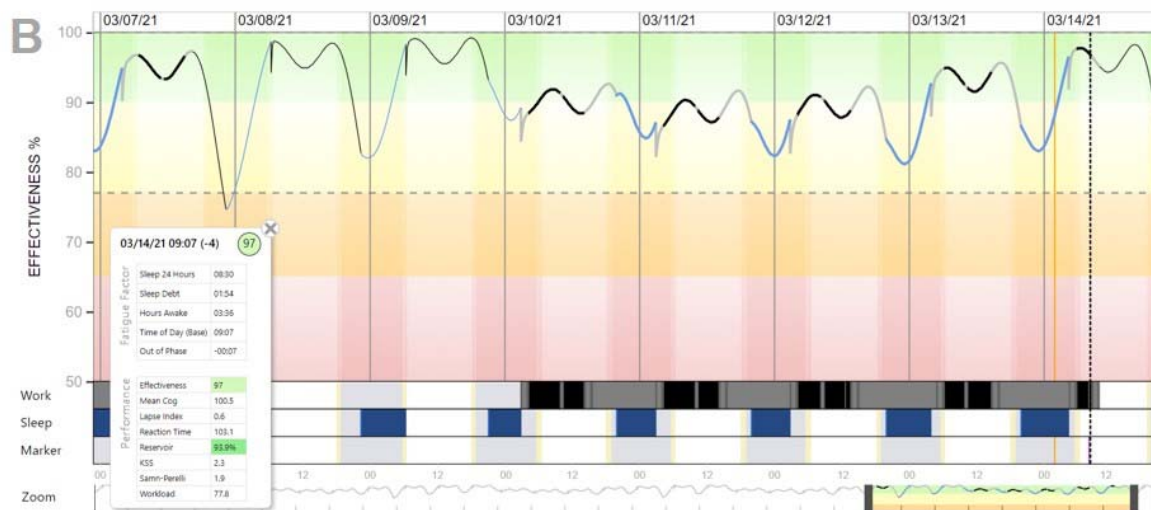
A biomathematical fatigue modeling application (SAFTE-FAST WebSFC) was used to further evaluate fatigue risk factors that may have been present in the Train Operator's schedule. The analysis was based on the Train Operator's work schedule, bed and wake times from the day before the incident and reported habitual sleep durations. The estimated performance effectiveness at the time of the incident was 97%. The analysis identified no factors contributing to an increased risk of fatigue at the time of the incident.

Figure 1 - Modeling analysis output shows estimated performance effectiveness during the incident work shift (A) and for the week leading up to the work shift (B) based on the employee work and reported sleep schedule. Estimates were based on the Train Operator's work schedule, bed and wake times from the day before the incident, and reported habitual sleep durations (8 hours a day). Bold portions of the modeled curve show work (in black) and sleep times (in blue). Effectiveness is shown on the vertical axis, with colored fields in the chart background signifying ranges of effectiveness scores, including high effectiveness (>90%) in green and low effectiveness (<65%) in red. Time is shown on the horizontal axis. Markers for work and sleep times are shown in the lanes above the time of day on the horizontal axis.
