WMSC Commissioner Brief: W-0104 – Collision, Customer Fatality – White Flint Station – May 14, 2021

Washington Metro Area Transit Authority
Department of Safety and Environmental
Management (SAFE)
FINAL REPORT OF INVESTIGATION A&I

White Flint Station – Collision - Serious Injury

May 14, 2021

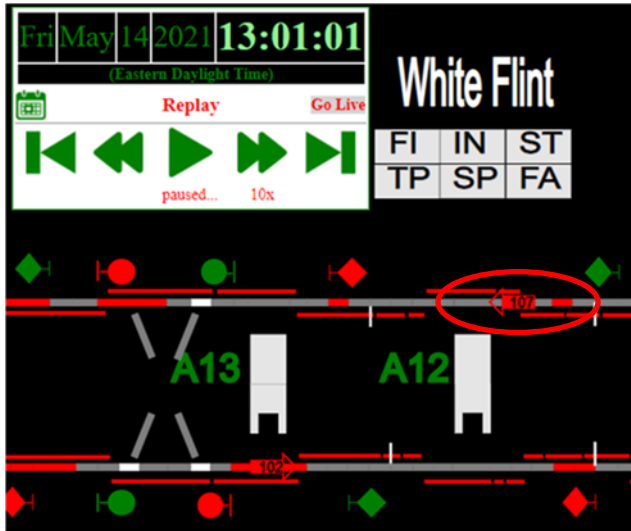
Figure 1 - Train ID 107 on approach to White Flint Station.

The analysis of the Vehicle Monitoring System (VMS) data showed that Train ID 107 entered White Flint Station, Track 2 at 28 MPH with the Master Controller (MC) in the B4 position, and Emergency braking was implemented 2 feet into the platform. Based on VMS data, the wheel rotation ceased at 130 feet into White Flint Station Platform, where the train began to slide. The train slid for approximately 6 feet before coming to a complete stop 165 feet into the platform.

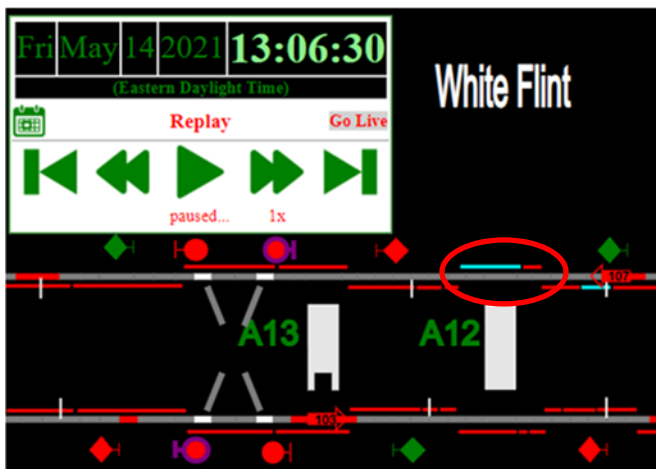
Figure 2 – Third rail power de-energized at White Flint Station, Track 2 (teal color). Train 107 remained immobile after the T/O keyed down on the lead car. The backwards movement displayed in AIMS is possibly a result of the rear cars resting on another circuit.

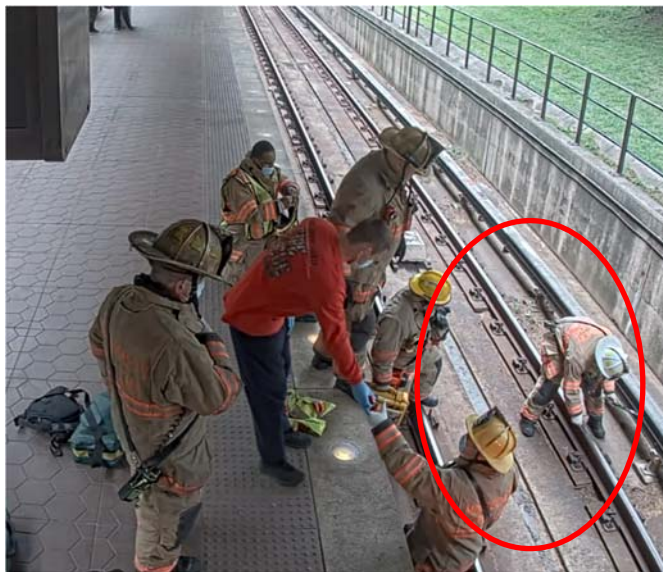
Figure 3: At approximately 13:12 hours, MCFRS hot stucked and confirmed third rail power was de-energized.

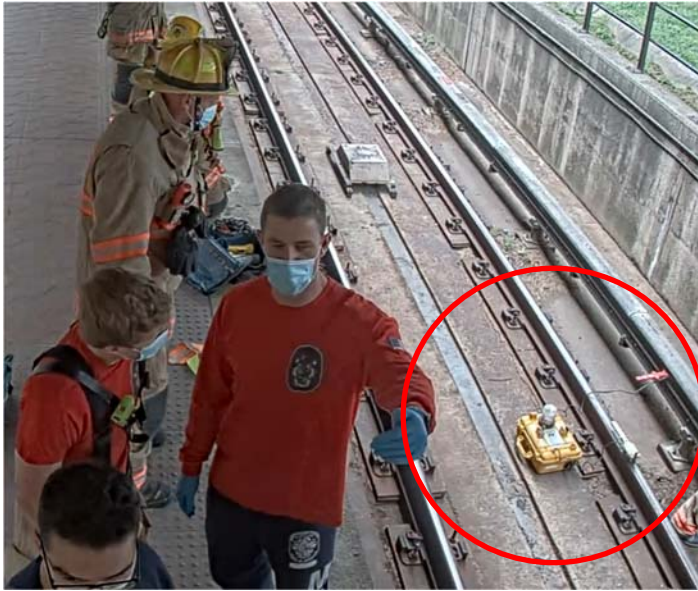
Figure 4: Shows that MCFRS deployed the WSAD after confirming third rail power was de-energized.

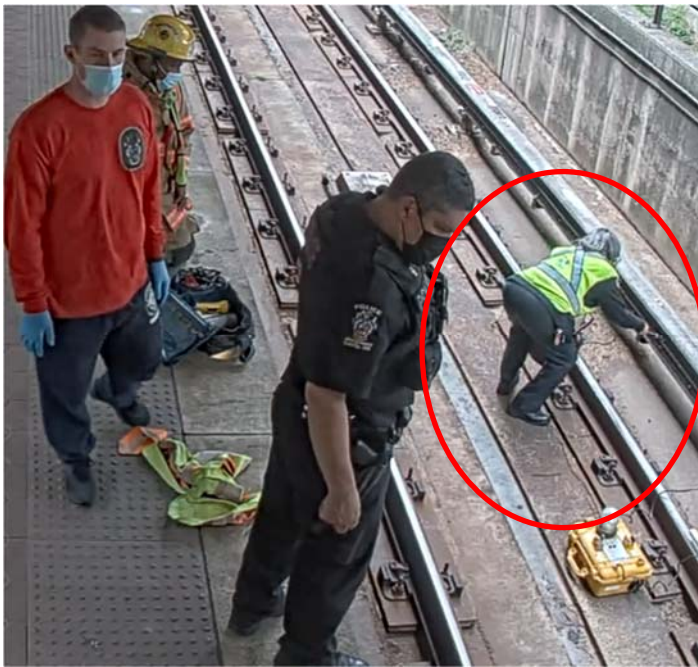
Figure 5: At approximately 13:16 hours, the RTRA Supervisor hot stuck and confirmed third rail power was de-energized.

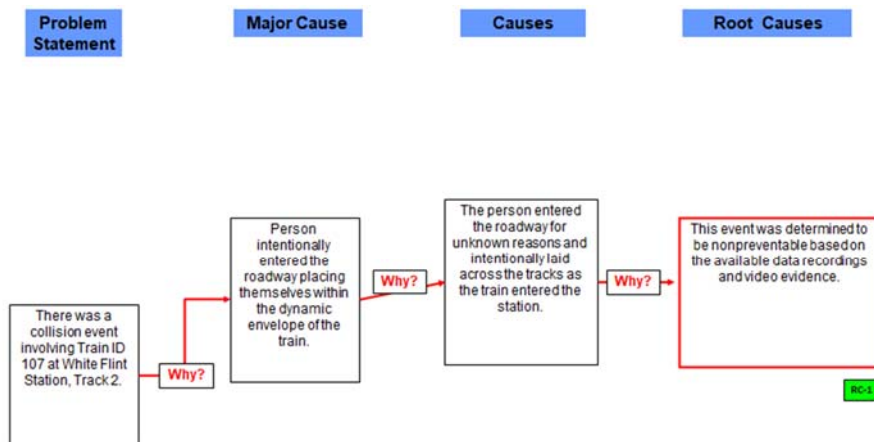
Appendix C- Root Cause Analysis

The probable cause of the person struck by a train event at White Flint Station on May 14, 2021, was the person's intentional action to place themselves on the roadway within the dynamic envelope of the train. As the person placed themselves on the roadway, the T/O activated the Emergency Push button and placed the Master Control (MC) handle in B5. Unfortunately, the T/O was unable to prevent contact with the person, resulting in serious bodily injuries. Based on a post-incident
