WMSC Commissioner Brief: W-0105 – Collision, Customer Fatality – NoMa-Gallaudet Station – May 23, 2021

Washington Metro Area Transit Authority
Department of Safety and Environmental
Management (SAFE)
FINAL REPORT OF INVESTIGATION A&I E21209

NoMa-Gallaudet Station
Collision
May 23, 2021

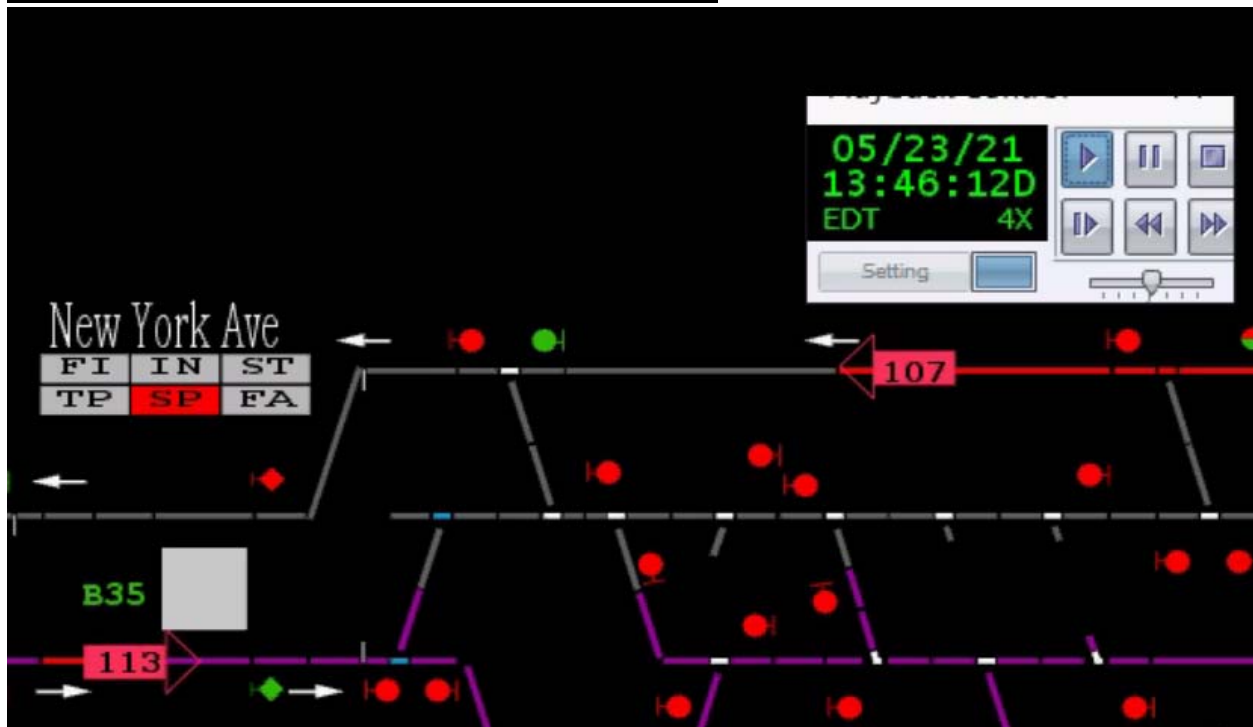
Diagram 1 - Based on the AIMS playback, Train ID 113 entered NoMa-Gallaudet Station, Track 1, at 13:46:12 hours, which appears to be when they reported making contact with a person on the roadway, per ARS.

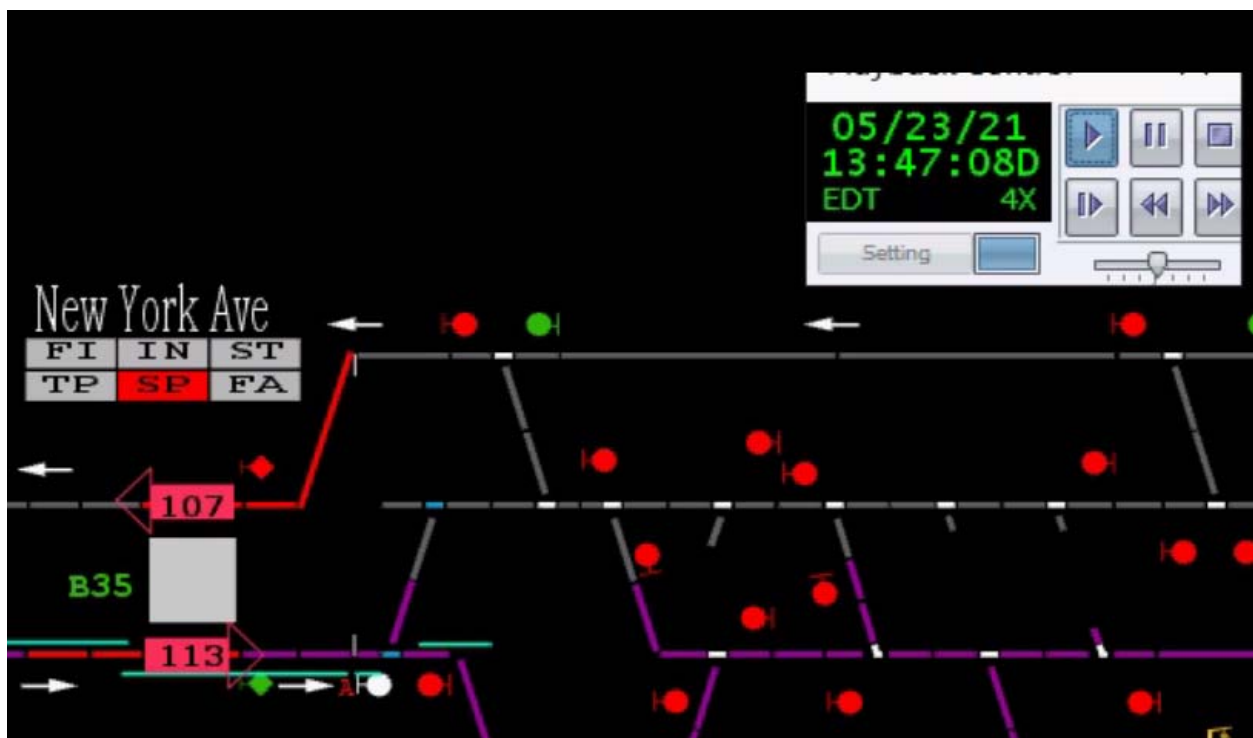
Diagram 2 - Based on the AIMS, the teal color on the AIMS power display shows ROCC subsequently de-energized third rail power at NoMa-Gallaudet Station, Track 1 at 13:47:08 hours.

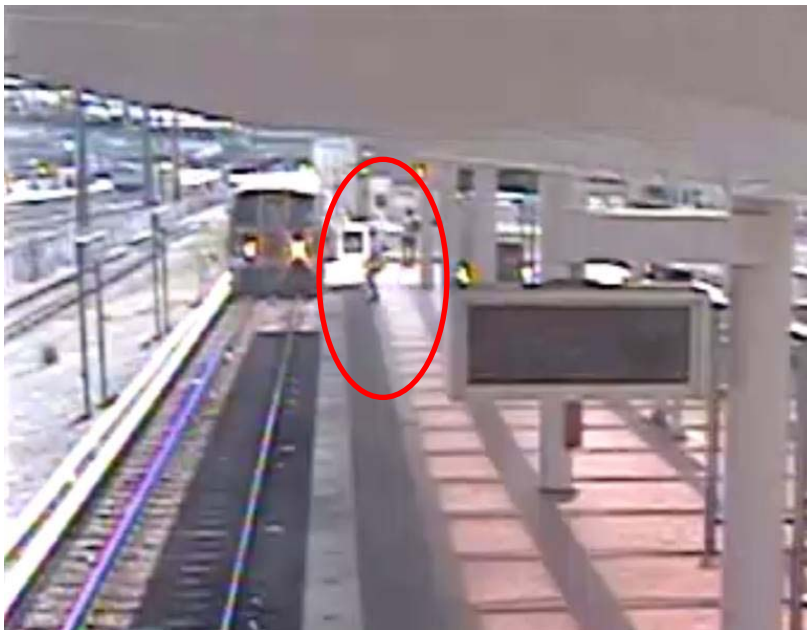
Figure 2 - Based on the CCTV, at approximately 13:46 hours, as the train entered the station, the person jumped into the dynamic envelope, intentionally placing himself in the path of the approaching train.

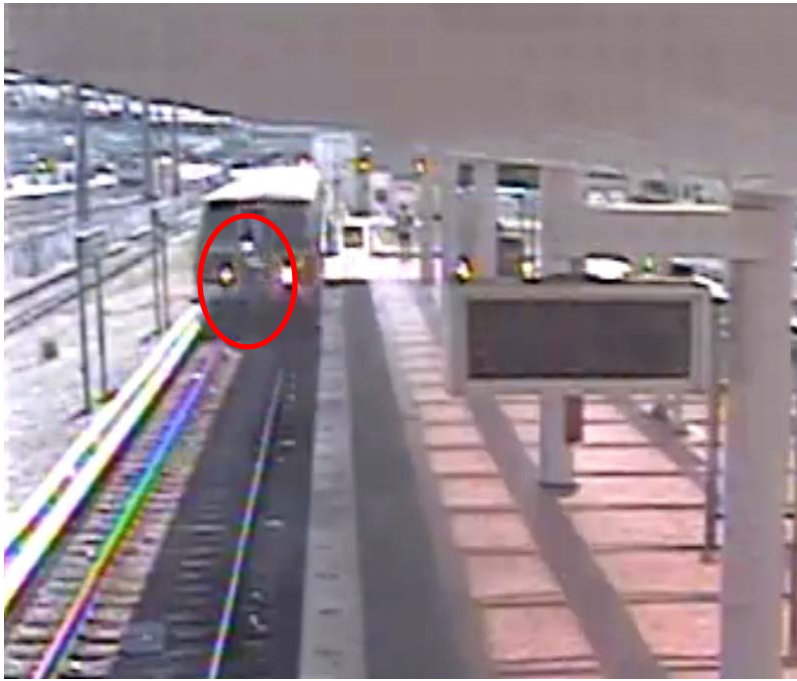
Figure 3 - Based on the CCTV, at approximately 13:46 hours, as the train entered the station, the person jumped into the dynamic envelope, intentionally placing himself in the path of the approaching train.

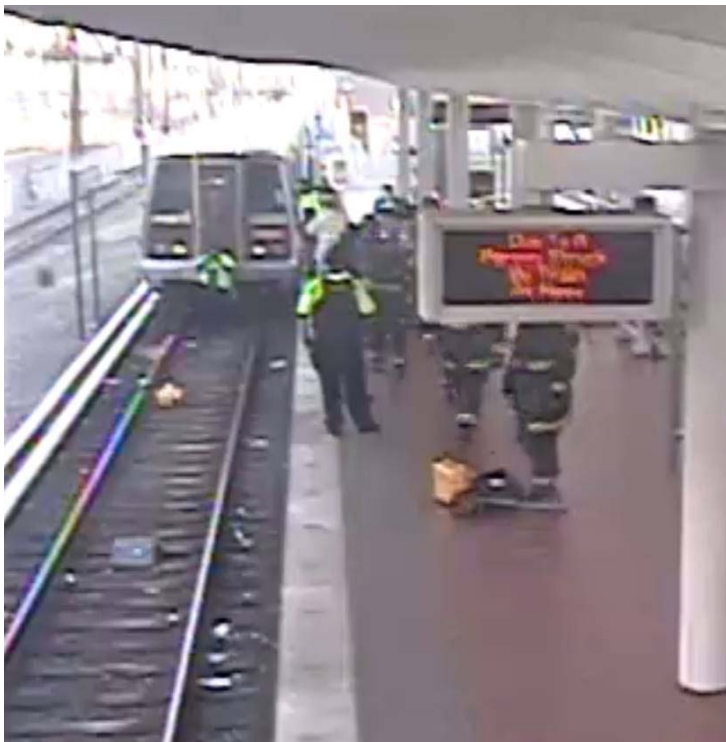
Figure 8 - Based on the CCTV, at approximately 19:05 hours, the fire department extricated the person from the roadway.

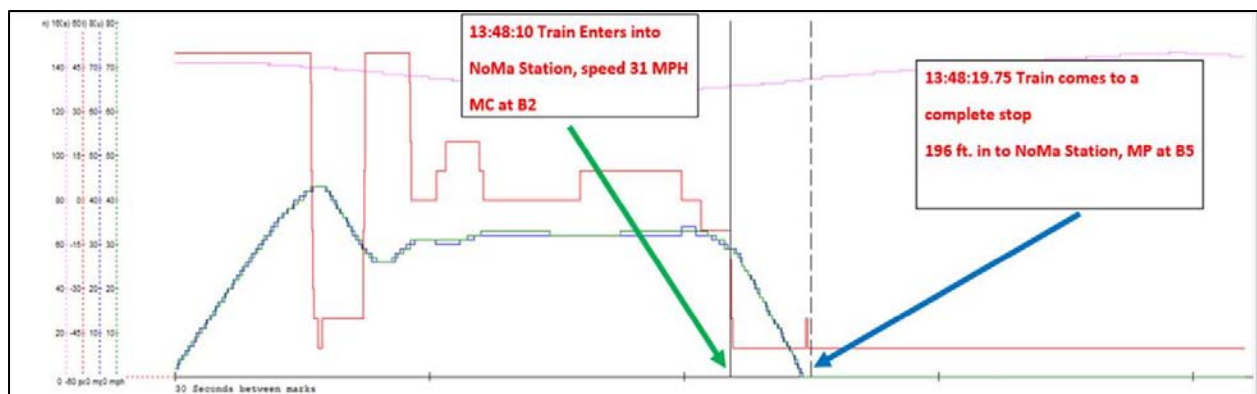
Diagram 3 - ER Graphical Analysis from Car 3172

Note: The VMS data on the lead married pair 3117-3116 was not available. This resulted in CMOR IIT personnel not determining the train speed and distance covered when entering the NoMa-Gallaudet Station, Track 1 from the lead car. CMOR IIT personnel reported this was due to the DAM; VMS equipment in the married pair (DAM A and DAM B) was not communicating in real-time and showed no speed during the incident time. Speed analysis was performed using the trailing cars in the consist, as noted in Diagram 3 below from car 3172. Based on the CMOR IIT post-incident analysis, there was no data to support any anomalies with the consist that may have contributed to this incident.

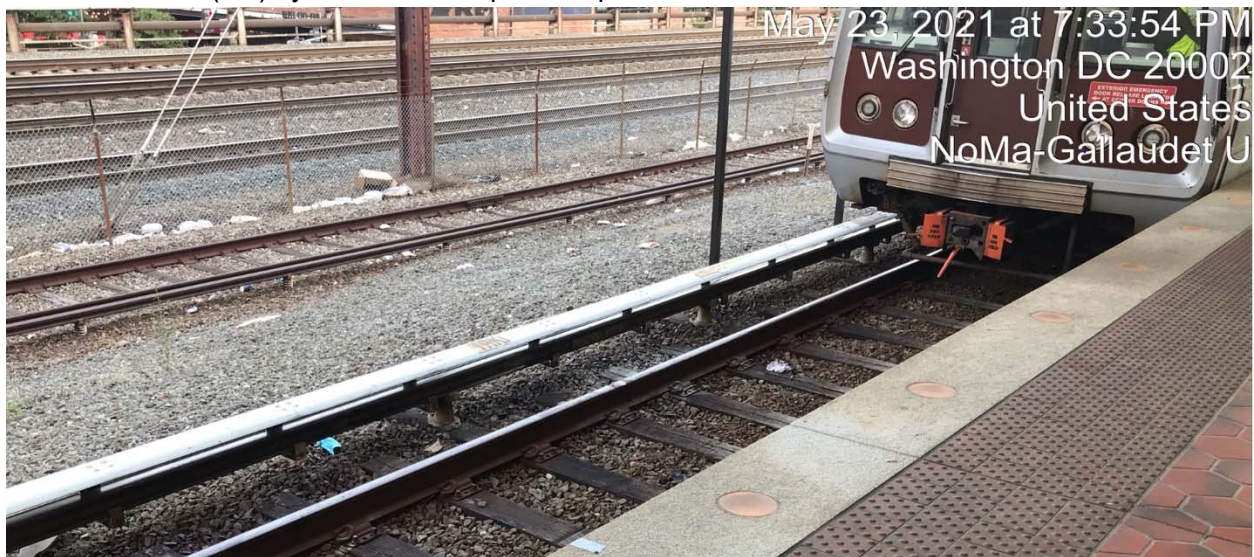
SAFE performed an inspection of the station after the incident. There were no adverse safety concerns that contributed to the incident. All the station's Emergency Trip Systems (ETS) and Public Address (PA) systems were reported operational.

Figure 8 – NoMa-Gallaudet Station, Track 1 incident scene.
