## **WMSC Commissioner Brief: W-0106 – Improper Movement – Foggy Bottom Station – May 21, 2021**

**FINAL REPORT OF INVESTIGATION A&I E21204**

<b>Date of Event:</b>	May 21, 2021
<b>Type of Event:</b>	O-7 Improper movement of any rail vehicle on the mainline or in a yard, including over improperly aligned switch(es).
<b>Incident Time:</b>	18:52 hours
<b>Location:</b>	Foggy Bottom Station, Track #1
<b>Time and How received by SAFE:</b>	19:55 hours, SAFE Phone
<b>WMSC Notification Time:</b>	20:50 hours
<b>Responding Safety Officers:</b>	N/A
<b>Rail Vehicle:</b>	L7234x7235-7227x26-7094x7095-7181x7180T
<b>Injuries:</b>	None
<b>Damage:</b>	None
<b>Emergency Responders:</b>	Office of Rail Transportation (RTRA)
<b>SMS I/A Number</b>	20210521#93434

Foggy Bottom – Improper movement

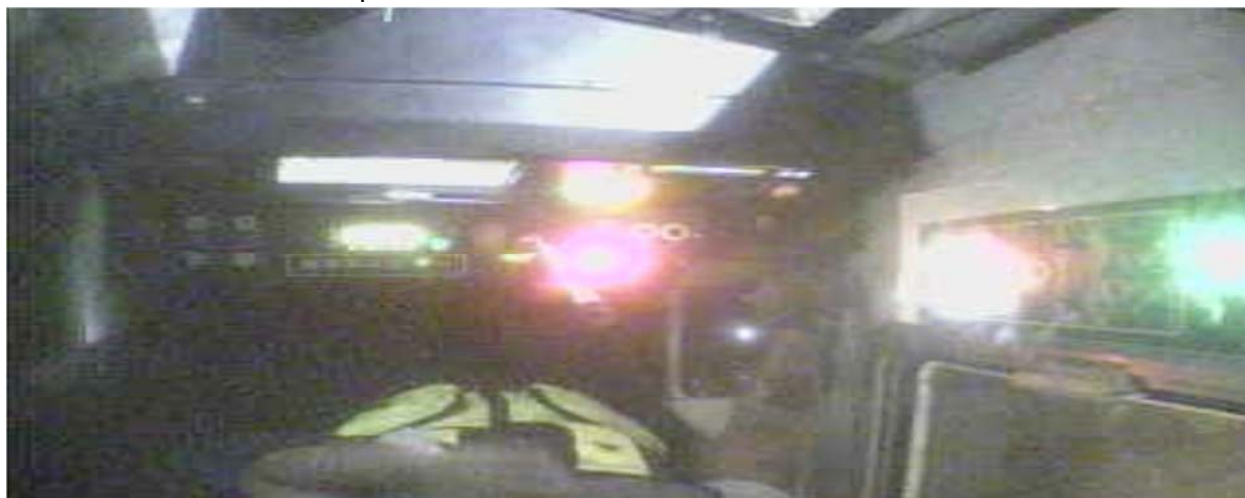
*Train ID Train Operator in the trailing cab attempting to move the train; however, the Train Operator had no speed readouts.*

Train ID 907 Train Operator entered stop and proceed method without contacting ROCC and moved their consist towards Rosslyn on track #1.

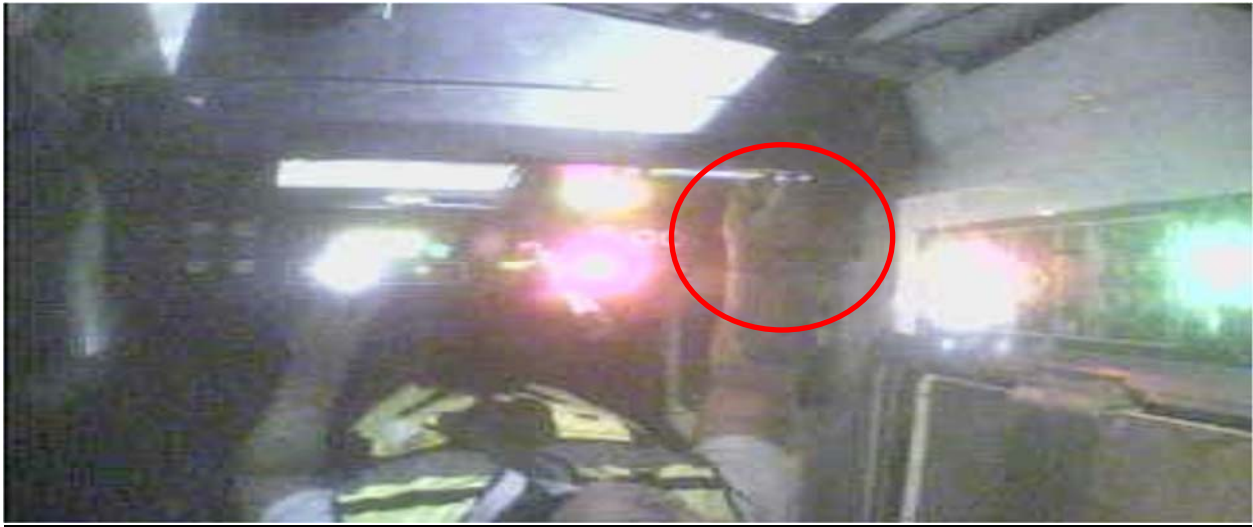
*At approximately 1857 hours, Train ID 907 Train Operator enters stop and proceed mode.*

The CMOR IIT downloaded the Vehicle VMDS data and determined the following: Train ID 907 Train Operator keyed up Trailing Car 7180, activated stop and proceed mode, and traveled 843.2 feet before coming to a complete stop outside Foggy Bottom Station platform limits Track #1.

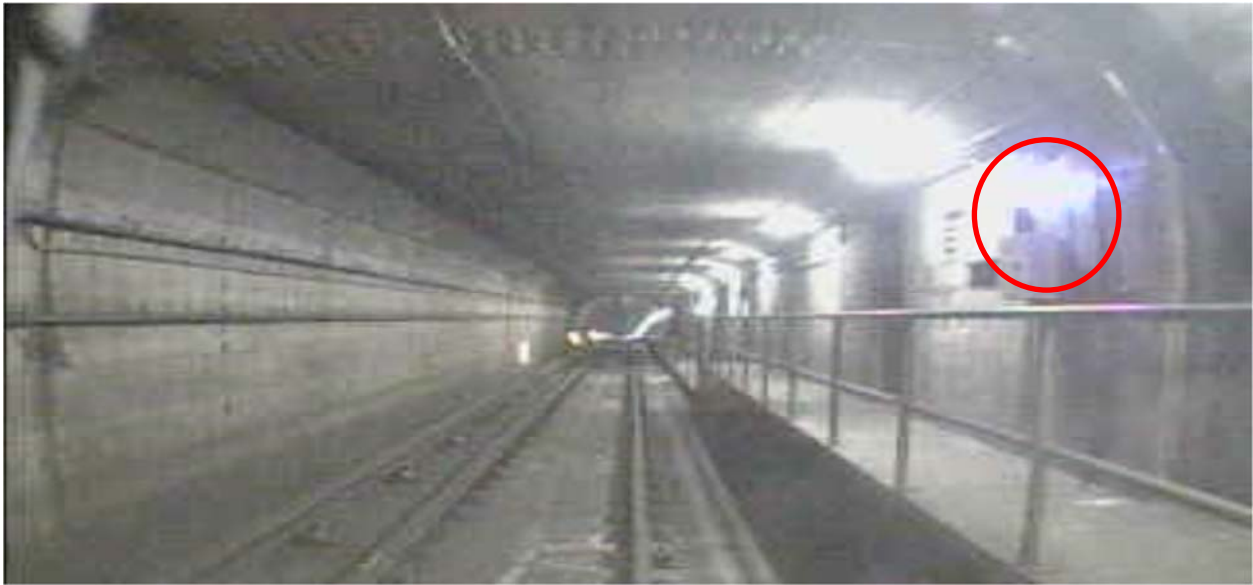
*Train ID 907 Train Operator begins to move. Use the blue ETS station to the right as a marker. ETS boxes are located every 800 feet.*

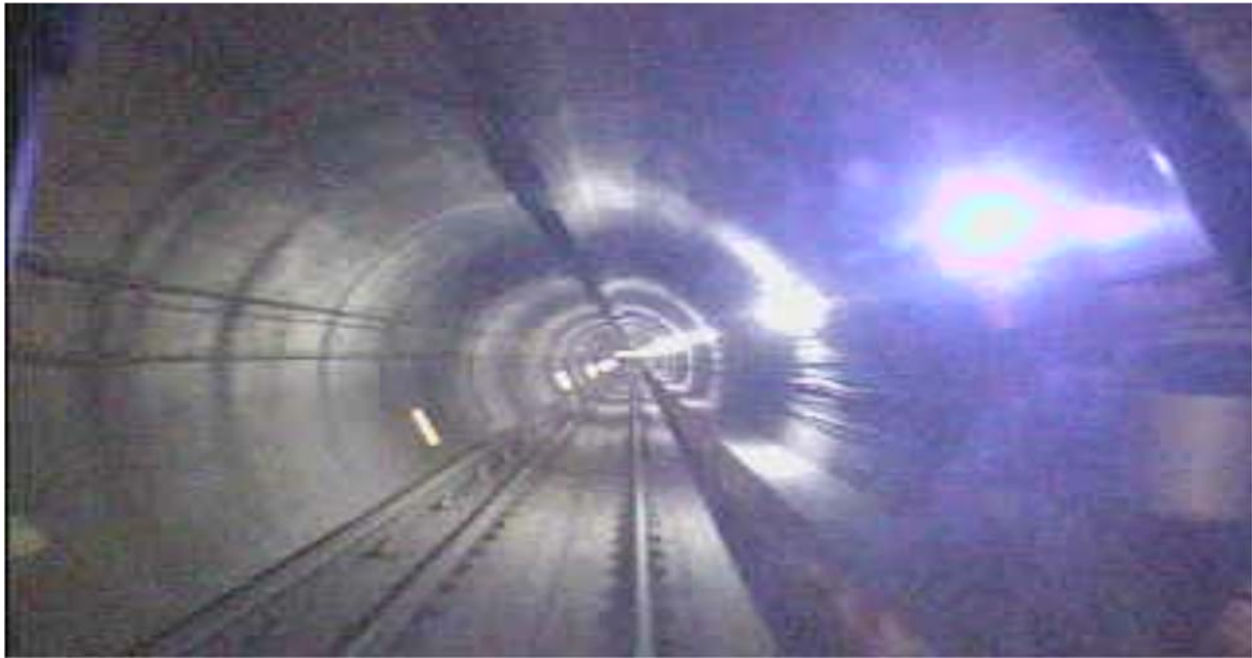
*Train ID 907 Train Operator reached the second ETS box approximately 800 feet after moving in Rosslyn Station's direction.*

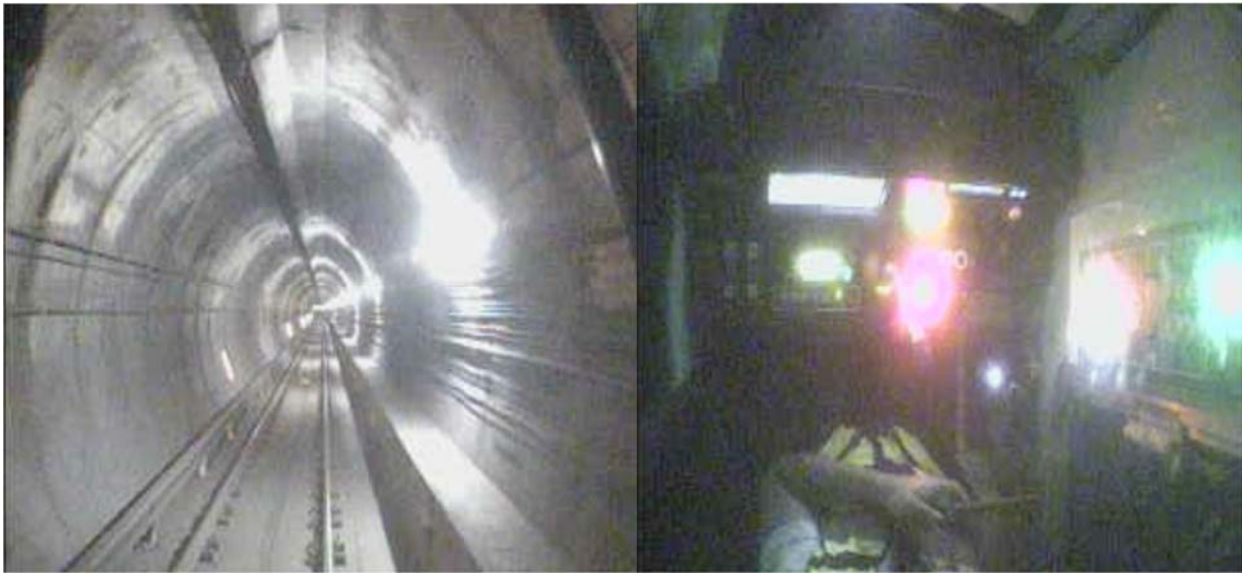
*Train ID 907 Train Operator comes to a complete stop 837.2 feet later and communicates with the ROCC Radio RTC.*

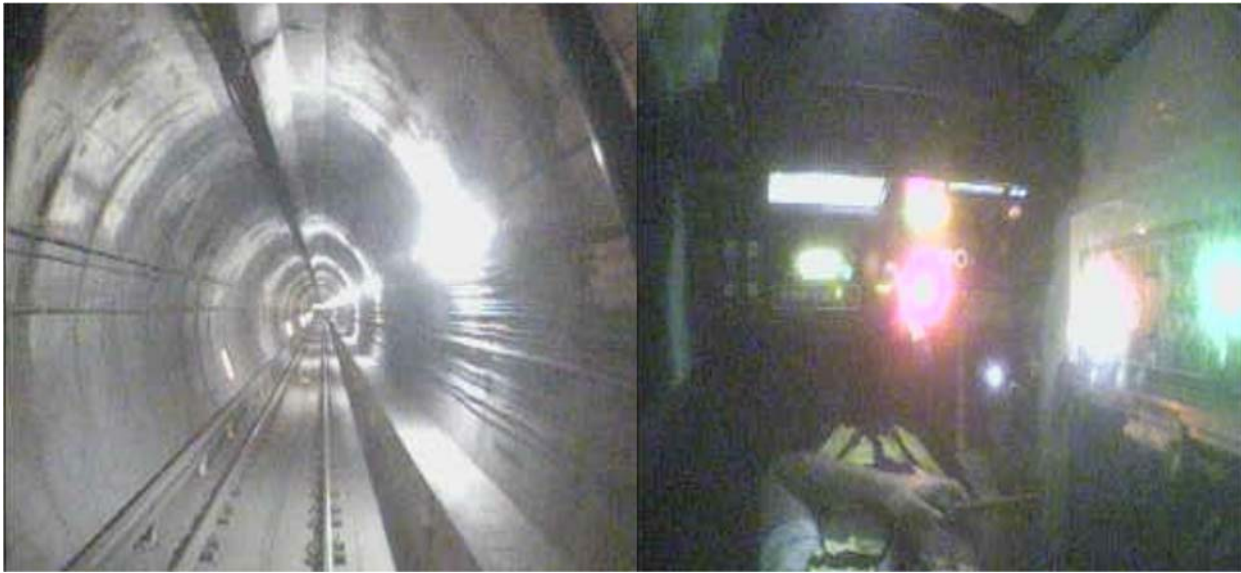
*Train ID 907 Train Operator comes to a complete stop 837.2 feet later and communicates with the ROCC Radio RTC.*

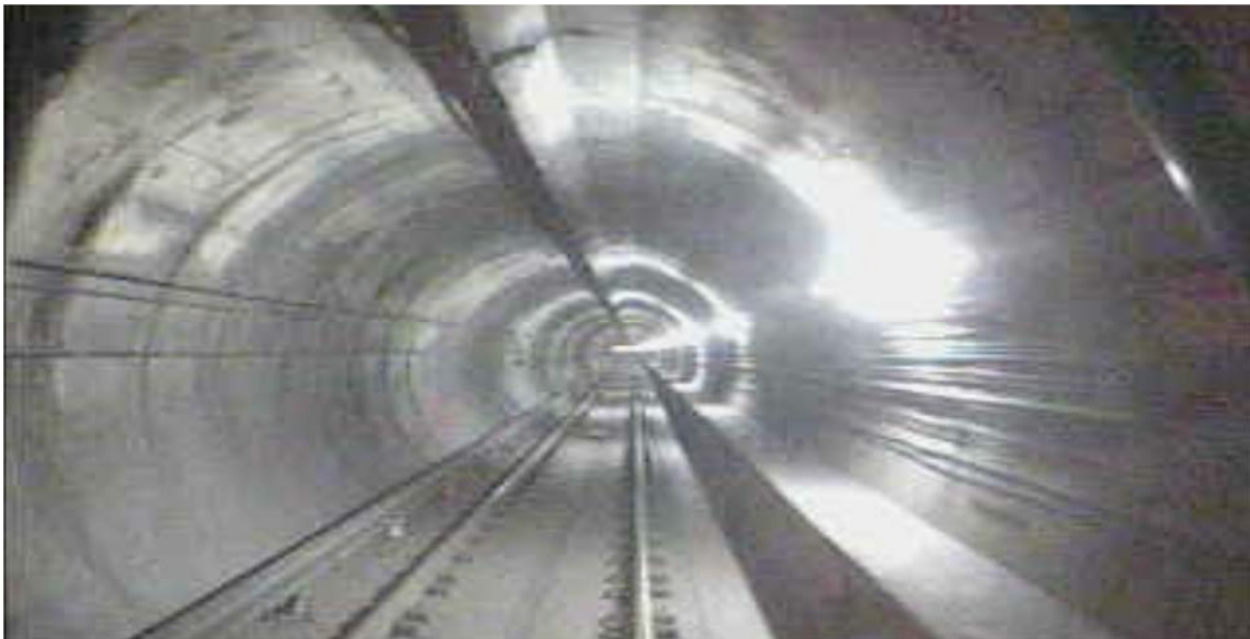
*Train ID 907 Train Operator keyed down Car 7180, heading in Rosslyn Station’s direction. Left Chain Marker reflection is no longer visible.*

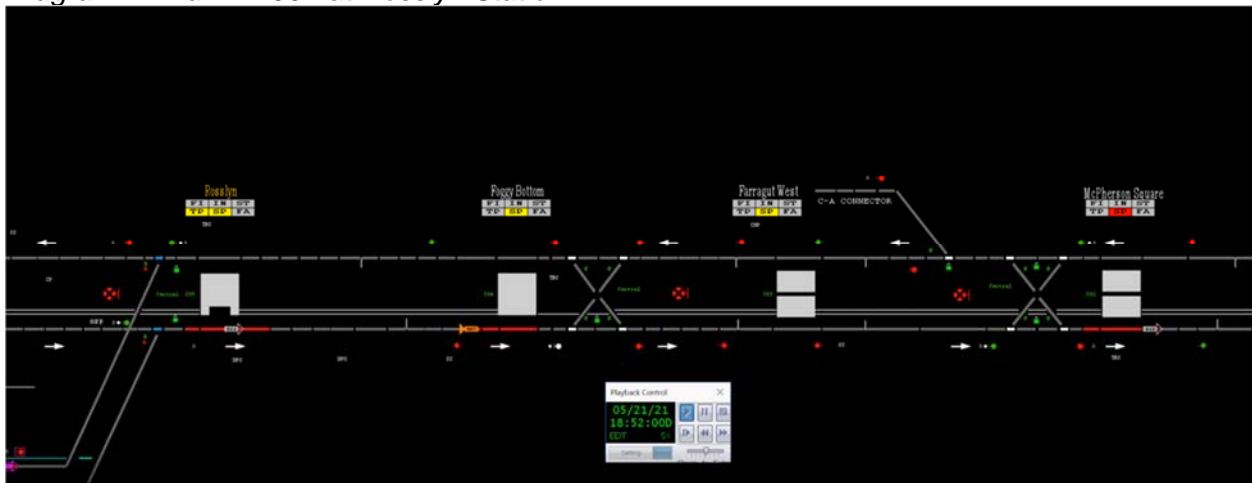
Diagram 2: Train ID 907 keyed up on the trailing end in Rosslyn Station's Direction

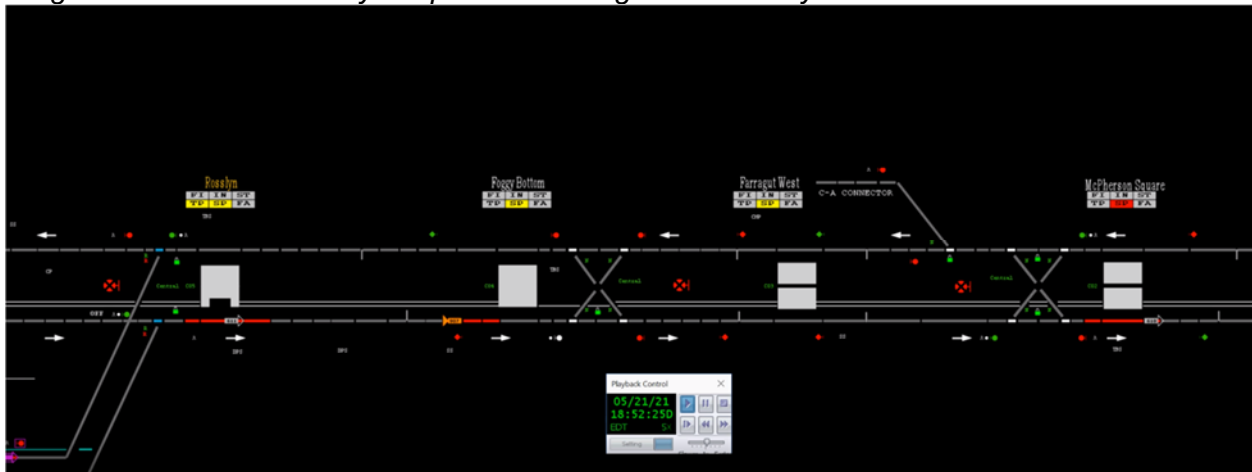
Diagram 3: Train ID 907 moved towards Rosslyn Station Track #1.

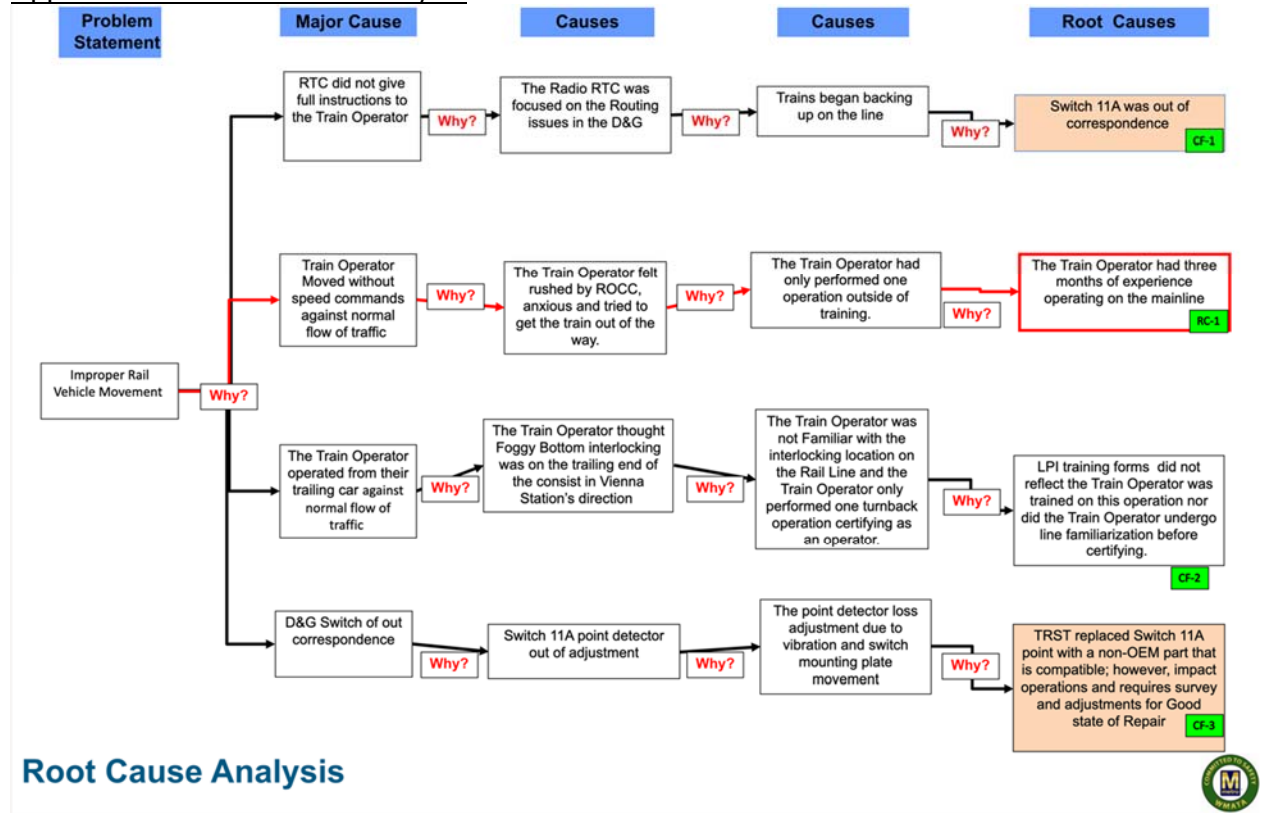
### Appendix B – Root Cause Analysis

The initial probable cause of this event was switch 11A out of correspondence at the D&G junction causing extensive passenger and train delays on the Orange, Blue, and Silver lines cause ROCC to turn trains back at strategic locations to minimize customer delays. The Radio RTC gave a set of incomplete instructions to Train ID 907 Train Operator that were not fully repeated due to excessive radio traffic from ATCM personnel.

<b>Corrective Action Code</b>	<b>Description</b>	<b>Responsible Party</b>	<b>Due Date</b>
93434_SAFECAPS_ RTRA_001	(RC-1, CF-2) Train Operator shall undergo Orange, Blue, and Silver Line familiarization, Virtual Refresher Training, incident interlocking simulation, moving without speed commands	RTRA SRC	Completed – July 16, 2021
93434_SAFECAPS_ ROCC_002	(CF-1) ROCC shall reinstruct RTC on the importance of General Rule 1.79 communication.	ROCC SRC	10/15/21
93434_SAFECAPS_ ATCM_003	(CF-3) ATCM shall ensure Switch 11A is returned to a Good state of Repair.	ATCM SRC	12/31/21
93434_SAFECAPS_ ROQT_004	(CF-2) ROQT shall evaluate LPI and Line Familiarization CBT to identify opportunities to improve interactive activities, including assessment testing enhancement.	ROQT SRC	12/31/21
93434_SAFECAPS_ ATCM_005	(CF-3) ATCM will evaluate the impacts and change control implications of changing out original parts with non-OEM parts, and will track in Maximo when non-OEM parts are used.	ATCM SRC	12/31/21
