**WMSC Commissioner Brief: W-0107 & W-0108 – Improper Roadway Worker Protection – Tenleytown Station – April 9, 2021**

*Prepared for Washington Metrorail Safety Commission meeting on September 21, 2021*

# Tenleytown-AU Station – Improper Roadway Worker Protection (RWP)

Outside of Tenleytown Station, between Chain Marker A1-271+00 to A1-283+00  
Improper Roadway Worker Protection  
April 9, 2021

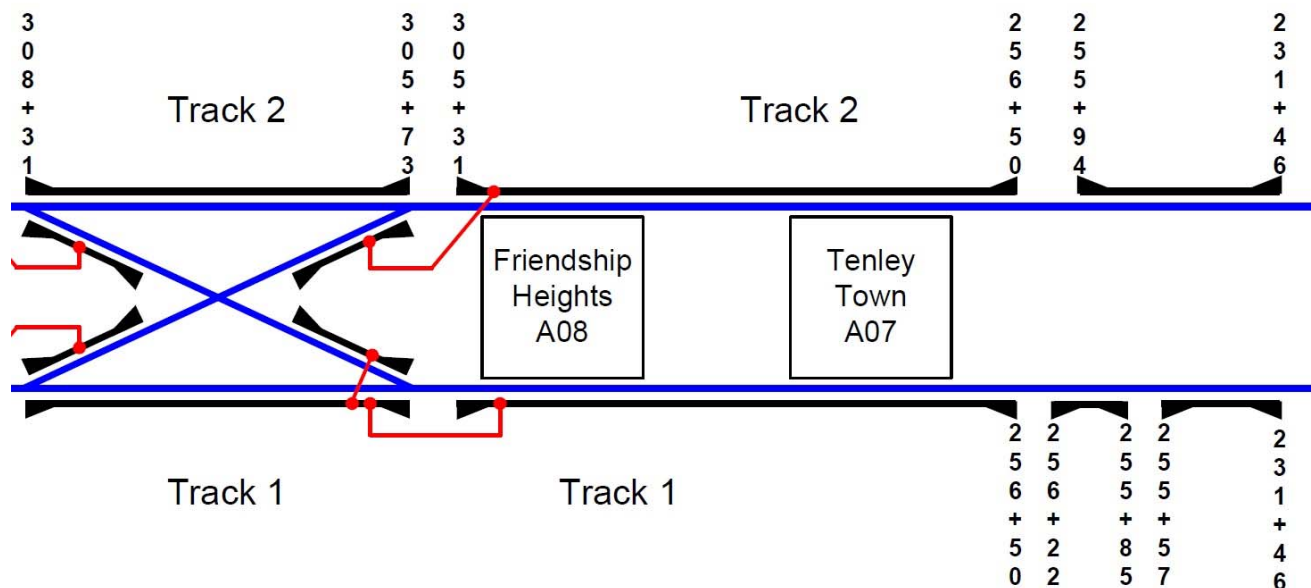
Diagram 1 – Contact Rail Drawing shows a third rail gap from CM A1 256+22 to 256+50. RWIC protected work area included CM A1 191+00 to 268+00.

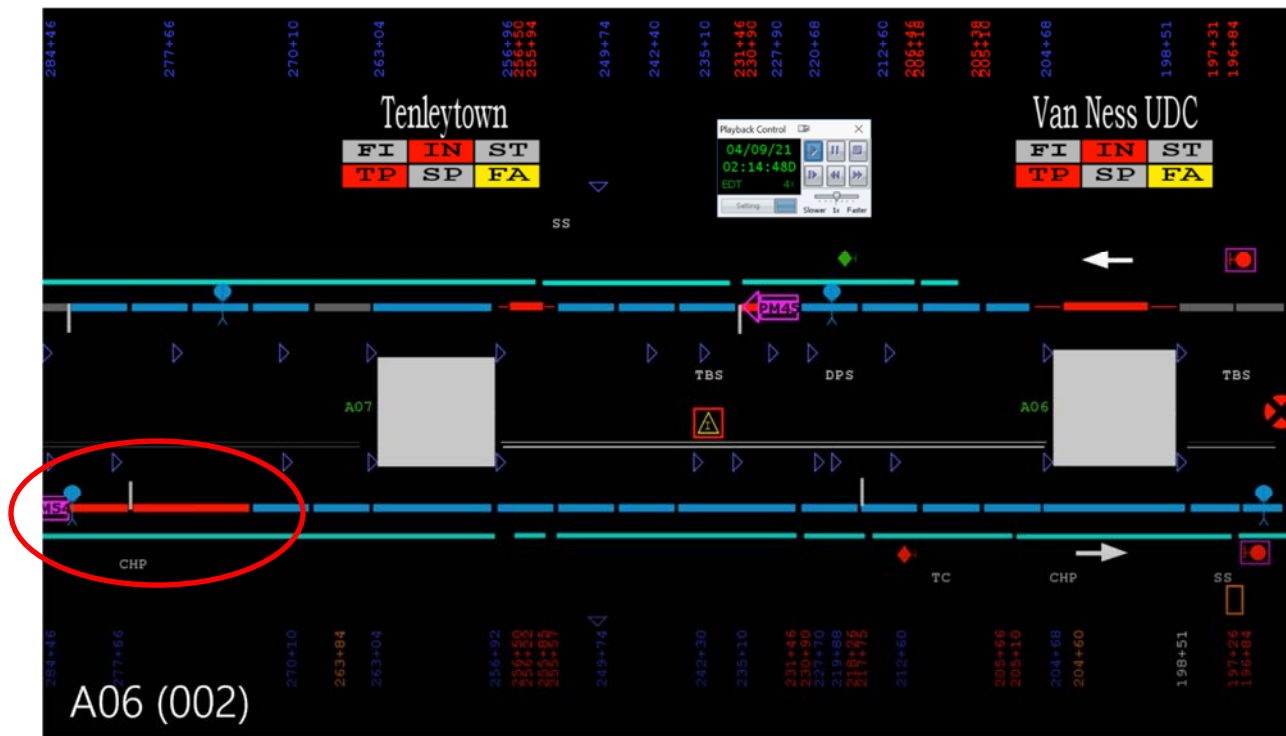
Diagram 2 – AIMS playback illustrating PM 54 exceeding their working limits and encroaching PLNT's work zone at 02:14:48 hours.

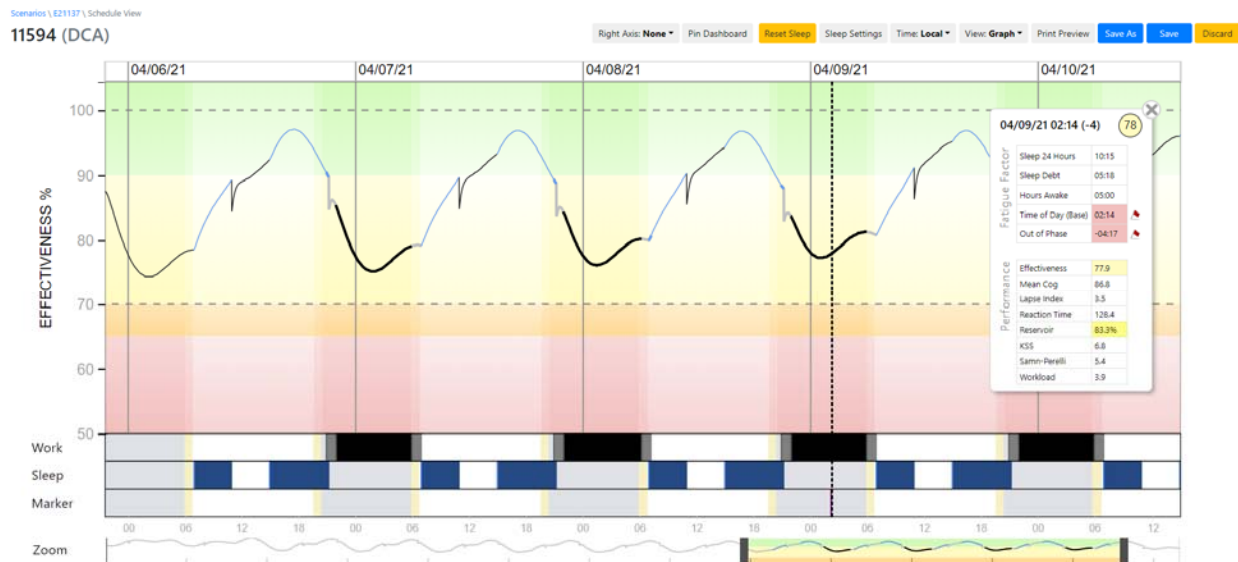
Since a fatigue risk factor was present, a biomathematical fatigue modeling application titled the Sleep, Activity, Fatigue and Task Effectiveness - Fatigue Avoidance Scheduling Tool (SAFTE-FAST) was used to further evaluate fatigue risk factors that may have been present in the employee's schedule. The analysis was based on the employee's work schedule, bed and wake times from the day before the incident and reported habitual sleep durations. Estimated performance effectiveness at the time of the incident was 78%. The analysis confirmed time of day (i.e. performance impacted by the time of circadian low) as contributing to an increased risk of impaired performance at the time of the incident.

Figure 1 - Modeling analysis output shows estimated performance effectiveness for the period leading up to the incident, based on the employee work and reported sleep schedule. Estimates were based on the employee's work schedule, bed and wake times from the day before the incident and reported habitual sleep durations (10.25 hours a day, split in two periods). Bold portions of the modeled curve show work (in black) and sleep times (in blue). Effectiveness is shown on the vertical axis, with colored fields in the chart background signifying ranges of effectiveness scores including high effectiveness (>90%) in green, and low effectiveness (<65%) in red. Time is shown on the horizontal axis. Markers for work and sleep times are shown in the lanes above the time of day on the horizontal axis.

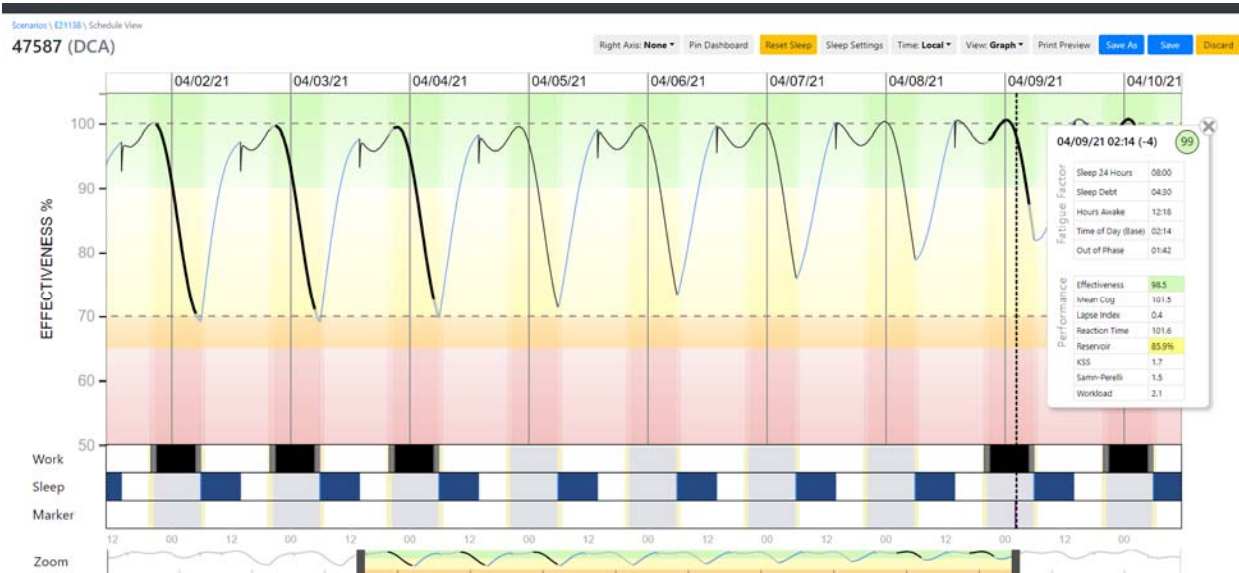
Since a fatigue risk factor was present, SAFTE-FAST was used to further evaluate fatigue risk factors that may have been present in the employee's schedule. The analysis was based on the employee's work schedule, bed and wake times from the day before the incident and reported habitual sleep durations. Despite the time of day, the estimated performance effectiveness at the time of the incident was 99%. This may be due to the effect of the controller's sleep schedule in the week leading up to the event. Maintaining a daytime sleep schedule can help shift the circadian clock into a better alignment with the night work schedule.

Figure 2 - Modeling analysis output shows estimated performance effectiveness for the period leading up to the incident, based on the employee work and reported sleep schedule. Estimates were based on the employee's work schedule, bed and wake times from the day before the incident and reported habitual sleep durations (10.25 hours a day, split in two periods). Bold portions of the modeled curve show work (in black) and sleep times (in blue). Effectiveness is shown on the vertical axis, with colored fields in the chart background signifying ranges of effectiveness scores including high effectiveness (>90%) in green, and low effectiveness (<65%) in red. Time is shown on the horizontal axis. Markers for work and sleep times are shown in the lanes above the time of day on the horizontal axis.

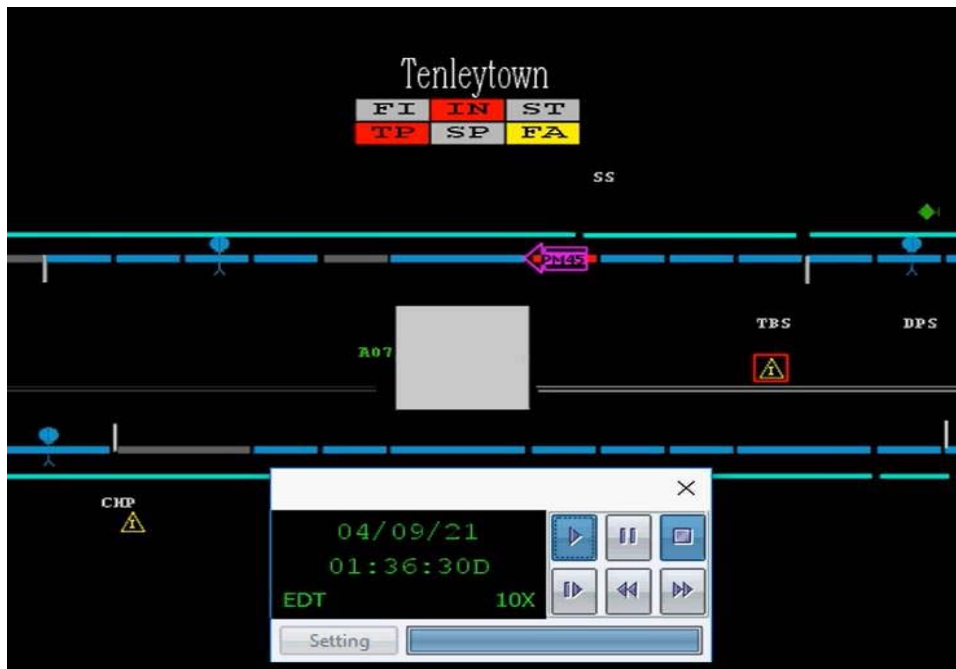
Diagram 1 - Based on the AIMS, at 01:36:30 hours, blue block, and human form status were in place before the PLNT-RWIC entered the roadway to hot stick and confirm that third rail power was de-energized between Tenleytown Station, Track 1 and Track 2.

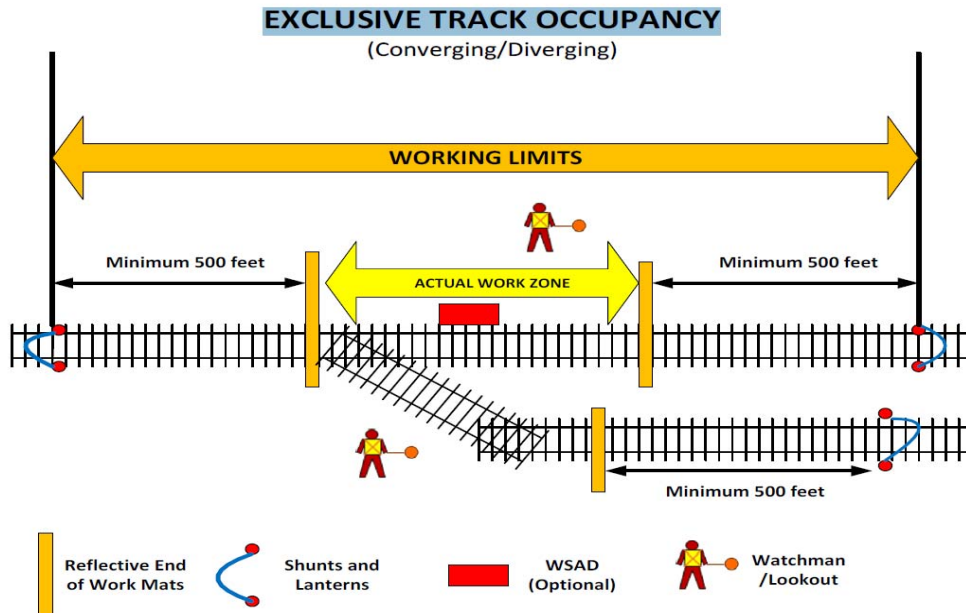
Diagram 2 – Correct ETO protection diagram.

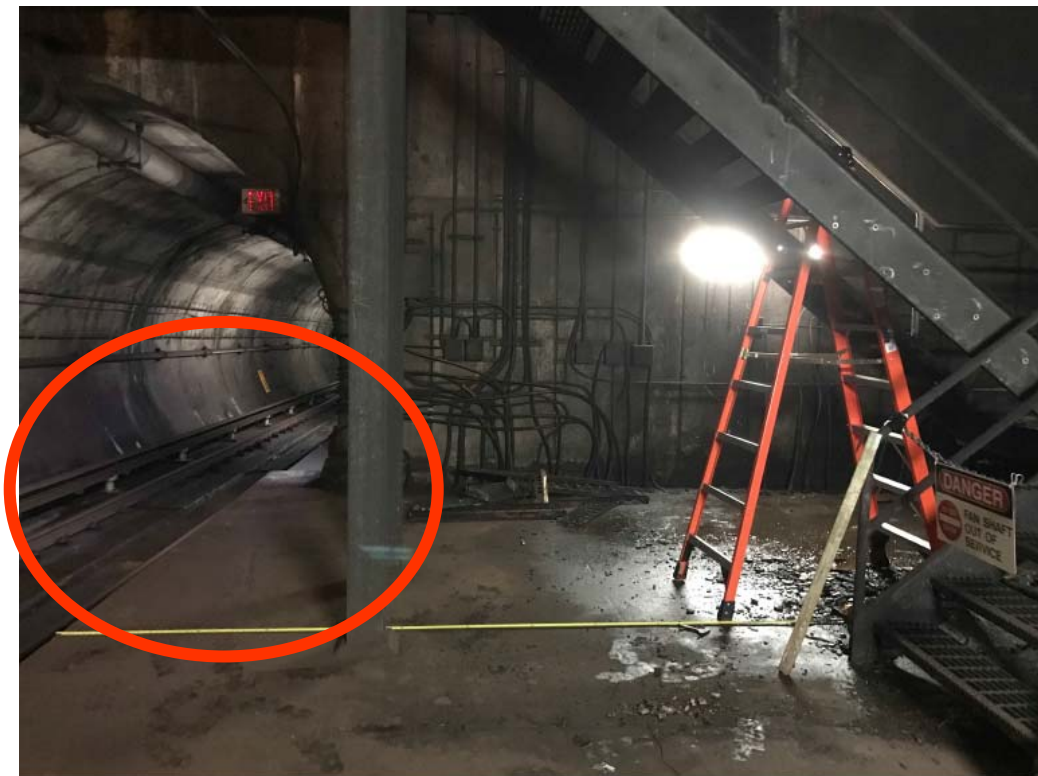
Although the work was performed away from the physical tracks, the work area is considered part of the right-of-way. The PLNT-RWIC downgraded their protection by not setting up required safety equipment, thus not following their stated on-track protection of ETO-Authority. This is not in compliance with the MSRP RWP, as detailed in section 5.13.7. An ETO RWP setup requires shunts to be located at 500 feet outside of each end of the working zone, red lanterns or e-flares, "END Work AREA" mats, and WSADS. **NOTE:** RWICs are not allowed under any circumstance

Figure 1 - The Tenleytown Station, Track 1, FA-10 Vent and Emergency Egress Shaft work location without handrails or protective railings on the edge of the platform, which means it is considered part of the roadway.

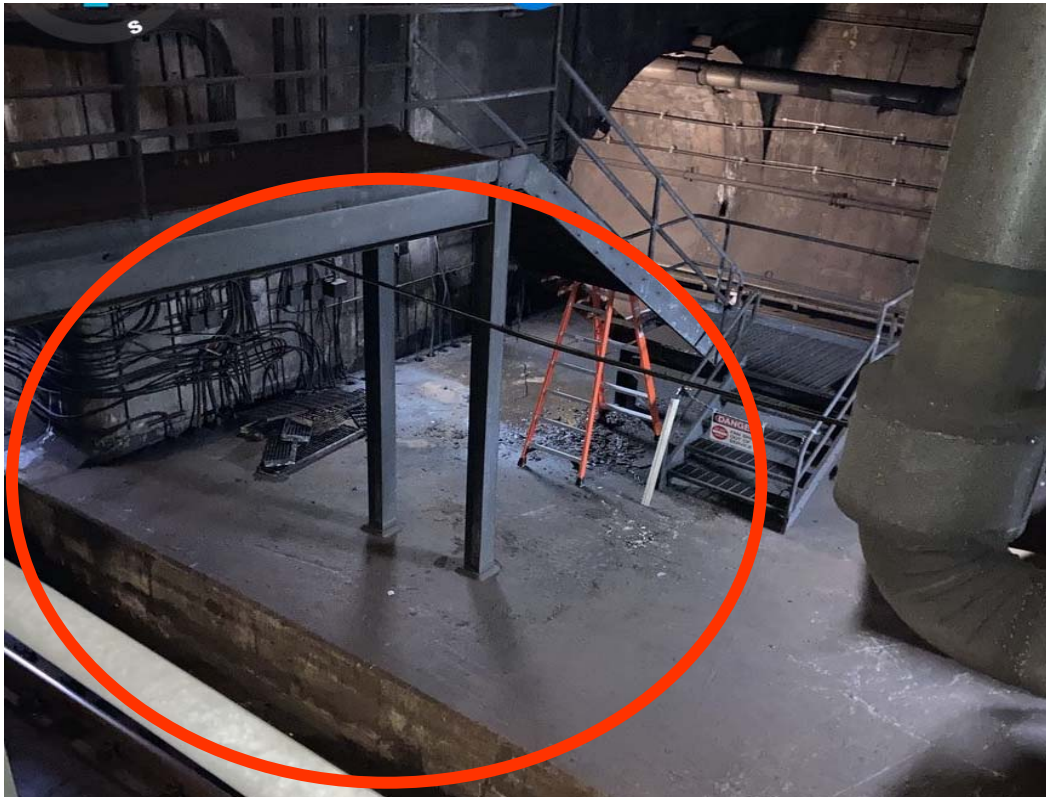
Figure 2 - The Tenleytown Station, Tracks 1 and 2, FA-10 Vent and Emergency Egress Shaft location without handrails or protective railings on the edge of the platform, which means it is considered part of the roadway.

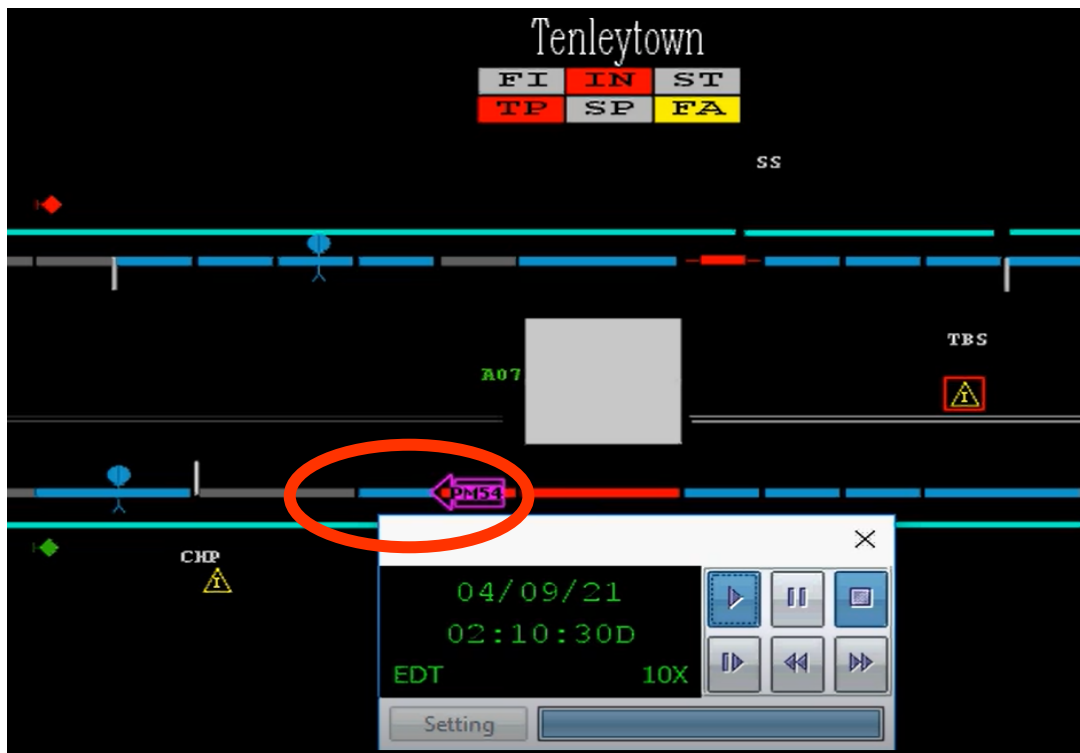
Diagram 3 - Based on the AIMS, at 02:10:30 hours, prohibit exits, block calls, cancellation of automatic signals, blue block, and human form status were in place when the rail vehicle operated through the PLNT-RWIC's work zone without permission.

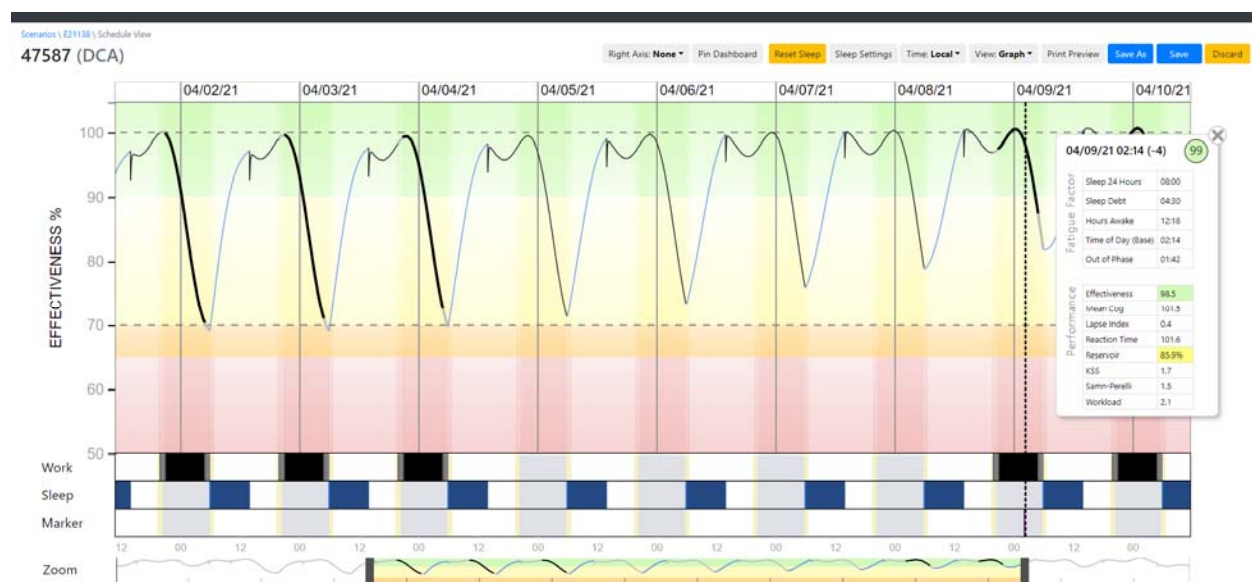
Since a fatigue risk factor was present, a biomathematical fatigue modeling application Sleep, Activity, Fatigue and Task Effectiveness - Fatigue Avoidance Scheduling Tool (SAFTE-FAST) was used to further evaluate fatigue risk factors that may have been present in the employee's schedule. The analysis was based on the employee's work schedule, bed and wake times from the day before the incident and reported habitual sleep durations. Despite the time of day, the estimated performance effectiveness at the time of the incident was 99%. This may be due to the effect of the controller's sleep schedule in the week leading up to the event. Maintaining a daytime sleep schedule can help shift the circadian clock into a better alignment with the night work schedule.

*Diagram 4 - Modeling analysis output shows estimated performance effectiveness for the period leading up to the incident, based on the employee work and reported sleep schedule. Estimates were based on the employee's work schedule, bed and wake times from the day before the incident and reported habitual sleep durations (10.25 hours a day, split in two periods). Bold portions of the modeled curve show work (in black) and sleep times (in blue). Effectiveness is shown on the vertical axis, with colored fields in the chart background signifying ranges of effectiveness scores including high effectiveness (>90%) in green, and low effectiveness (<65%) in red. Time is shown on the horizontal axis. Markers for work and sleep times are shown in the lanes above the time of day on the horizontal axis.*

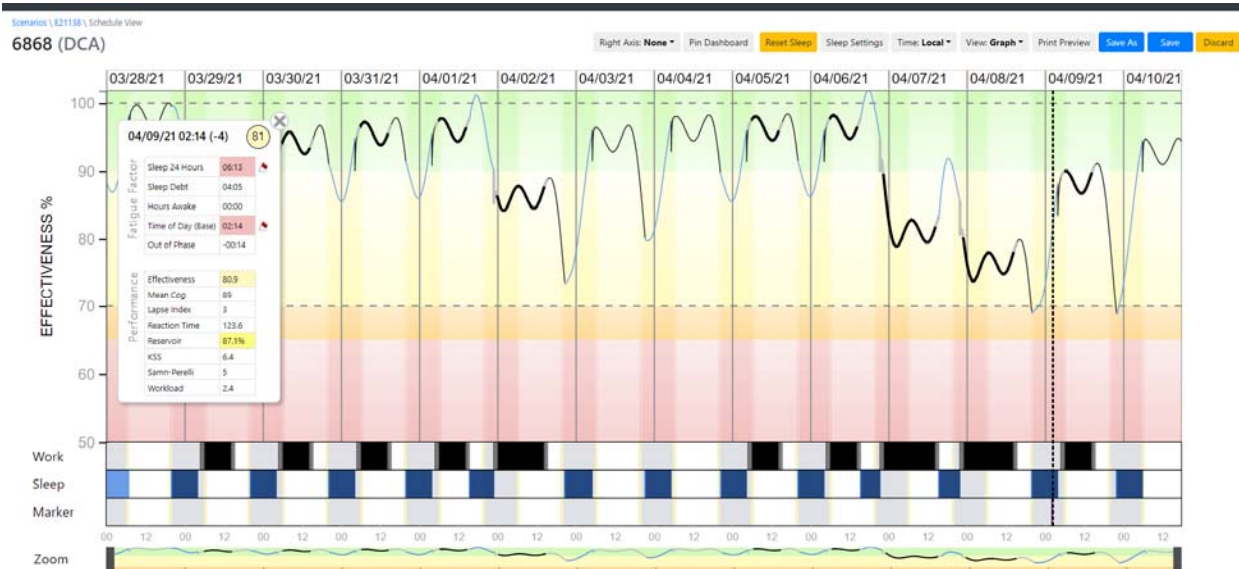
Since a fatigue risk factor was present, a biomathematical fatigue modeling application (SAFTE-FAST) was used to further evaluate fatigue risk factors that may have been present in the employee's schedule. The analysis was based on the employee's work schedule, bed and wake times from the days before the incident and reported habitual sleep durations. The estimated performance effectiveness at the time of the incident was 81%. The analysis confirmed time of day (i.e., performance impacted by the time of circadian low) and recent sleep duration as contributing to an increased risk of impaired performance at the time of the incident.

Diagram 5 - Modeling analysis output shows estimated performance effectiveness for the period leading up to the incident, based on the employee work and reported sleep schedule. Estimates were based on the employee's work schedule, bed and wake times from the day before the incident and reported habitual sleep durations (8 hours a day, split in two periods). Bold portions of the modeled curve show work (in black) and sleep times (in blue). Effectiveness is shown on the vertical axis, with colored fields in the chart background signifying ranges of effectiveness scores including high effectiveness (>90%) in green, and low effectiveness (<65%) in red. Time is shown on the horizontal axis. Markers for work and sleep times are shown in the lanes above the time of day on the horizontal axis.

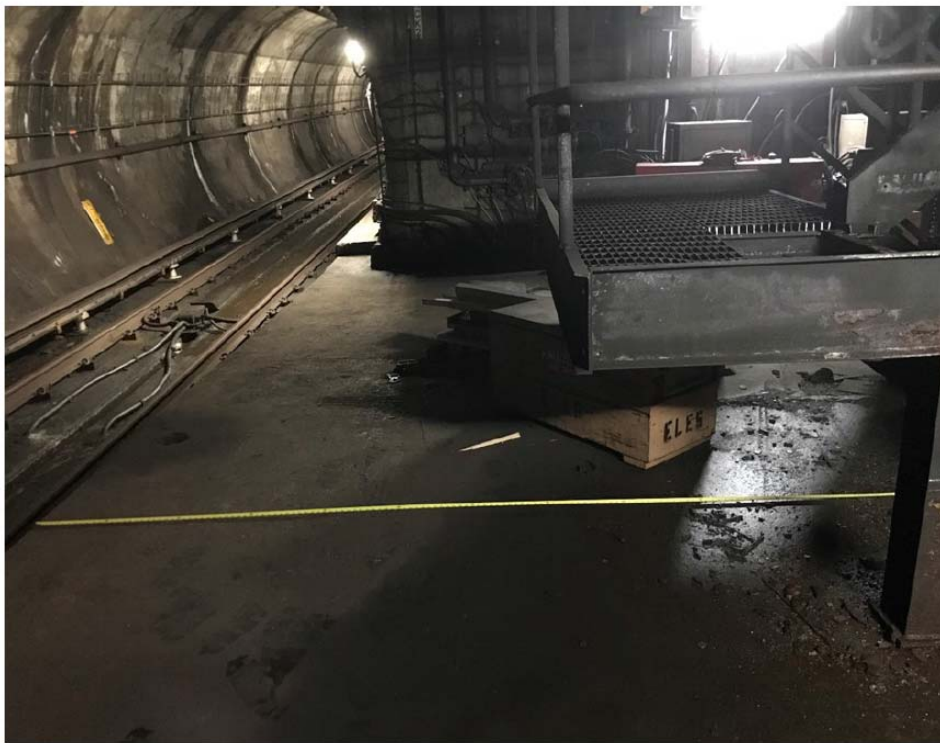
**Note: Egress Shafts, not protected by handrail, are considered Roadway.**

When setting up ETO work zones where power is deenergized, all applicable safety devices shall be installed including; shunts, lights, mats and WSADs.

The RWIC is **not** allowed under any circumstances to downgrade or deviate from the established Roadway Worker Protection procedures.
