**WMSC Commissioner Brief: W-0109 – Derailment – near Farragut West Station – April 29, 2021**

Prepared for Washington Metrorail Safety Commission meeting on September 21, 2021

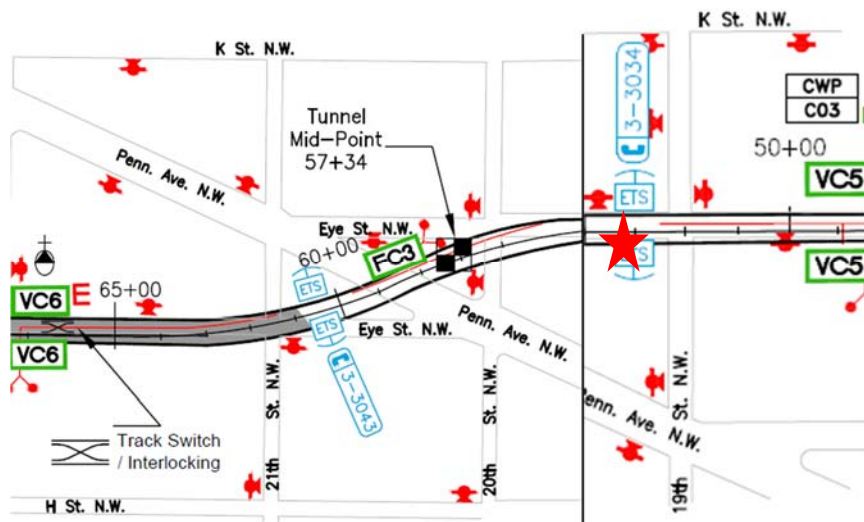
Diagram 1 - TR06 was the lead unit in a convoy block with ST03.

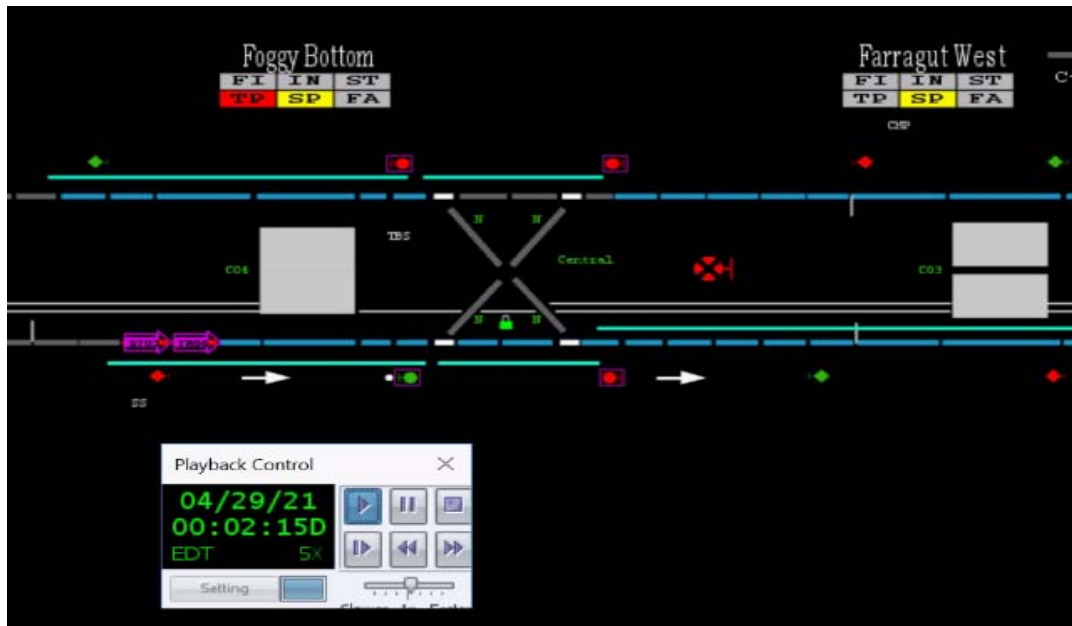
Diagram 2 - Based on the AIMS playback, at 00:02:15 hours, the teal symbol on the AIMS power display shows that the third rail power was de-energized before TR06 entered Foggy Bottom Station, Track 1.

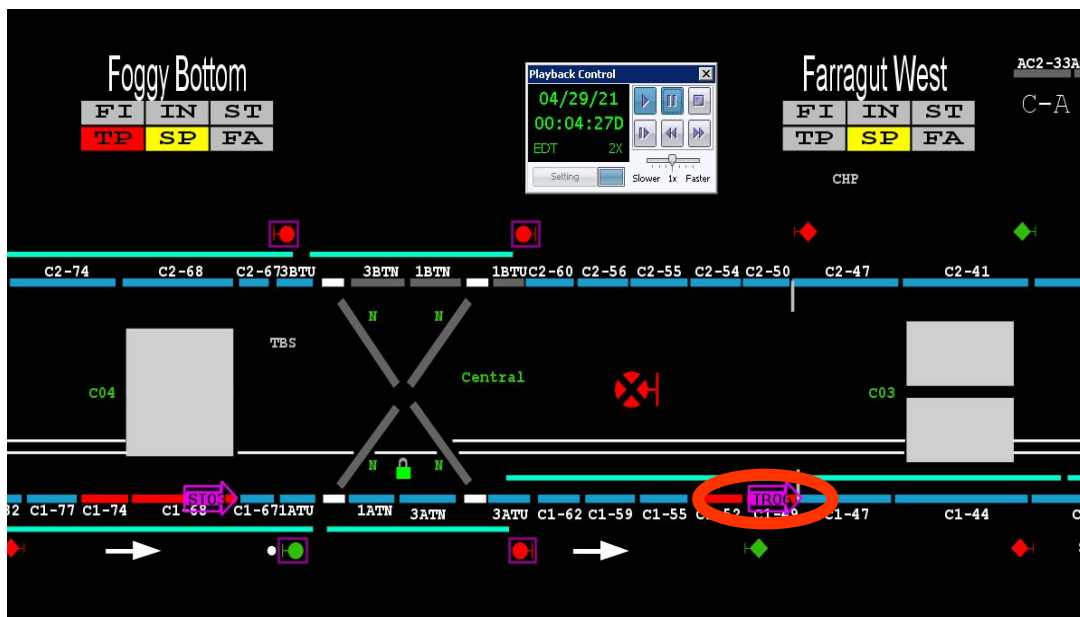
Diagram 5 - Based on the AIMS playback, at 00:04:27 hours, TR06 came to a stop, occupying track circuits C1-52 and C1-49.

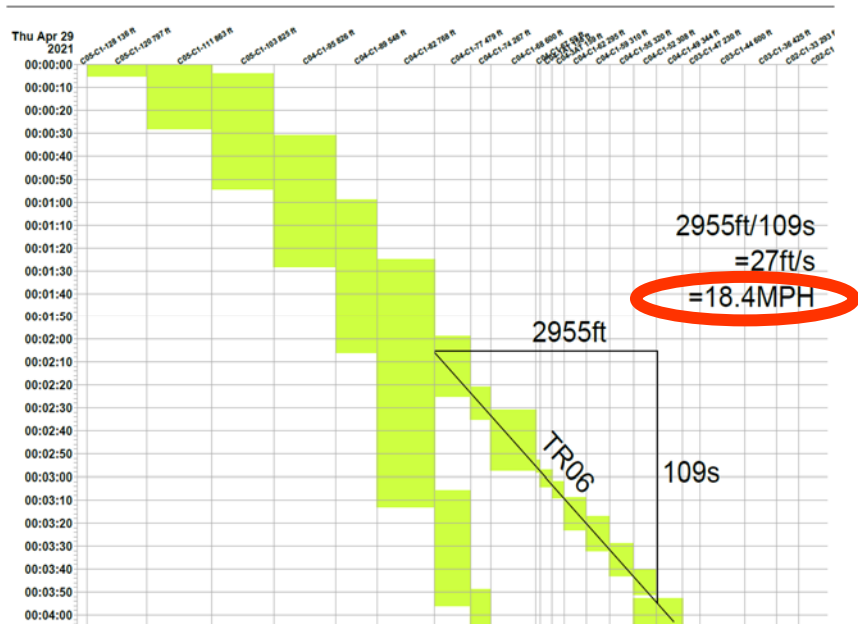
ITSS track circuit occupancy chart revealed speed calculation for the mostly-shunting machine labeled TR06 in AIMS playback. Based on AIMS playback, TR06 came to a stop, occupying track circuits C1-52 and C1-49 at 00:04:27 hours. The black diagonal line drawn through the green occupancies on the occupancy chart showed TR06 moving 2955 feet in the 109 seconds before it stopped. This translates to an average speed of 27 ft/s or 18.4 mph.

Diagram 6 – This illustration represents a track occupancy chart showing the calculation of TR06's average speed. The black diagonal line drawn through the green occupancies on the occupancy chart shows TR06 moving 2955 feet in the 109 seconds before it stopped; 2955 feet in 109 seconds is 27 ft/s or 18.4 mph.

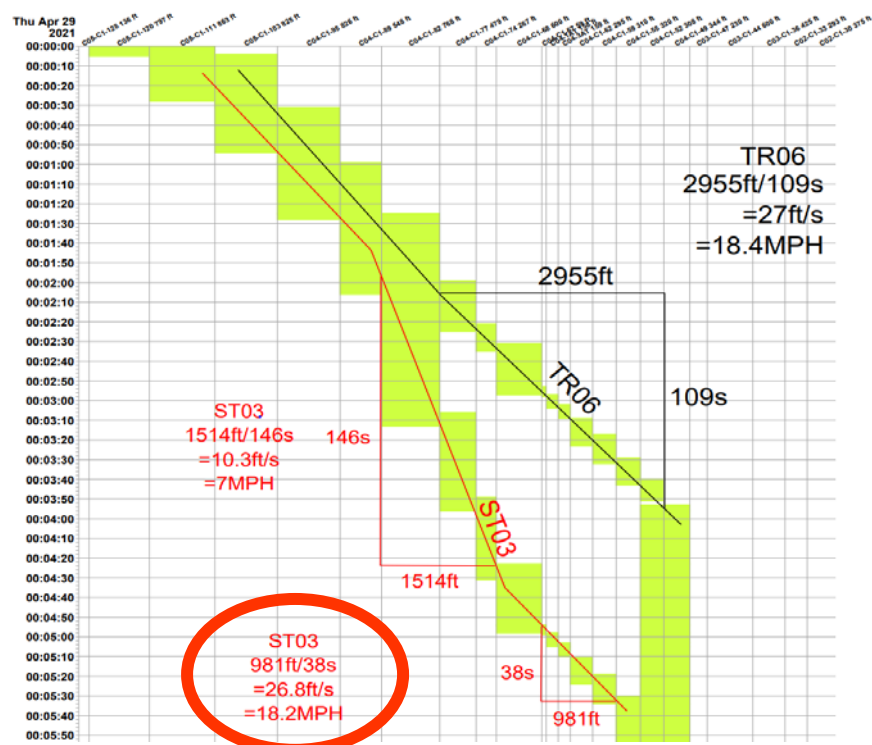
Diagram 7 – This illustration represents a track occupancy chart showing the calculation of ST03's average speed. ST03 progress and speed calculations are shown in red in two distinct segments. First, ST03 traveled at an average speed of 7 mph, from 00:01:57 hours to 00:04:23 hours. Then, from 00:04:23 hours to 00:04:54 hours, ST03 accelerated (increased its speed). As a result, ST03 traveled at an average speed of 18.2 mph, from 00:04:54 hours to approximately 00:05:32 hours.

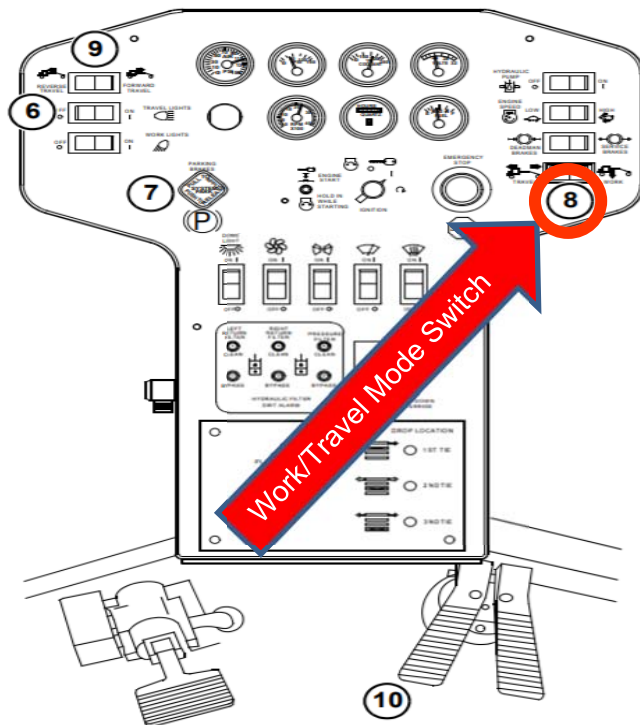
- TRST's investigation verified that an alarm was installed on TR06 to warn the operator that the unit is not in proper mode for travel. The Equipment Operator AA acknowledged that the alarm on TR06 activated when they switched it from travel mode to work mode. It remained activated before the derailment. The Equipment Operator AA failed to follow MSRPH Cardinal Rule Section 4.3, which states, "Employees shall not alter or render inoperative and safety devices on vehicles, equipment, structures and/or any other WMATA property, except as authorized by these rules or other WMATA procedures, and then only when proper measures are taken to safeguard personnel and equipment."

Figure 2 - This illustration represents the TR06 operator's center-enclosed cab panel. The Equipment Operator AA placed the work/travel switch to the work mode.

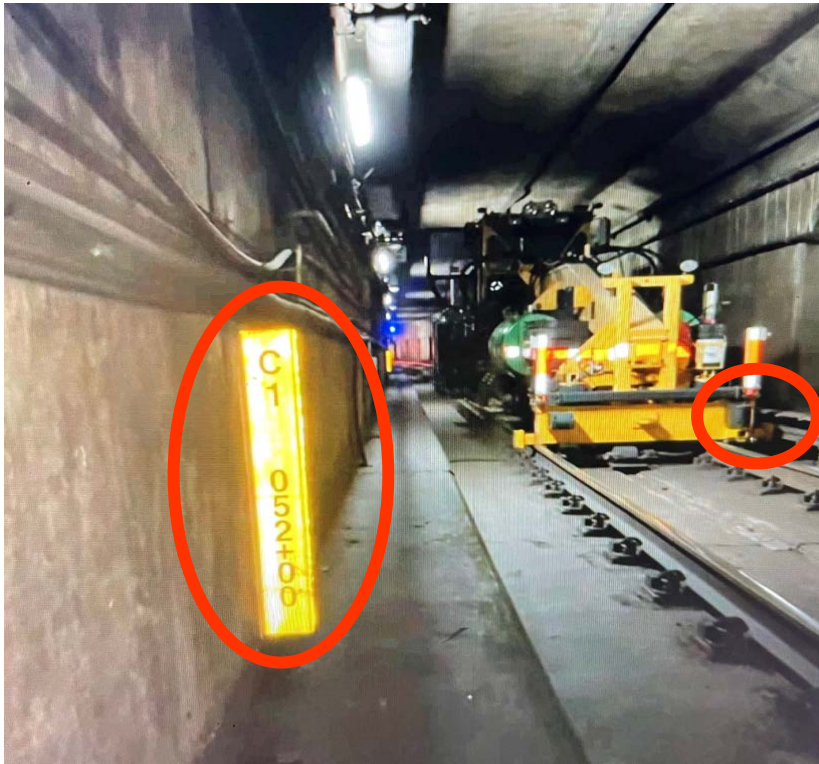
Figure 3 - TR06 derailed between CM C1-052+00 to CM C1-053+00 and made contact with the third rail.

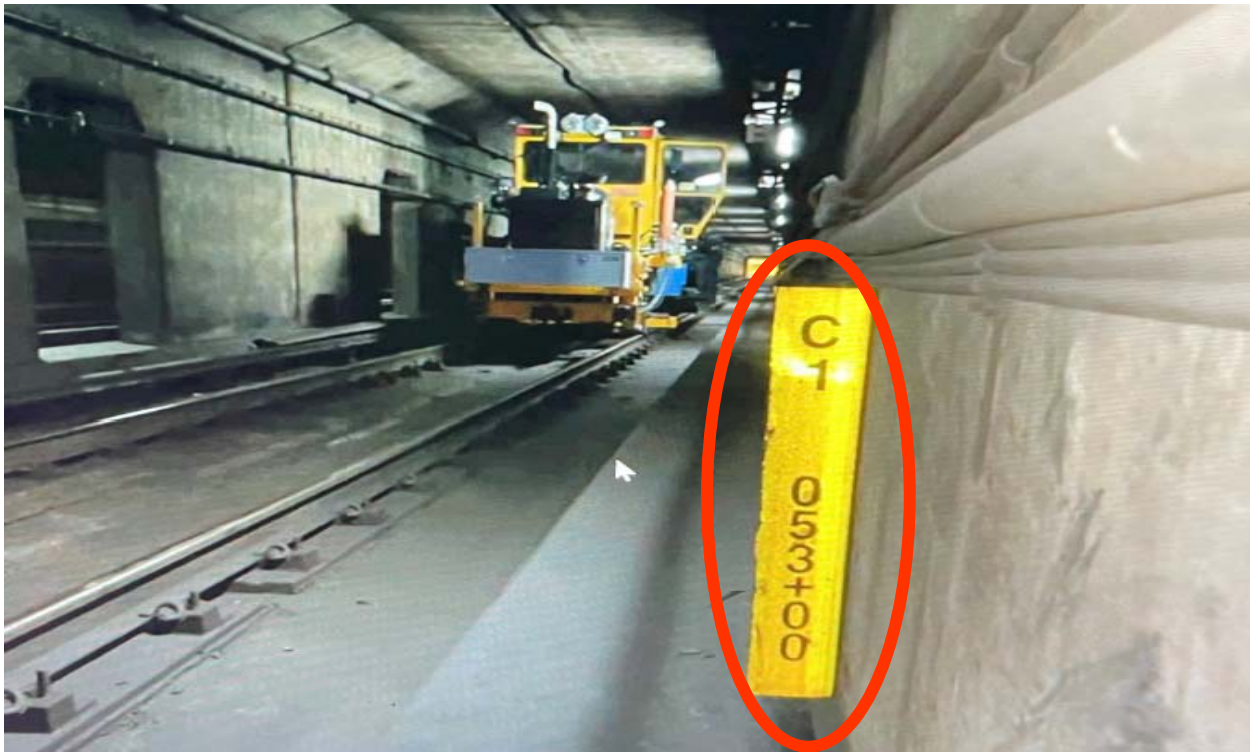
Figure 4 - TR06 derailed between CM C1-052+00 to CM C1-053+00 and made contact with the third rail.

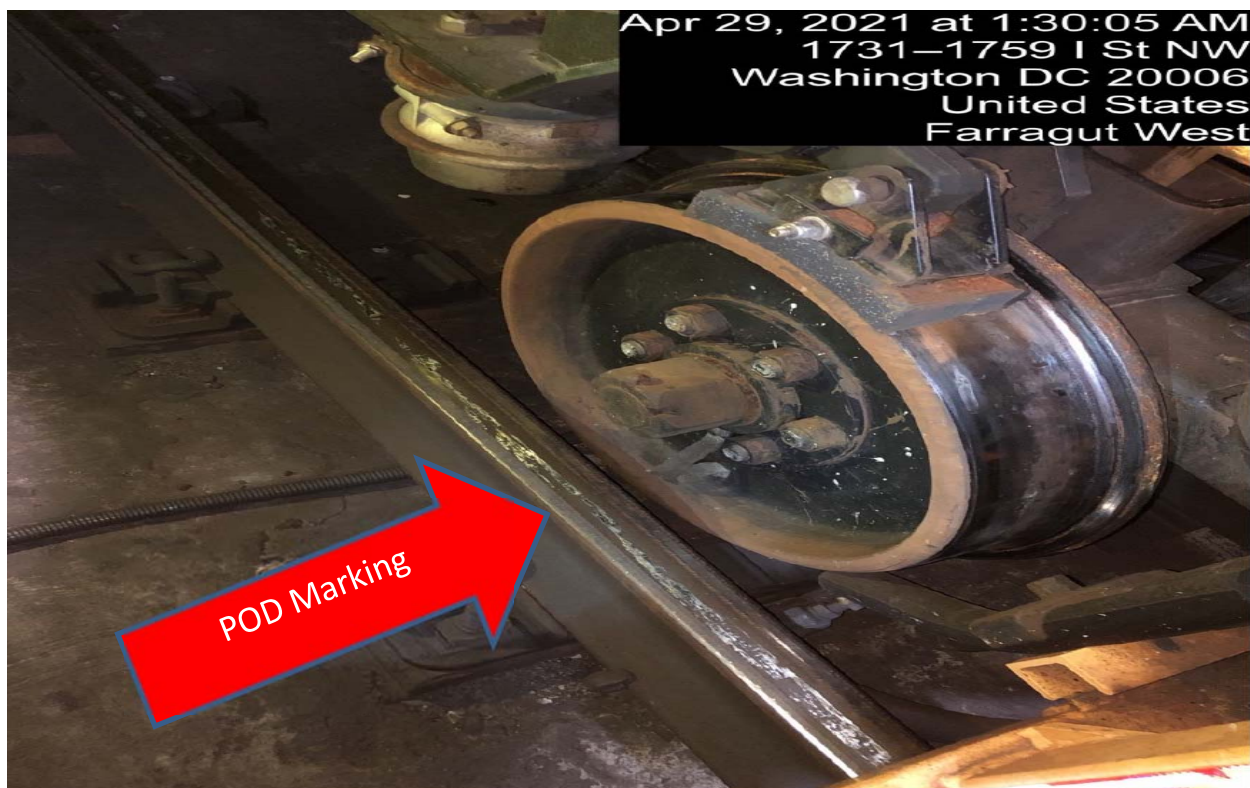
Figure 5 - Wheel climb Point of Derailment (POD) marking of TR06's front truck. The Point of Rest (POR) was approximately 3-6 inches away from the derailment location.

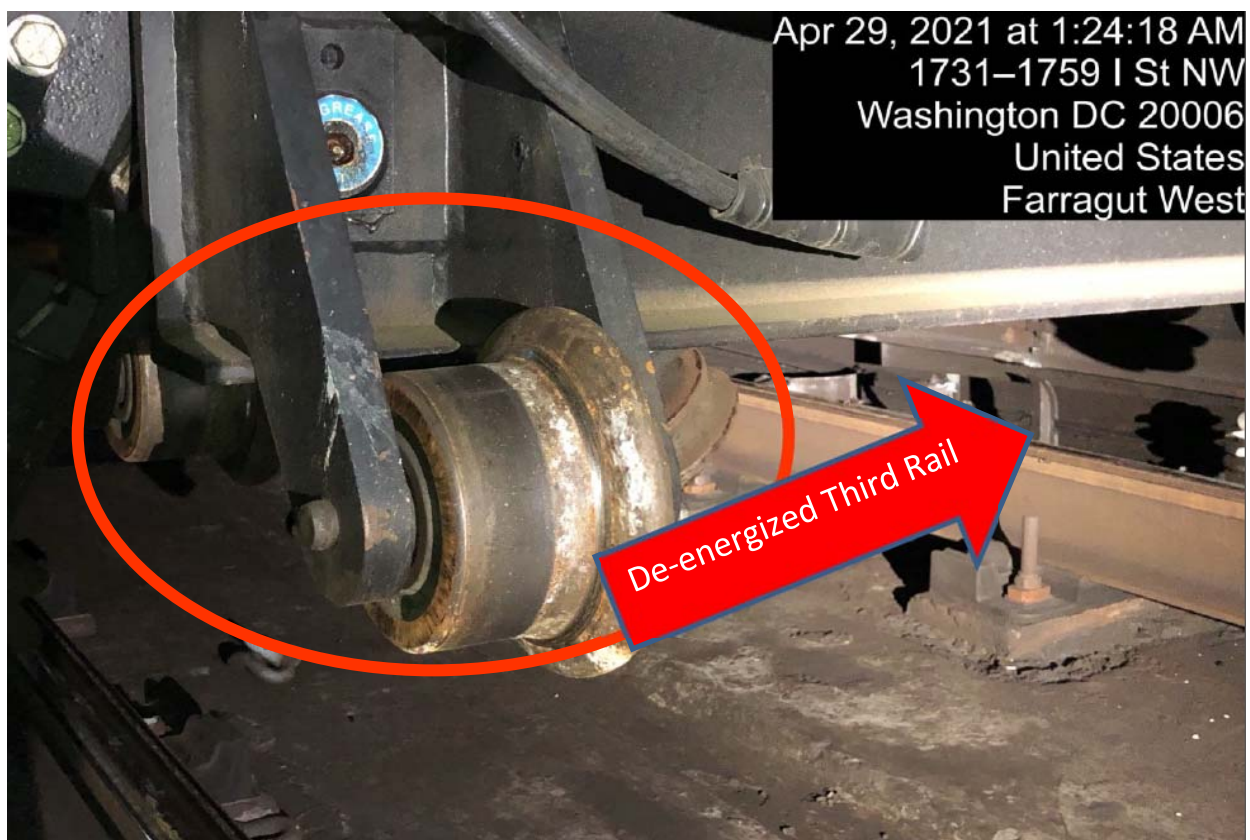
Figure 6 – TR06 rail clamp rollers, frame wheels derailed, and TR06 contacted the third rail.

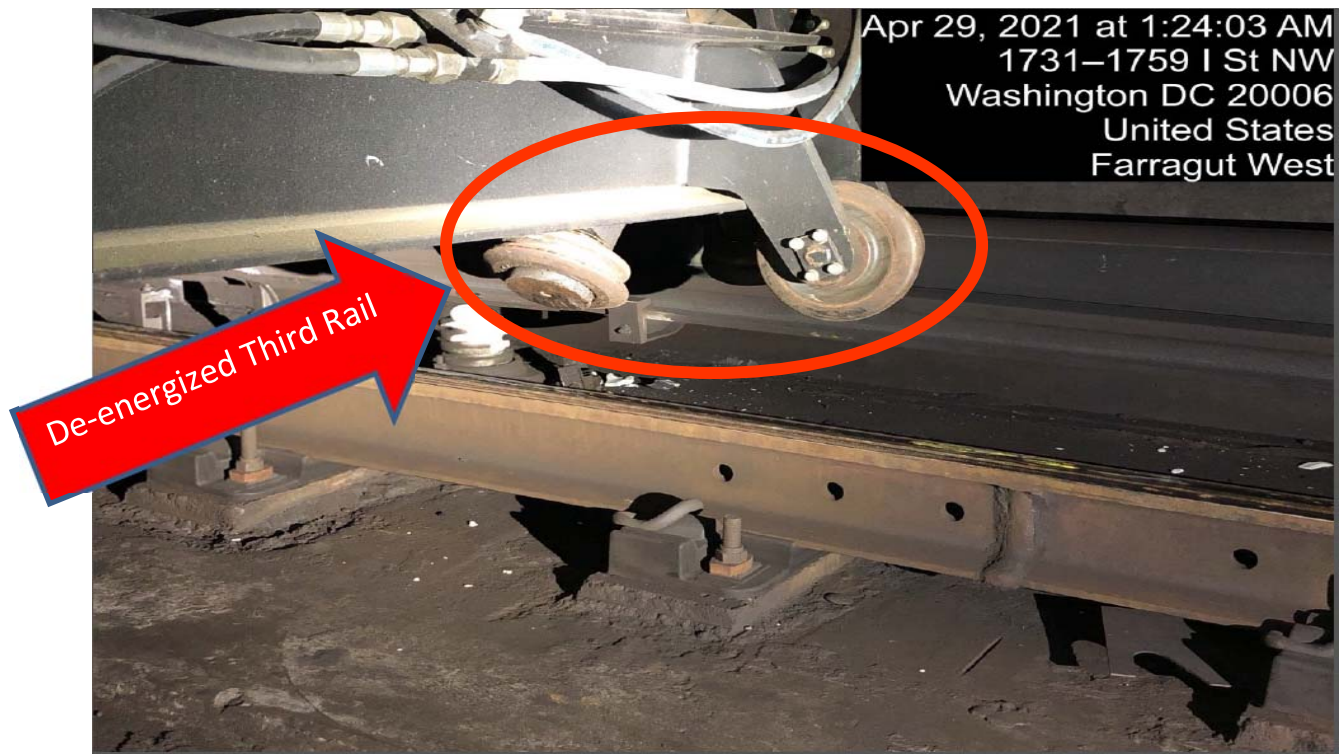
Figure 7 – TR06 rail clamp rollers, frame wheels derailed, and TR06 contacted the third rail.
