WMSC Commissioner Brief: W-0111 – Serious Injury – Shaw-Howard U Station – April 12, 2021

Washington Metro Area Transit Authority
Department of Safety and Environmental
Management (SAFE)
FINAL REPORT OF INVESTIGATION A&I E21142

**Shaw Howard U Station – Serious Injury
April 12, 2021**

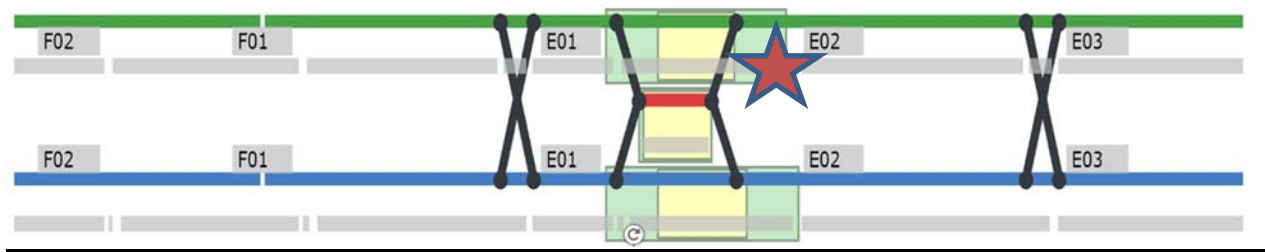
Field Sketch/Schematics

Track 1 Actual Work Area: E038+00 E046+66 Protected Work Area: E033+00 E051+66

Track 2 Actual Work Area: E038+00 E045+30 Protected Work Area: E033+00 E050+30

Track 3 Actual Work Area: E036+51 E043+19 Protected Work Area: E036+27 E043+27

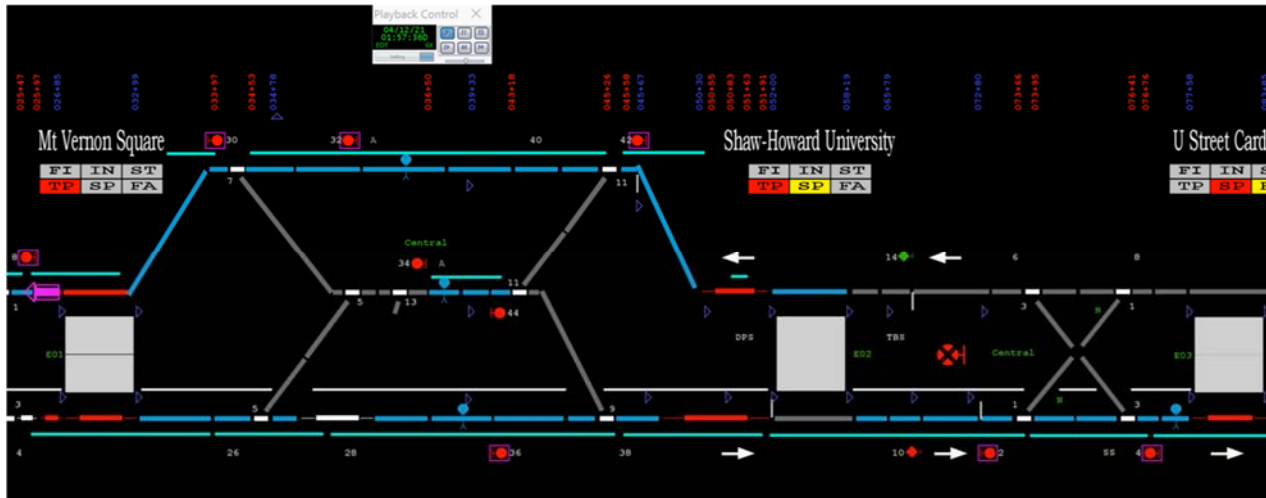
Diagram 1 – Third rail Power de-energized between the respective CM's and pocket track in the Fire Protection Technician work location.

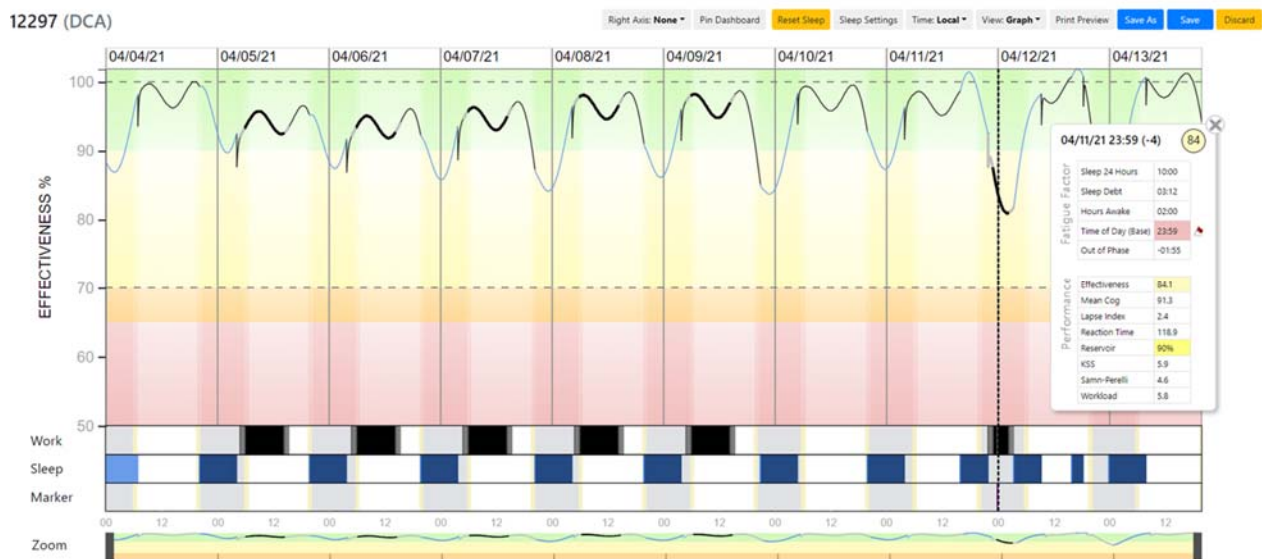
Since a fatigue risk factor was present, a biomathematical fatigue modeling application (SAFTE-FAST WebSFC) was used to further evaluate fatigue risk factors that may have been present in the employee's schedule. The analysis was based on the employee's work schedule, bed, and wake times from the day before the incident, and reported habitual sleep durations. The estimated performance effectiveness at the time of the incident was 84%. The analysis confirmed time of day, i.e., performance impacted by the time of circadian low, as contributing to an increased risk of impaired performance at the time of the incident.

Modeling analysis output shows estimated performance effectiveness for the period leading up to the incident, based on the Fire Protection Technician work and reported sleep schedule. Estimates were based on the employee's work schedule, bed, and wake times from the day before the incident and reported habitual sleep durations (6 hours of sleep in the evening leading up to the incident, a total of 10 hours of sleep on the 24 hours preceding the incident, and a habitual sleep duration of 9 hours). Bold portions of the modeled curve show work (in black) and sleep times (in blue). Effectiveness is shown on the vertical axis, with colored fields in the chart background signifying ranges of effectiveness scores, including high effectiveness (>90%) in green and low effectiveness (<65%) in red. Time is shown on the horizontal axis. Markers for work and sleep times are shown in the lanes above the time of day on the horizontal axis.

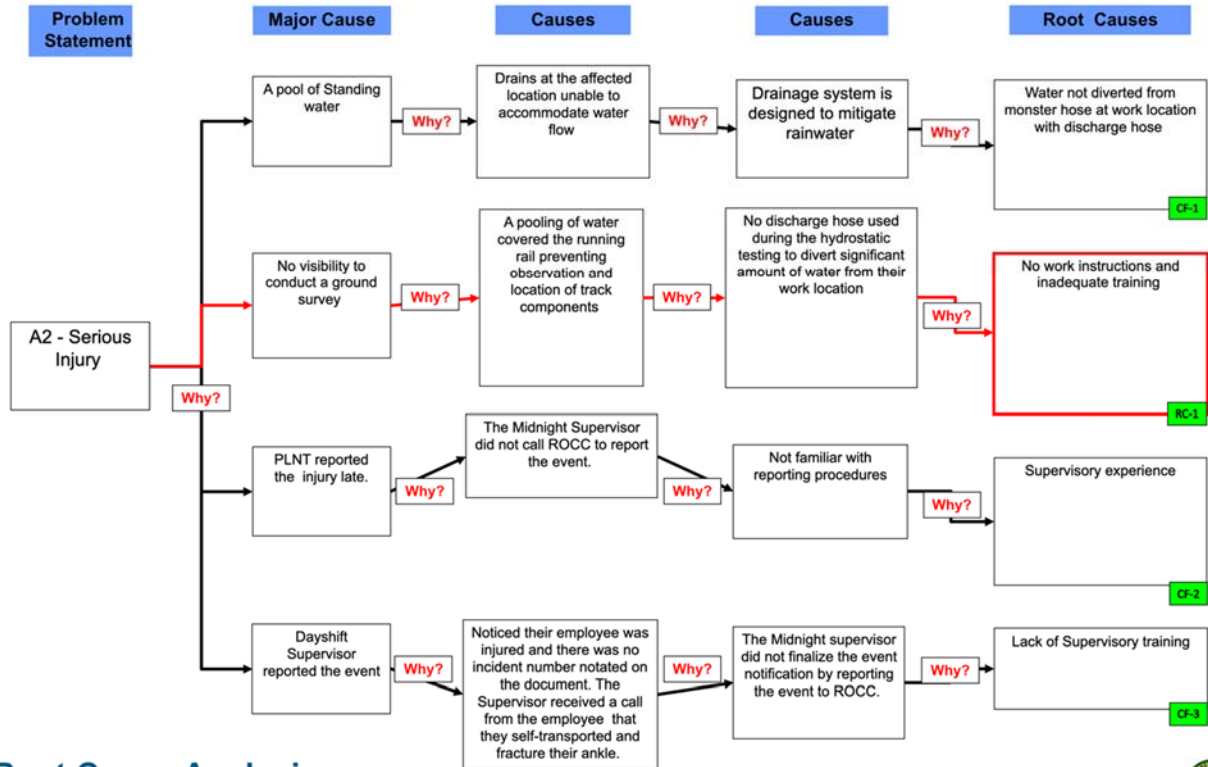
Attachment 1 – Root Cause Analysis page 1 of 1.

The probable cause of the serious injury at Shaw Howard U Station on April 12, 2021, was the absence of a Testing and Maintenance Checklist outlining the use of a discharge hose to divert water from a work location while conducting annual testing. While the processes and checklists that were developed for usage were submitted as part of a CAP Closure, management was unsure of their approval status on the date of the incident.

The absence of proper work instructions and insufficient training caused a standing water condition that prevented the Fire Protection Technician from surveying the trackbed for hazardous ground conditions such as track components. Consequently, driving the Fire Protection Technician to fracture their ankle after unknowingly positioning their foot on the running rail while removing equipment on the roadway.

Corrective Action Code	Description	Responsible Party	Due Date
92752_SAFE CAPS_PLNT _001	(CF-1) Develop a lessons learned for those that perform this function to ensure employees use a discharge hose to divert water from the monster hose at a work location	PLNT	3/25/2021
92752_SAFE CAPS_PLNT _002	(RC-1) Develop a test and maintenance checklist that outlines standpipe and hydrostatic testing processes.	PLNT	3/25/2021
92752_SAFE CAPS_PLNT _003	(CF1, CF3) Re-instruct management on injury reporting procedures and undergo incident and investigation training	PLNT	4/16/2021
92752_SAFE CAPS_PLNT _004	(RC-1) Enroll the Fire Protection Technician in a body mechanics training course.	PLNT	6/12/21
