WMSC Commissioner Brief: W-0112 – Serious Injury – Clarendon Station – May 8, 2021

FINAL REPORT OF INVESTIGATION A&I E21194

Clarendon Station – Serious Injury

May 8, 2021

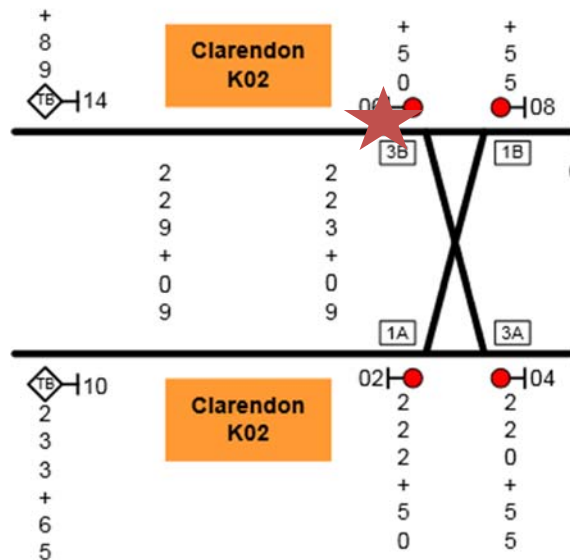
Field Sketch/Schematics

Outside of Clarendon Station, Track 2

**Incident Location is approximated based on video review and MTPD report*

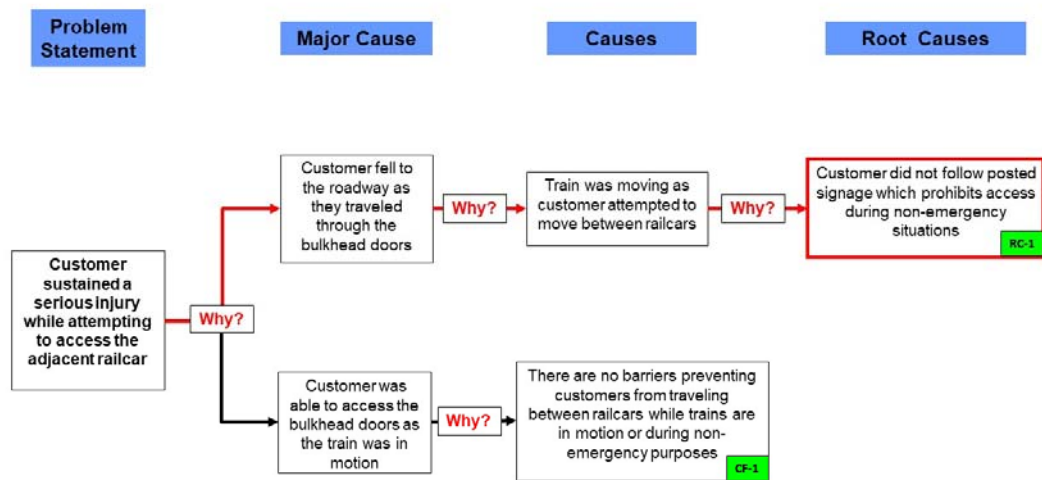
Appendix A - Root Cause Analysis

The probable cause of this event was failure to follow posted signage which prohibits customers from passing through WMATA railcar bulkhead doors, except for emergency purposes.

As the injured person bypassed standard warning devices in order to access bulkhead doors, there are no immediate recommendations or corrective actions related to this incident. The doors in question are required to remain accessible for use during emergencies and cannot be secured as part of normal operations. WMATA will continue to work to identify solutions to the prevent unauthorized persons from moving between rail cars while remaining compliant with emergency evacuation requirements.

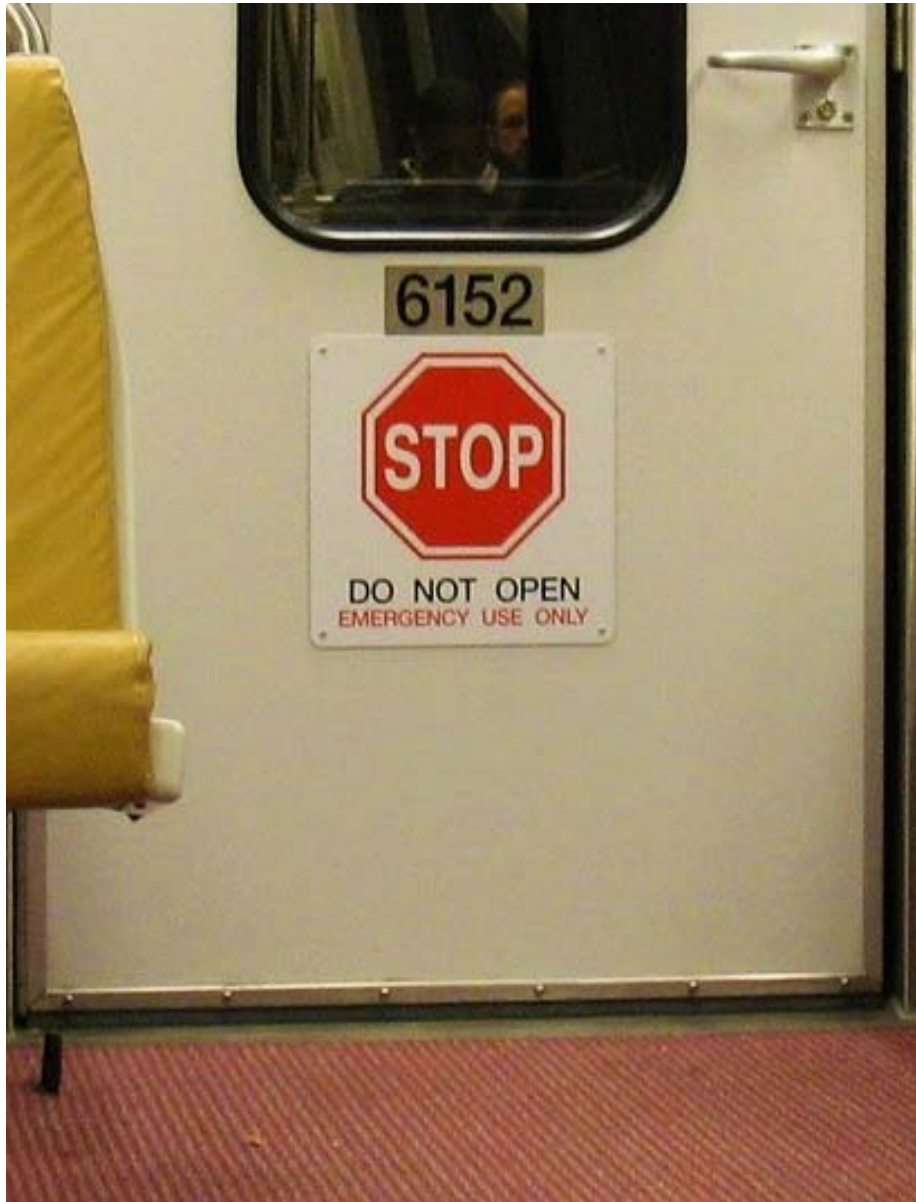
Picture 3 – Sample bulkhead signage on WMATA Railcar prohibiting passage except for emergency use only. (6000 series).

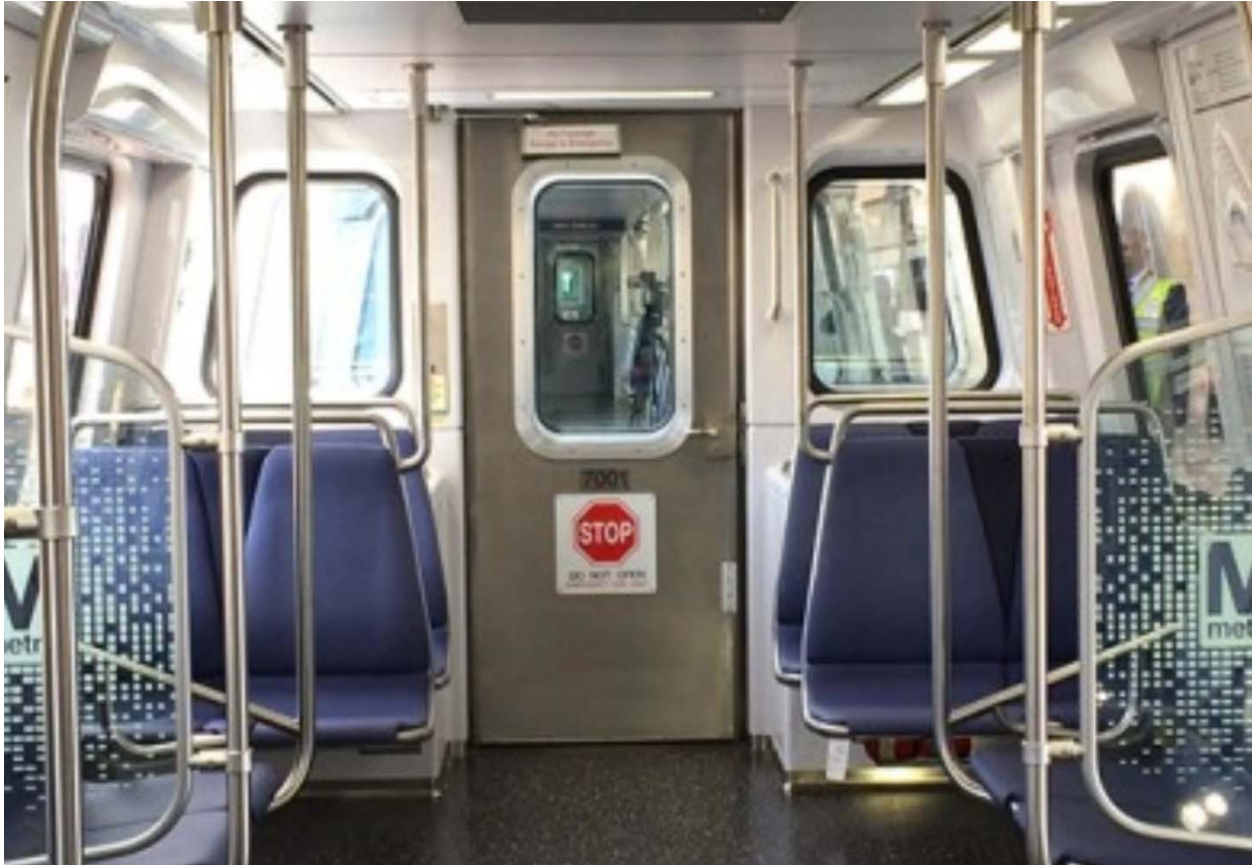
Metrorail has safety warning signage on end-of-railcar doors stating that the doors are for emergency use only. This event occurred on a 7000 Series train, a series that has signage just below the car number and window on these end-of-railcar doors that includes a stop sign with the word stop, "DO NOT OPEN EMERGENCY USE ONLY".

Picture 2 – Sample bulkhead signage on WMATA Railcar prohibiting passage except for emergency use only. (7000 series).
