**WMSC Commissioner Brief: W-0115 – Collision, Customer Fatality – Near Rhode Island Ave Station – June 6, 2021**

Washington Metro Area Transit Authority  
Department of Safety and Environmental  
Management (SAFE)  
FINAL REPORT OF INVESTIGATION A&I E21232

<b>Date of Event:</b>	06/06/2021
<b>Type of Event:</b>	Collision
<b>Incident Time:</b>	16:43 hours.
<b>Location:</b>	CM B2-171+00
<b>Time and How received by SAFE:</b>	17:06 hours. SAFE On-Call Phone
<b>WMSC Notification Time:</b>	18:35 hours.
<b>Responding Safety Officers:</b>	WMATA: No WMSC: No Other: No
<b>Rail Vehicle:</b>	Train ID 108 [L7474-7475.7461-7460.7284-7285.7463-7462T],
<b>Injuries:</b>	Fatality
<b>Damage:</b>	No
<b>Emergency Responders:</b>	DCFEMS, MTPD, RTRA, ERT and CMNT
<b>SMS I/A Incident Number:</b>	20210606#93707MX

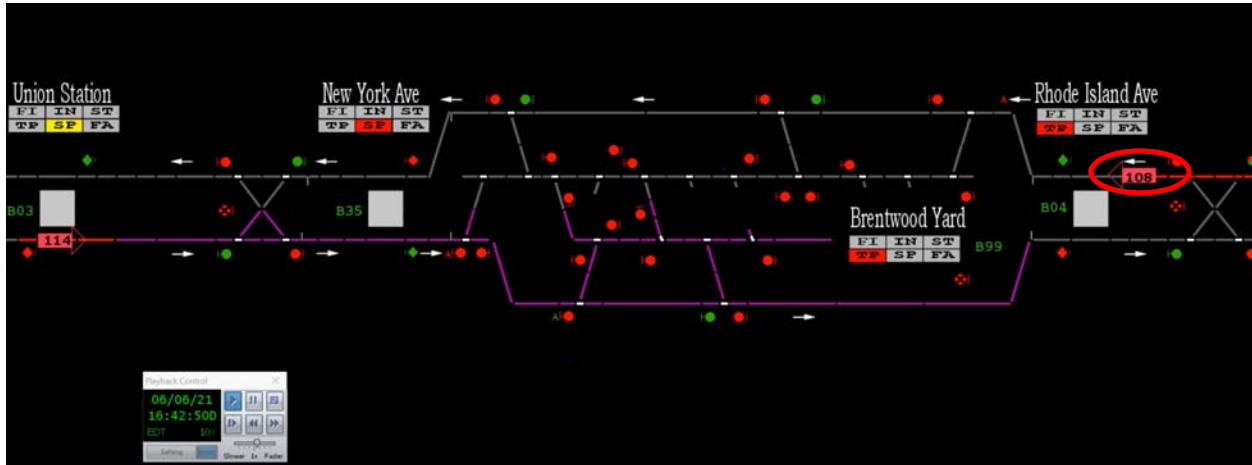
Diagram 1 - Based on the AIMS playback, Train ID 108 passed CM B2-171+00, in the direction of Rhode Island Avenue Station at 16:42:50 hours, which appears to be when they reported they heard a loud noise and didn't know what it was per ARS.

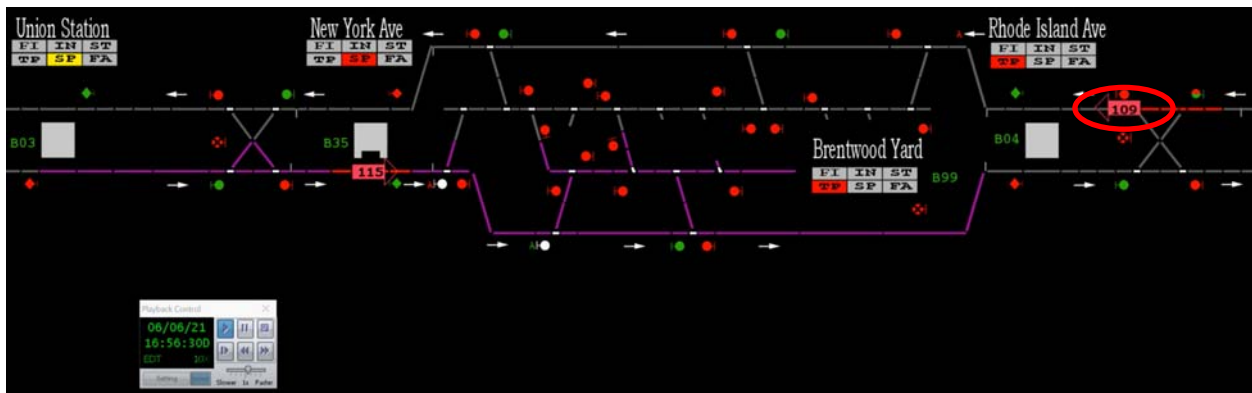
Diagram 2 - Based on the AIMS playback, Train ID 109 arrived at CM B2-171+00, in the direction of Rhode Island Avenue Station at 16:56:30 hours, which appears to be when they reported a person was lying down between the running rail and the catwalk, per ARS.

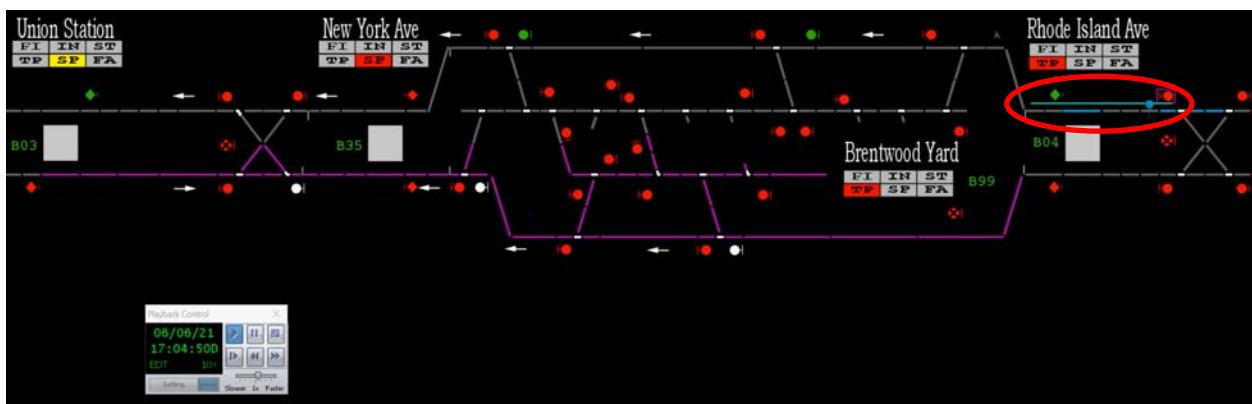
Diagram 3 - Based on the AIMS, at 17:04:50 hours, Train ID 109 reversed ends. The ROCC subsequently de-energized third rail power and prohibit exits, block calls, cancellation of automatic signals, blue block, and human form status at CM B2-171+00.

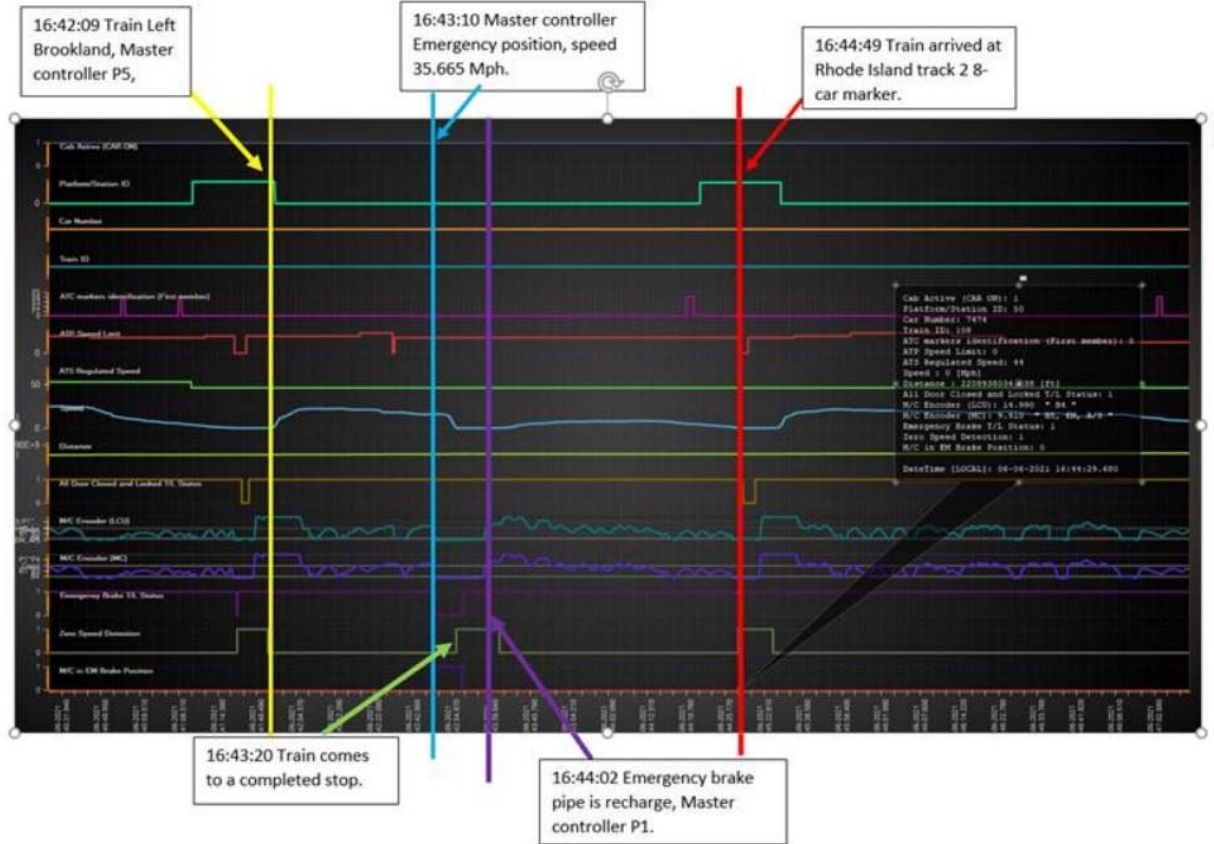
Diagram 4 - ER Graphical Analysis from Lead Car 7474

<b>Time</b>	<b>Description</b>
16:42:09 hrs.	Train ID 108 departed Brookland Station, Track 2, with the Master Controller (MC) in the P5 position.
16:43:09 hrs.	Train ID 108 contacted the person on the roadway with a train speed at 35.54 mph, 644 feet away from Rhode Island Avenue Station, Track 2 platform limits.
16:43:10 hrs.	Train ID 108 Train Operator moved the MC from the P1 to the emergency position, initiating an emergency braking application. The consist speed was 35.66 mph, 594.73 feet away from Rhode Island Avenue Station, Track 2 platform limits.
16:43:20 hrs.	Train ID 108 came to a complete stop 270.681 feet after initiating an emergency brake and was 324.05 feet away from Rhode Island Avenue Station, Track 2 platform limits.
16:43:53 hrs.	Train ID 108 emergency brake pipe was recharged, and the Full-Service Brake (FSB) Trainline (T/L) showed energized.

16:44:02 hrs.	Train ID 108 Train Operator moved the MC to the P1 position. Train ID 108 then continued in the direction to Rhode Island Avenue Station, Track 2.
16:44:49 hrs.	Train ID 108 Train Operator berthed the train at Rhode Island Avenue Station, Track 2, 8-car marker.

**Note:** Based on the CMOR IIT post-incident analysis, there were no braking or propulsion faults or any data to support any anomalies with the consist that may have contributed to this incident.

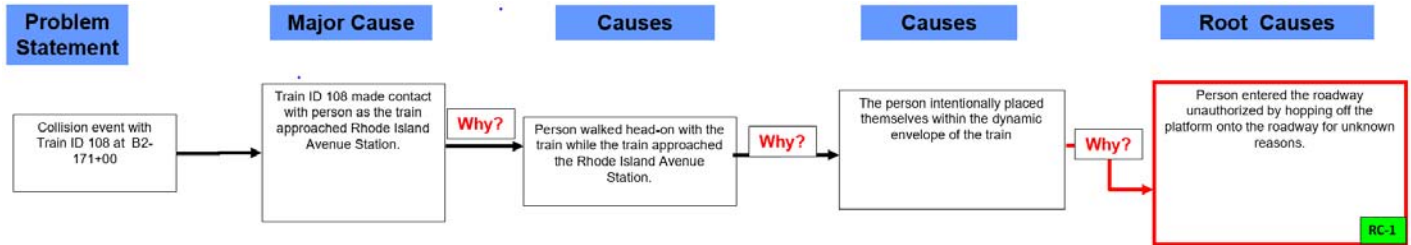
## Appendix D - Root Cause Analysis

The probable cause of this collision event was the intentional actions of the person entering the rail right-of-way without authorization for an unknown reason. As Train ID 108 approached the Rhode Island Avenue Station, the person fouled the dynamic envelope of the train and appeared to attempt to jump back on the catwalk before being struck by Train ID 108, Lead Car 7474. Based on Train ID 108's front-facing video, the environmental conditions were favorable and showed a clear day with good visibility. The person appeared in the front-facing video line of sight for approximately three seconds before the train made contact with the person on the roadway. However, during the virtual interview, the Train ID 108 Train Operator was unaware of a person on the roadway. The Train Operator reported that while passing the Rhode Island Avenue Station interlocking, they made their observation for a lunar signal and heard a loud noise. The Train ID 108 Train Operator stated they immediately placed the MC in the emergency position, stuck their head out the window, and did not see anything unusual during their visual inspection. The Train Operator notified the ROCC and requested the next train en route to the Rhode Island Avenue station conduct a track inspection based on the loud noise they heard. The ROCC instructed the Train ID 108 Train Operator to proceed on Rhode Island Avenue Station platform without performing a ground walk around after they reported no troubles were displaying on their console and the Train Operator found nothing during their visual inspection. The person being struck by Train ID 108 appeared to be accidental as the MTPD report revealed that the camera view in the cab area of the Train Operator appeared to show that the operator was not distracted at the time of the collision event.

There are no recommendations as mitigation for this event due to the person intentionally jumping off the platform, fouling the train's dynamic envelope.
