**WMSC Commissioner Brief: W-0116 – Evacuation, Runaway Train – Near Rhode Island Ave Station – March 26, 2021**

Prepared for Washington Metrorail Safety Commission meeting on October 26, 2021

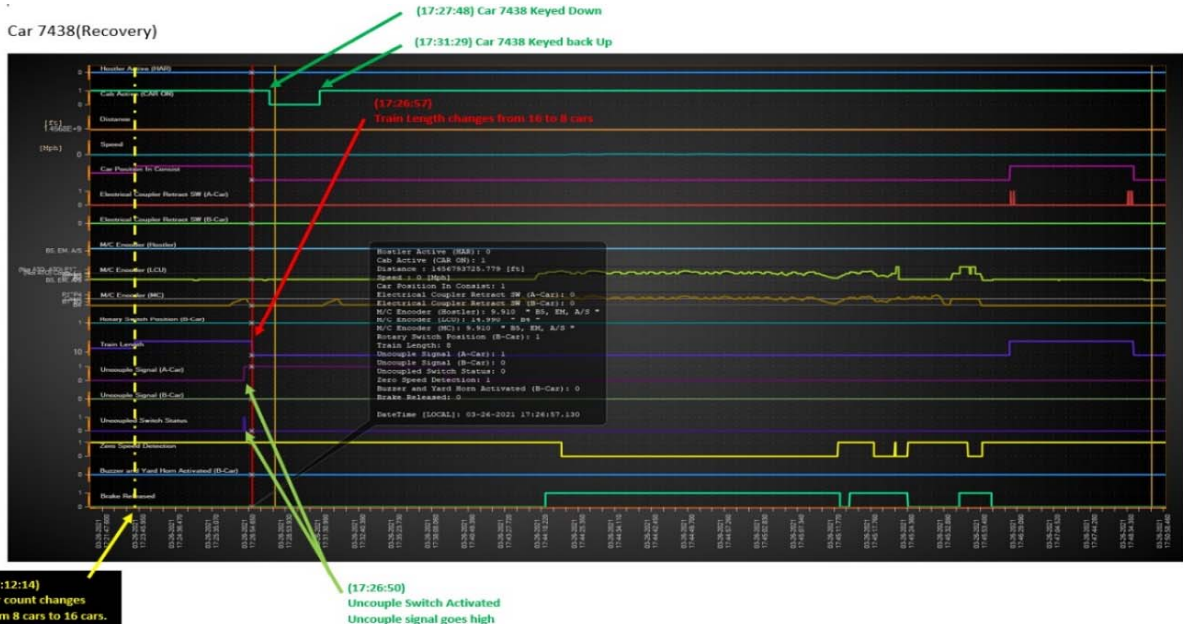
Based on the VMDS data, the two consists were initially coupled. While CMNT personnel were cutting out trucks on the disabled consist, the uncouple switch on the recovery consist Train ID 123 (Car 7438) was activated. Soon after, the console on car 7438 (Recovery Train) was keyed down. The Disabled Train was keyed up and back down. The Recovery Train was keyed back up during the time the trucks were still in the process of being cut out. After the last truck was cut out, the consist began to roll. The data shows trucks were then cut back in, and the disabled train came to a complete stop after traveling 137 feet. The consist was coupled again, and all trucks were cut back out. The train was then transported to Shady Grove Yard. The VMDS data is seen below.

Figure 1 - VMDS data of recovery train 7438 showing key down uncouple switch activation and the Train Operator keying down.

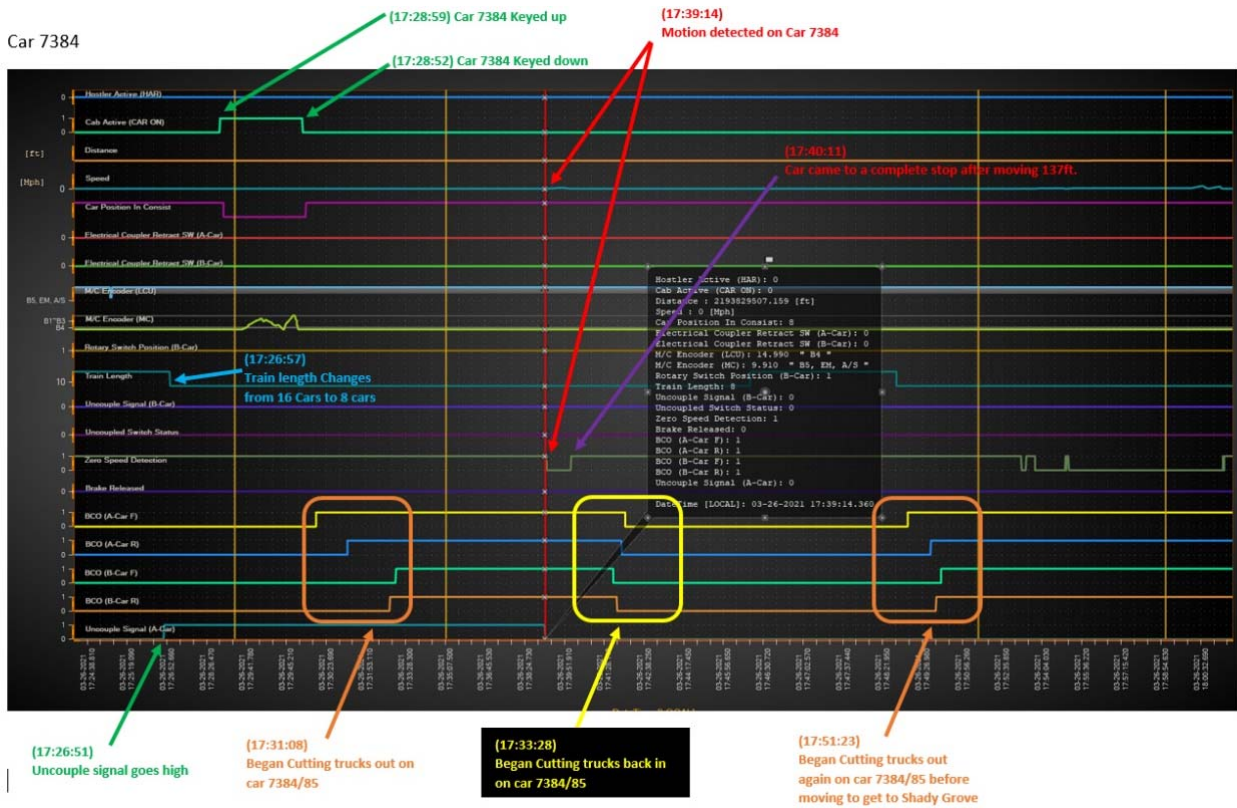
Figure 2 - VMDS data of recovery train 7384 showing train length change, key up and down up truck cut out and motion time parameters.

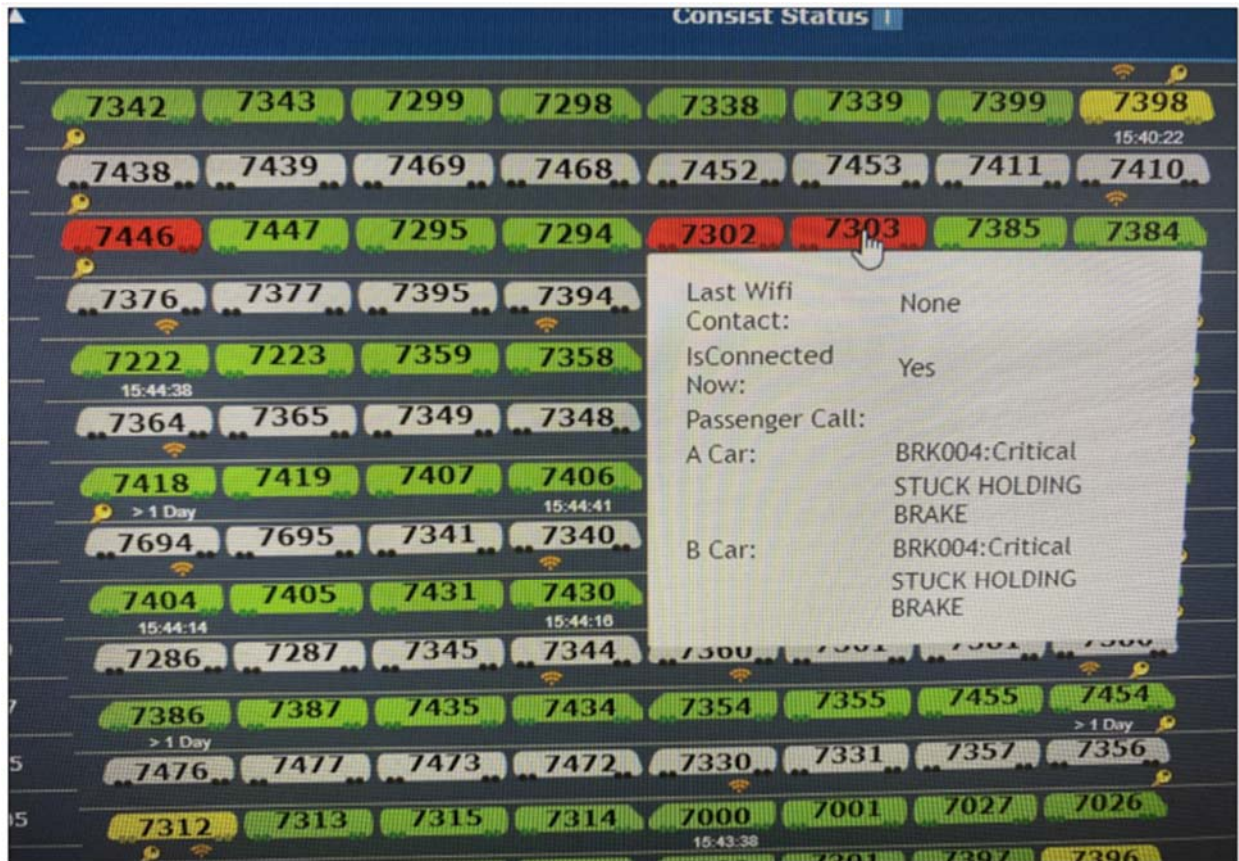
During the event, CMNT Desk reviewed the Fleet wise software data, which identifies failures of respective trains via remote access. The CMNT desk called the OPS 1 Button RTC to provide troubleshooting assistance. The CMNT Desk is relocated at Branch Ave Service and Inspection shop for COVID-19 mitigation. The screenshot below shows how the CMNT Desk remotely receives trouble information from the field; this image is captured from the trouble codes being sent from the disabled train.

Figure 3 - Fleet Wise software data display.

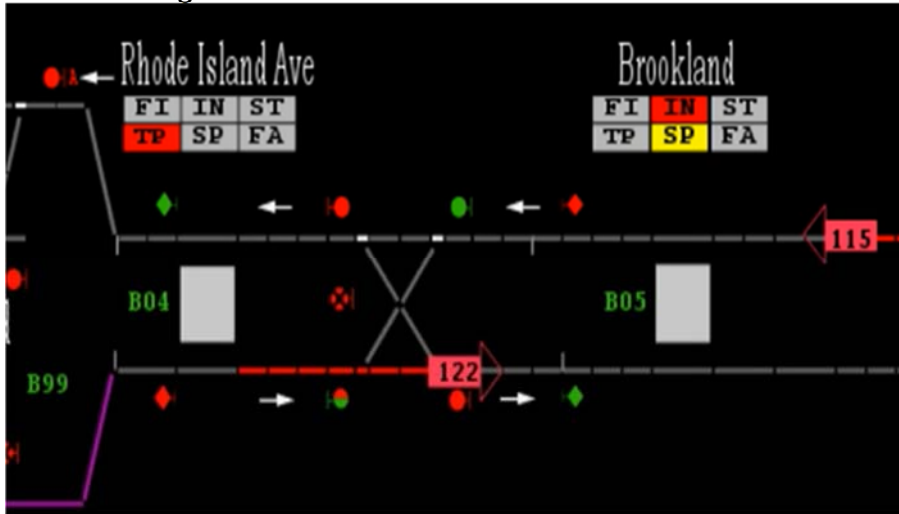
Diagram 1: Train 122 stopped due to a brake malfunction.

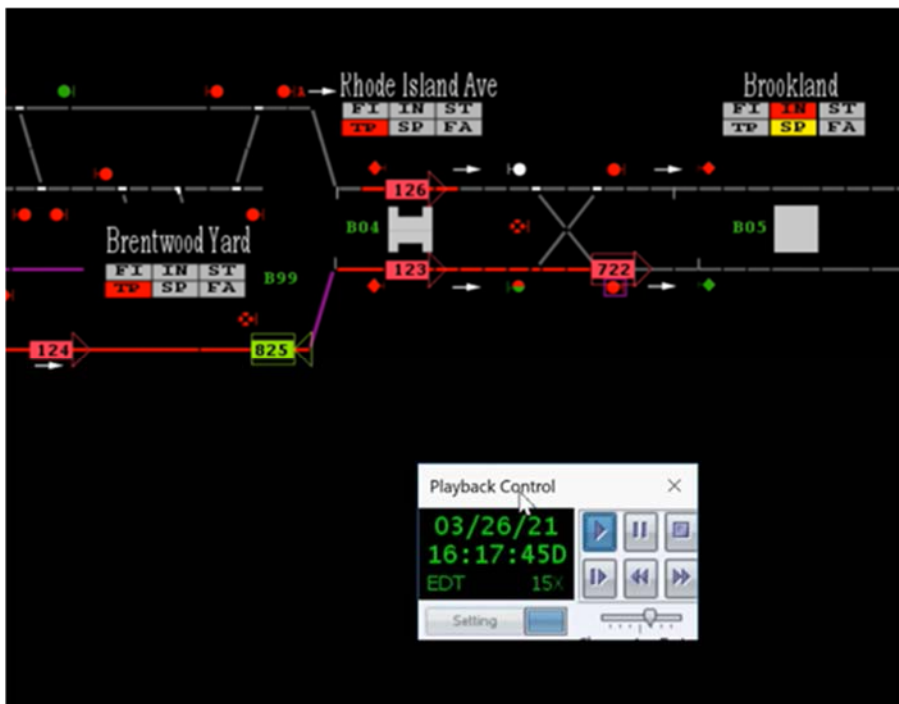
Diagram 2: Train ID 126 [First single-tracking Train] Serviced Rhode Island Track 2 Against traffic during the report of a customer on the Roadway. **Note: ROCC did not de-energize Third rail power for the first self-evacuating customer; the customer was on the platform limits in a timeframe of approximately 90 seconds.

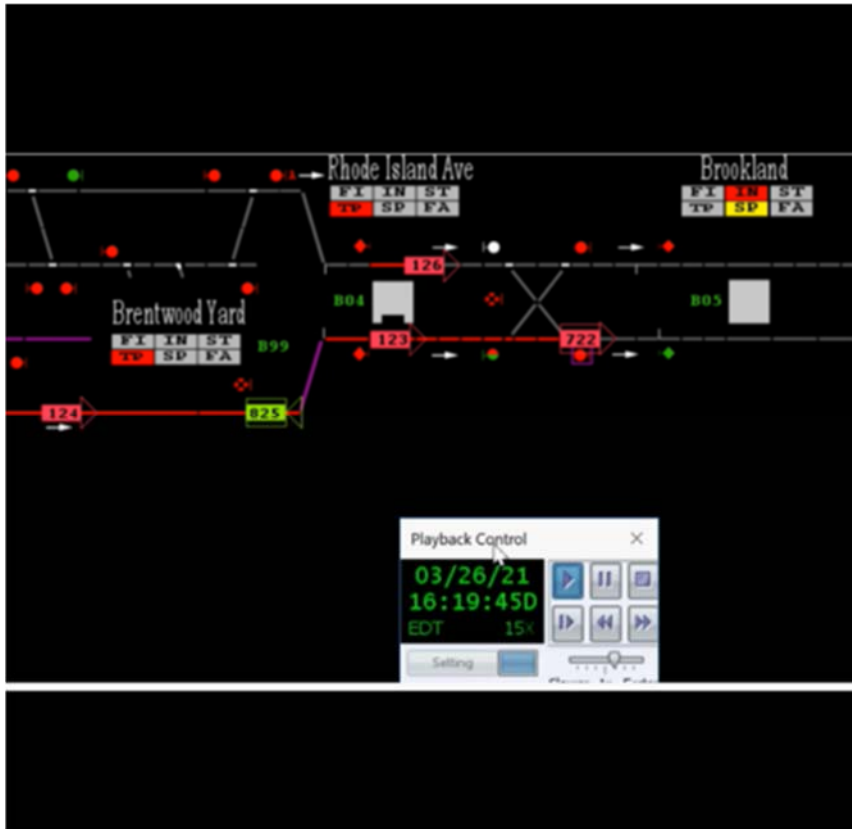
Diagram 3: Train ID 126 Departed Rhode Island Avenue Station after the customer was safely on the platform limits at Rhode Island Avenue Station.

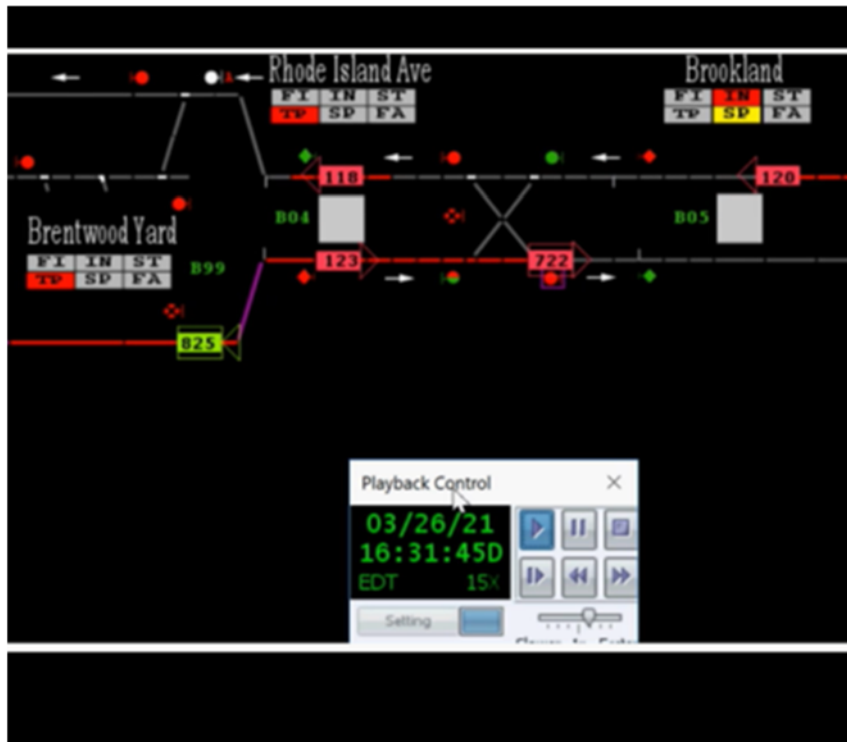
Diagram 4: Train ID 118 Serviced Rhode Island Avenue Station and operating with the normal flow of traffic on Track 2.

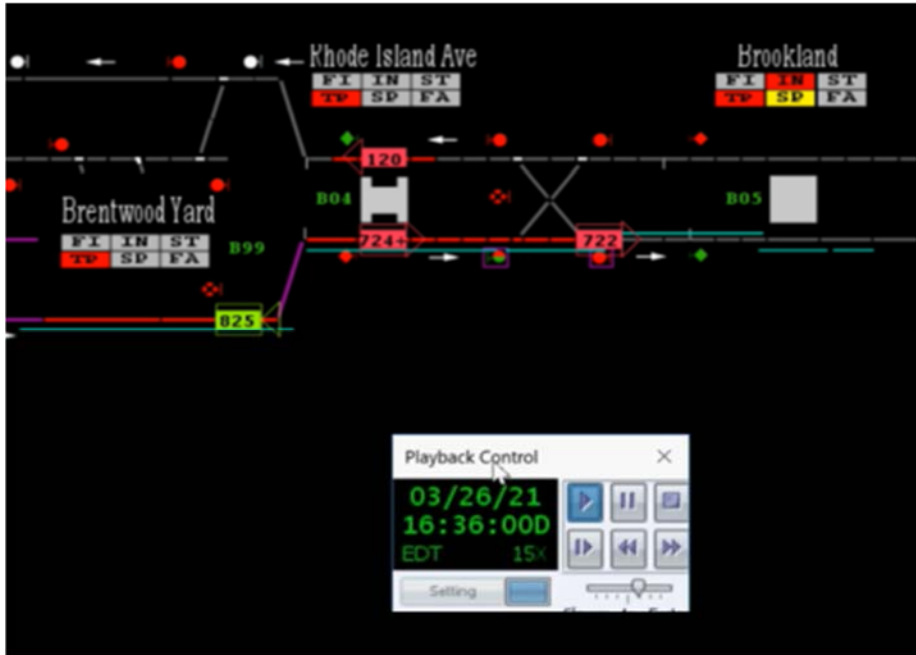
Diagram 5: Train ID 120 at Rhode Island Avenue Station, when ROCC de-energized Third Rail Power at approximately 16:36 hours. ** Note: Train ID 120 asked the Radio RTC if they wanted them to hold momentarily until the passenger was clear of the roadway. ARS playback did not yield evidence of the Radio RTC responding.

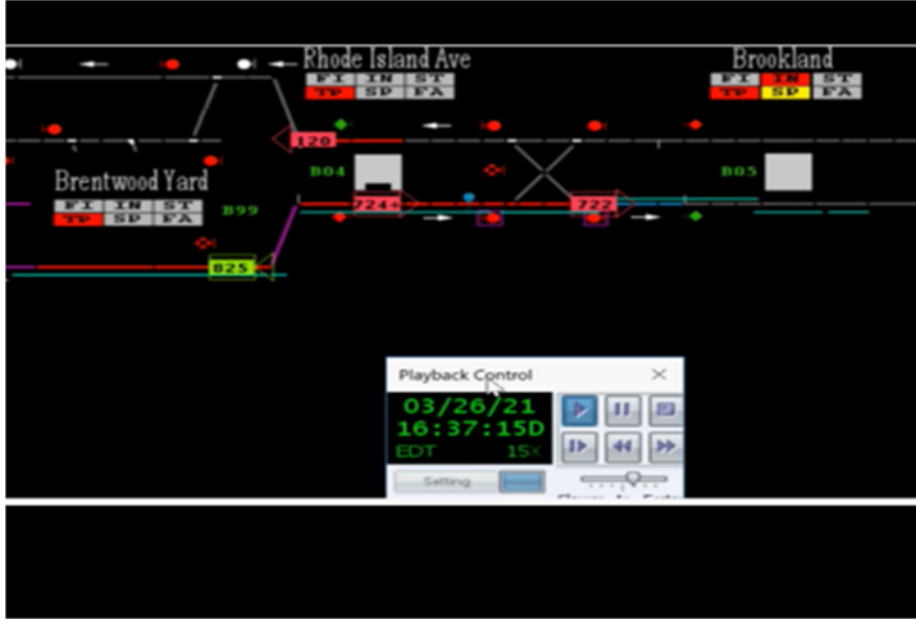
Diagram 6: Train ID 120 Serviced Rhode Island Avenue Station and Continued Operation Track 2 with the flow of traffic.

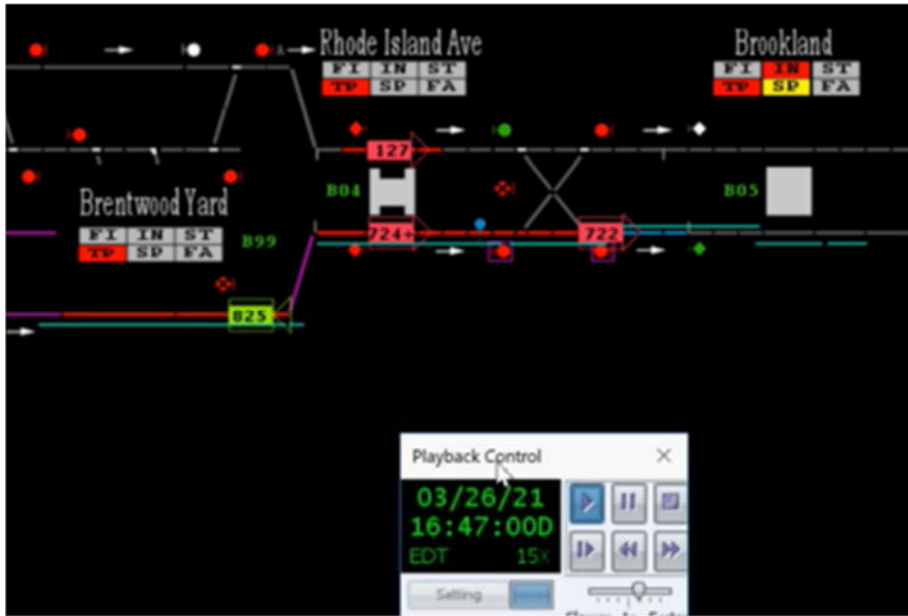
Diagram 7: Train ID 127 Serviced the Rhode Island Avenue Station Via Track 2 against the normal flow of Traffic at 1647 Hours
